FADED FOOTPRINTS

*Part 1;*  
*The story of the clean up on a portion of the Boisbriant property*

*by*  
*Douglas Cameron Ball*

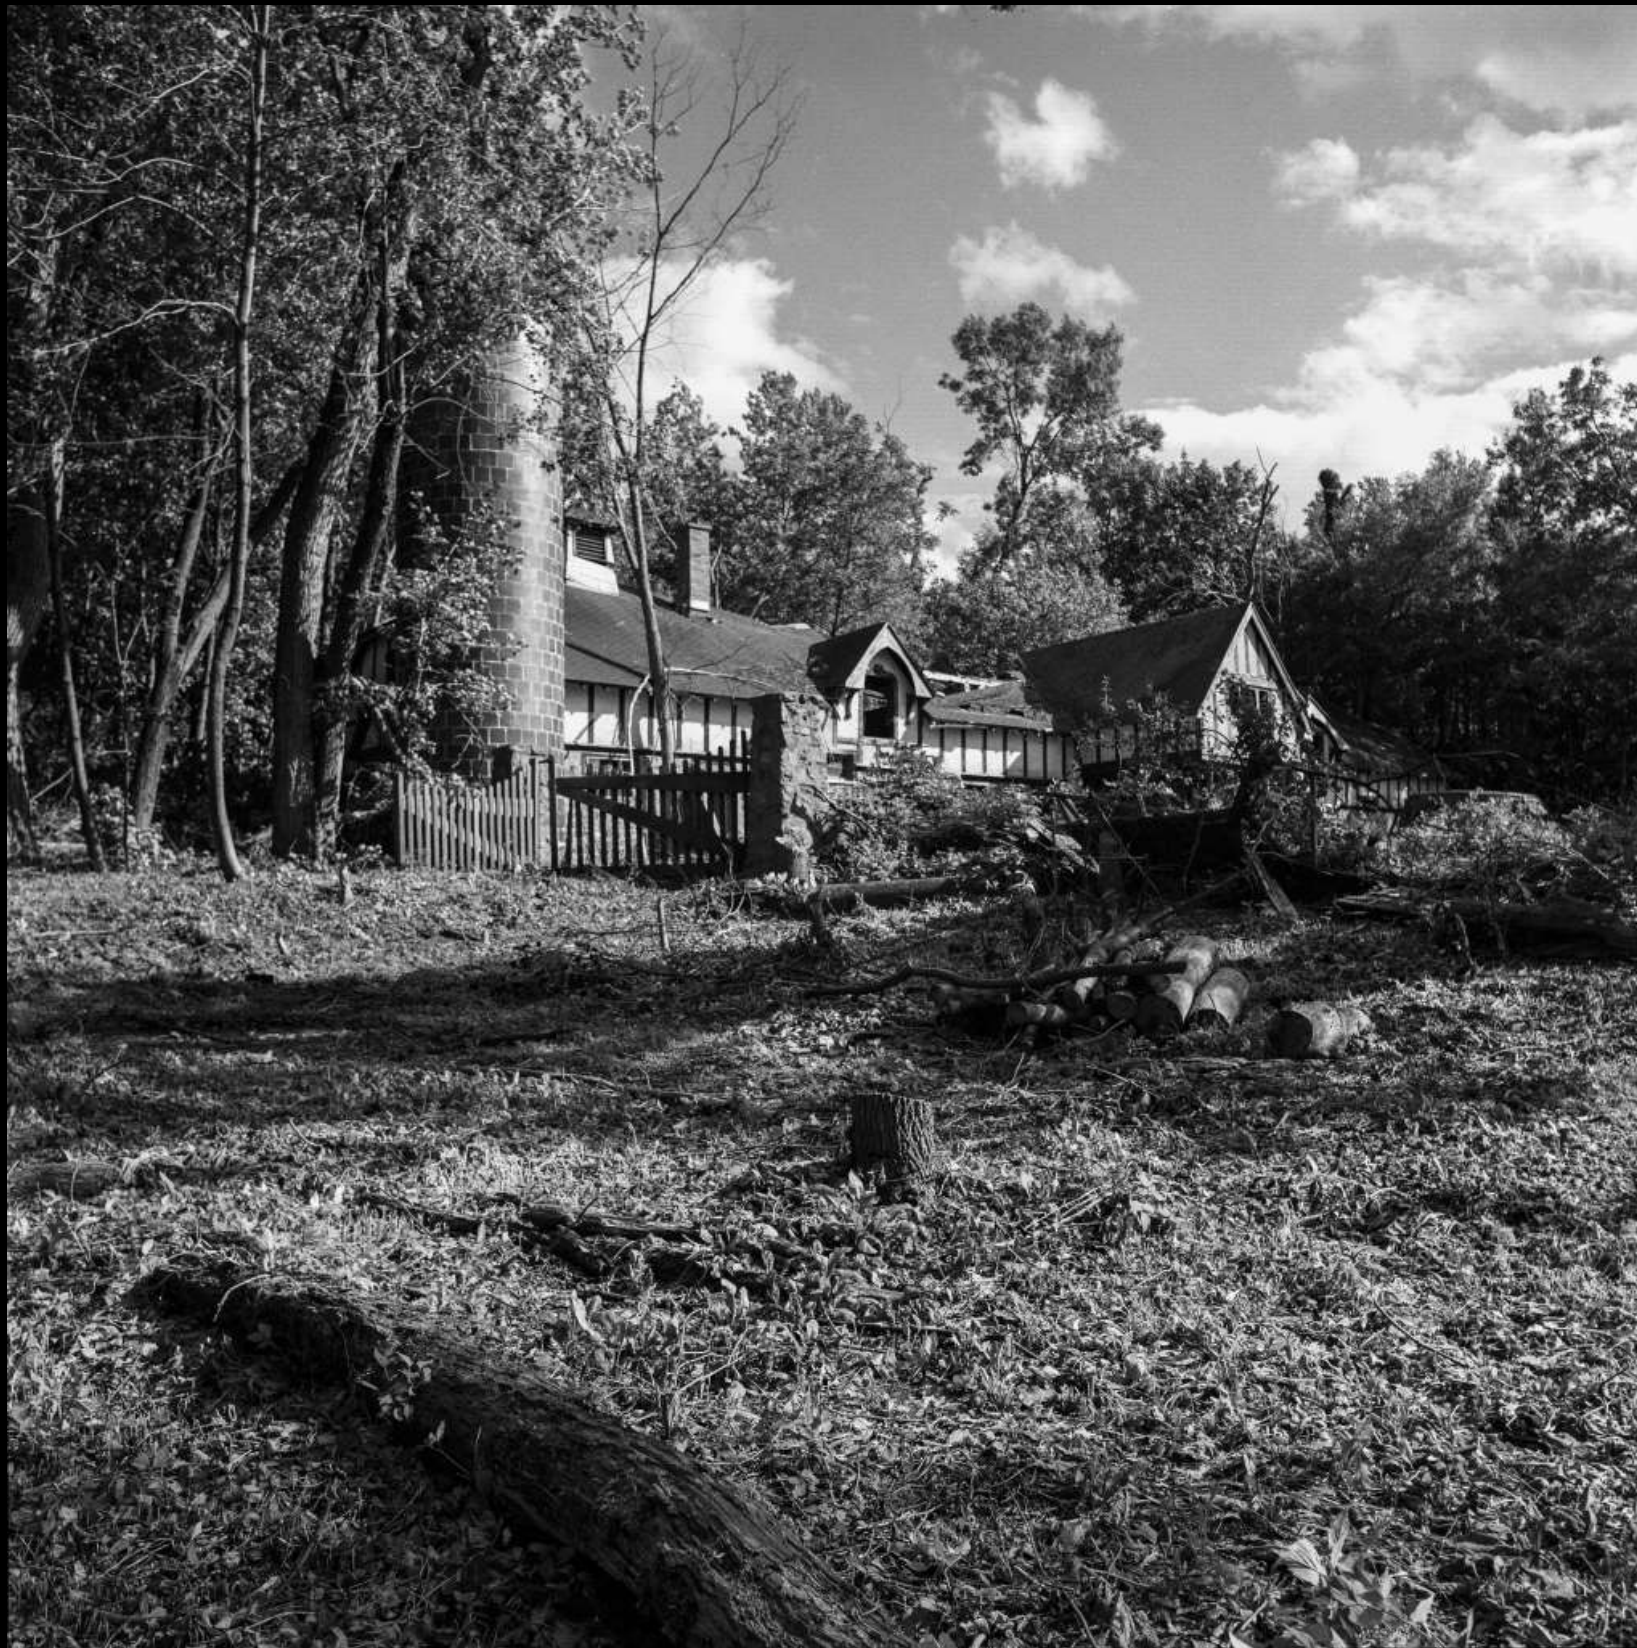
What must have been a truly magnificent stable had sadly suffered massive damage from the rear. The silo still stood however and was in relatively good condition.

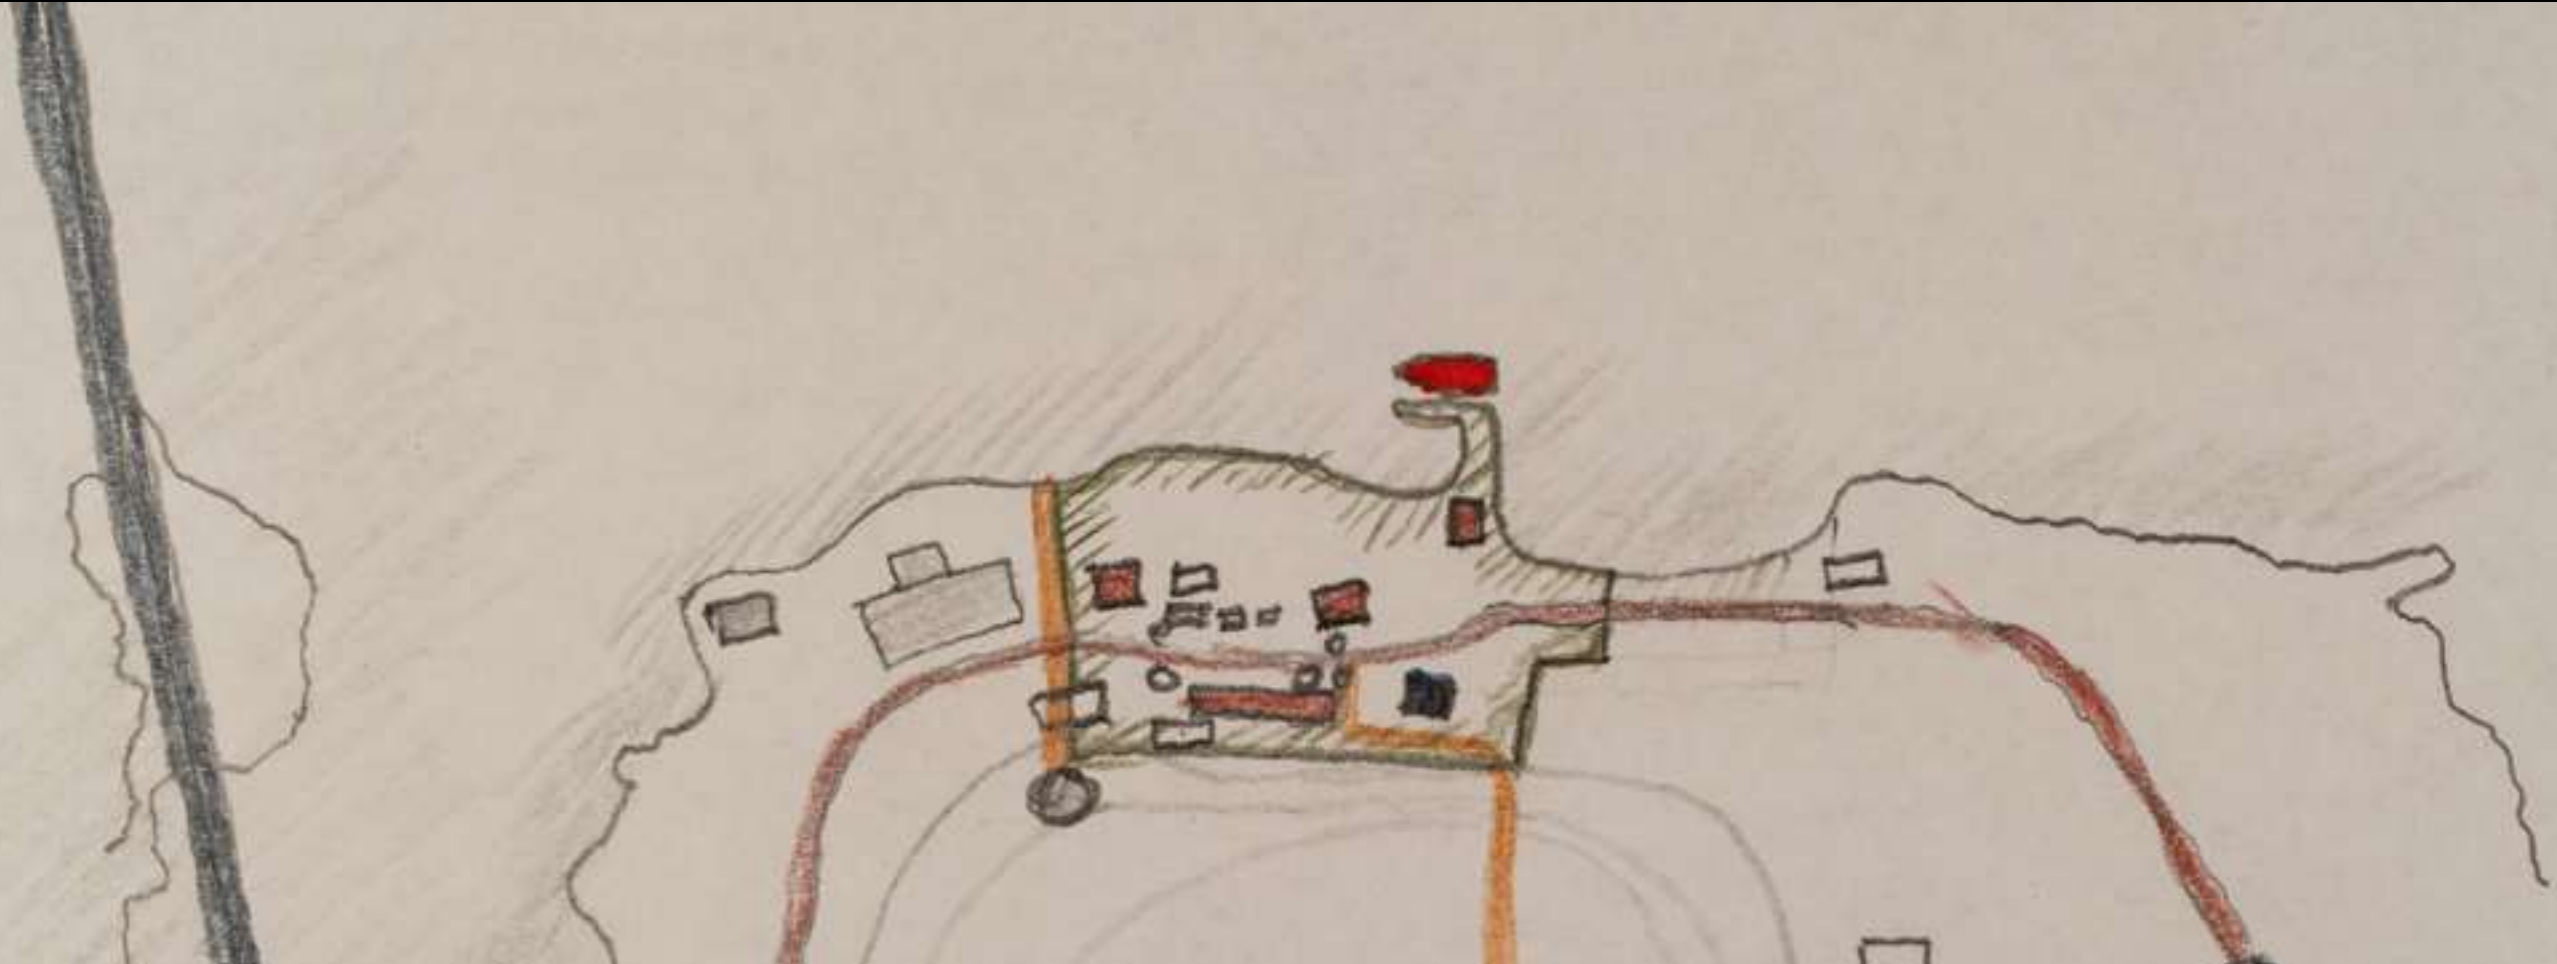
This drawing shows the property outlined in green. The buildings include the Stable, Squash Court, White House, and the Power House down by the water. Also shown is the pier built to allow a steamboat to be tied up. The red road was the original Senneville Road that passed through the property.

The yellow line is the new road into the property. To the left is the original main house, and to the left of that is what remains of Fort Senneville. The very first fortification ( round tower) is shown in green on the bottom left of what was Rosanna Seaborne Todd's property.

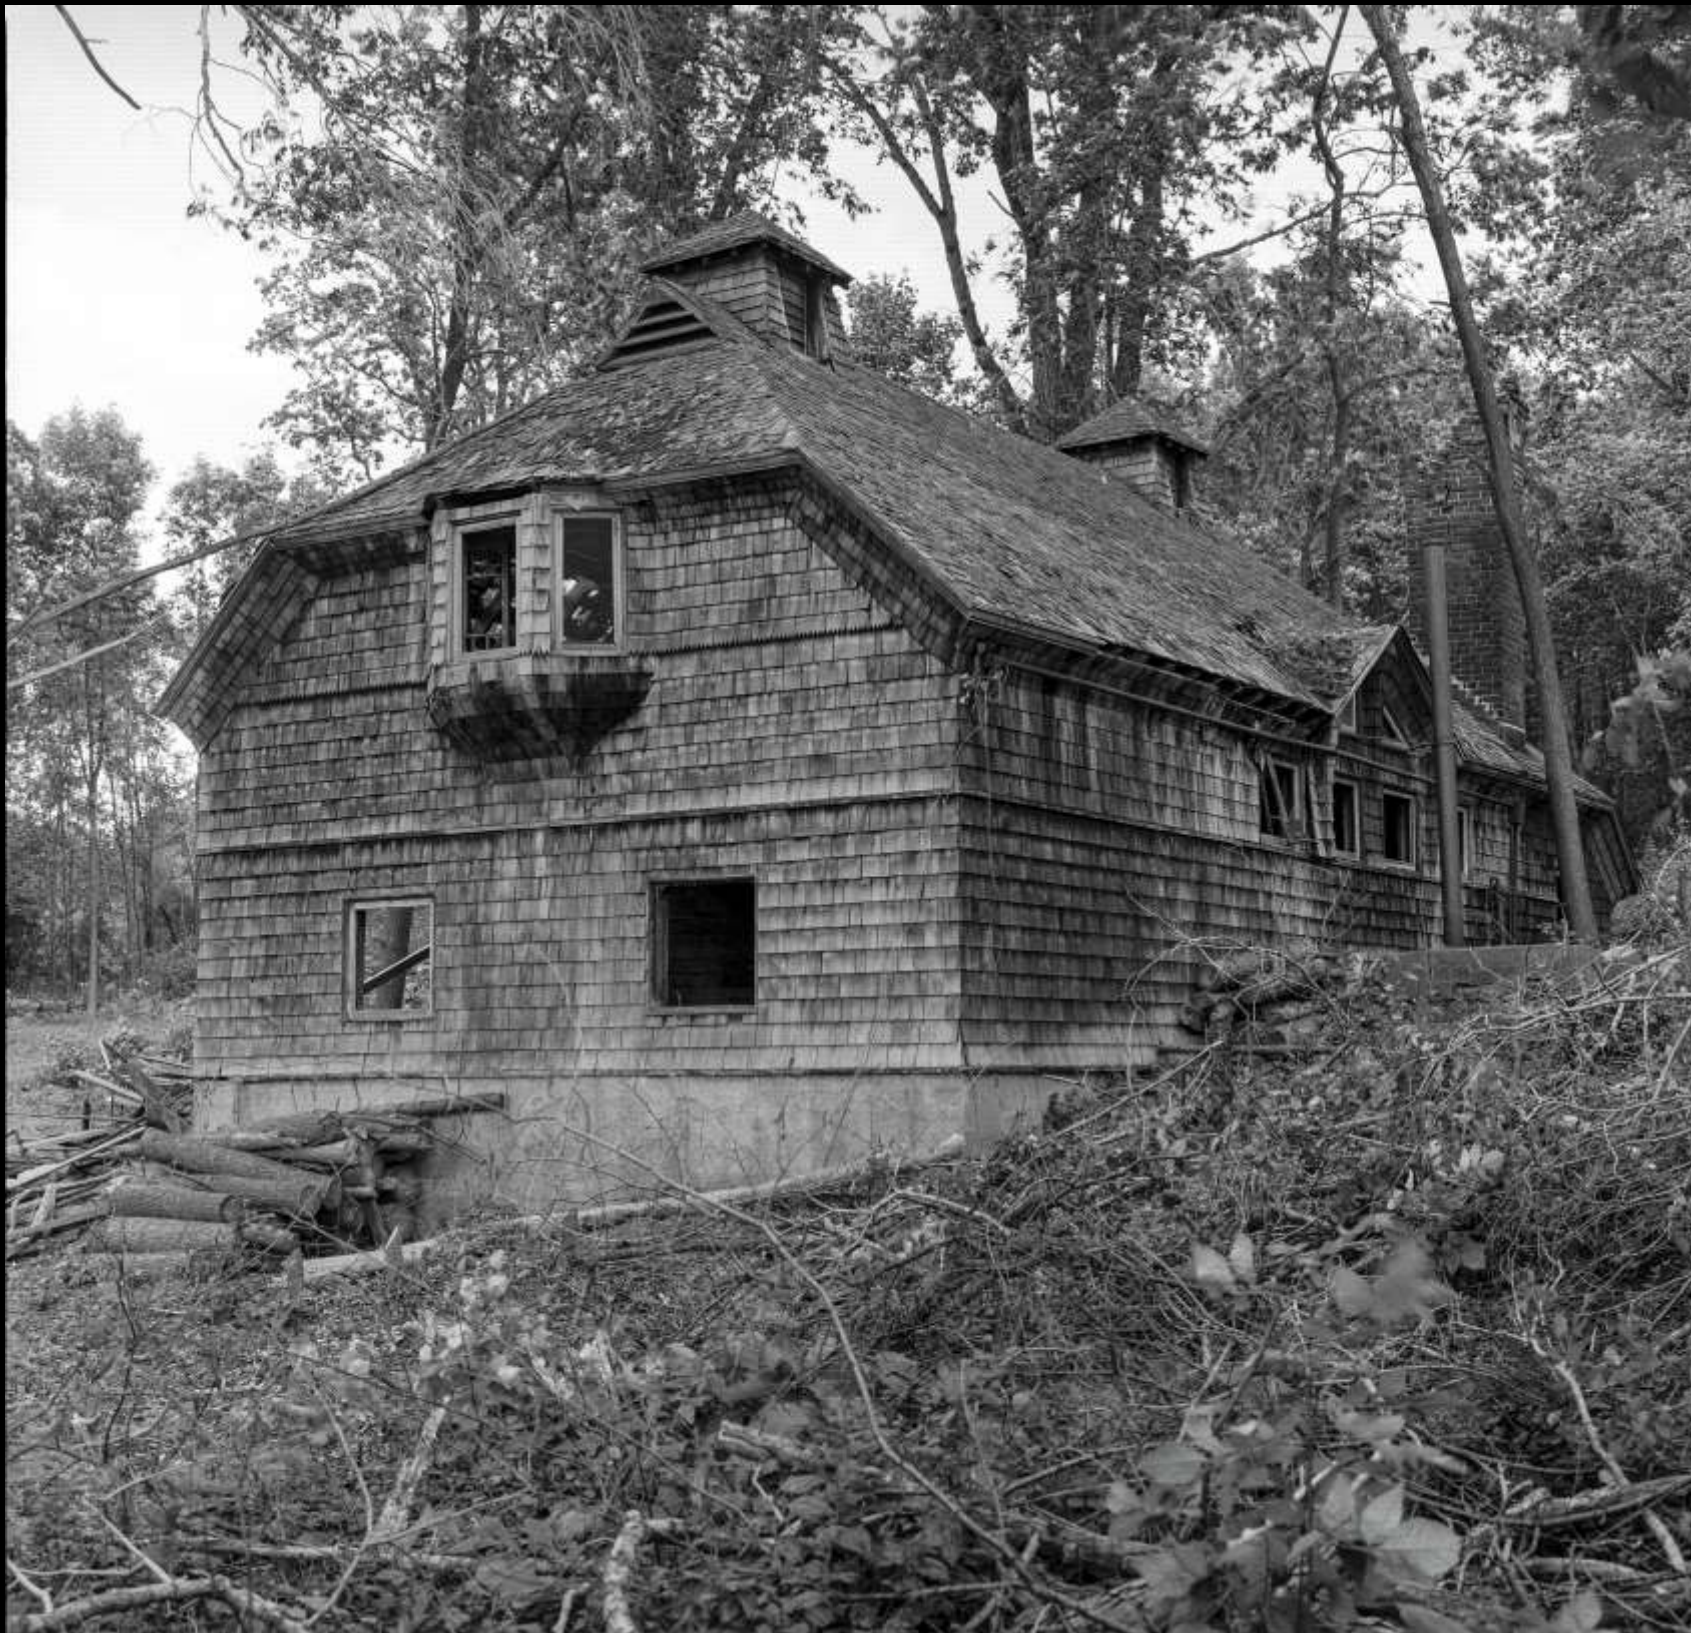
**The Power House;**

**The sills of the side walls were so rotten, you could move them in or out by pushing with your hands. Another big wind could have taken it down.**

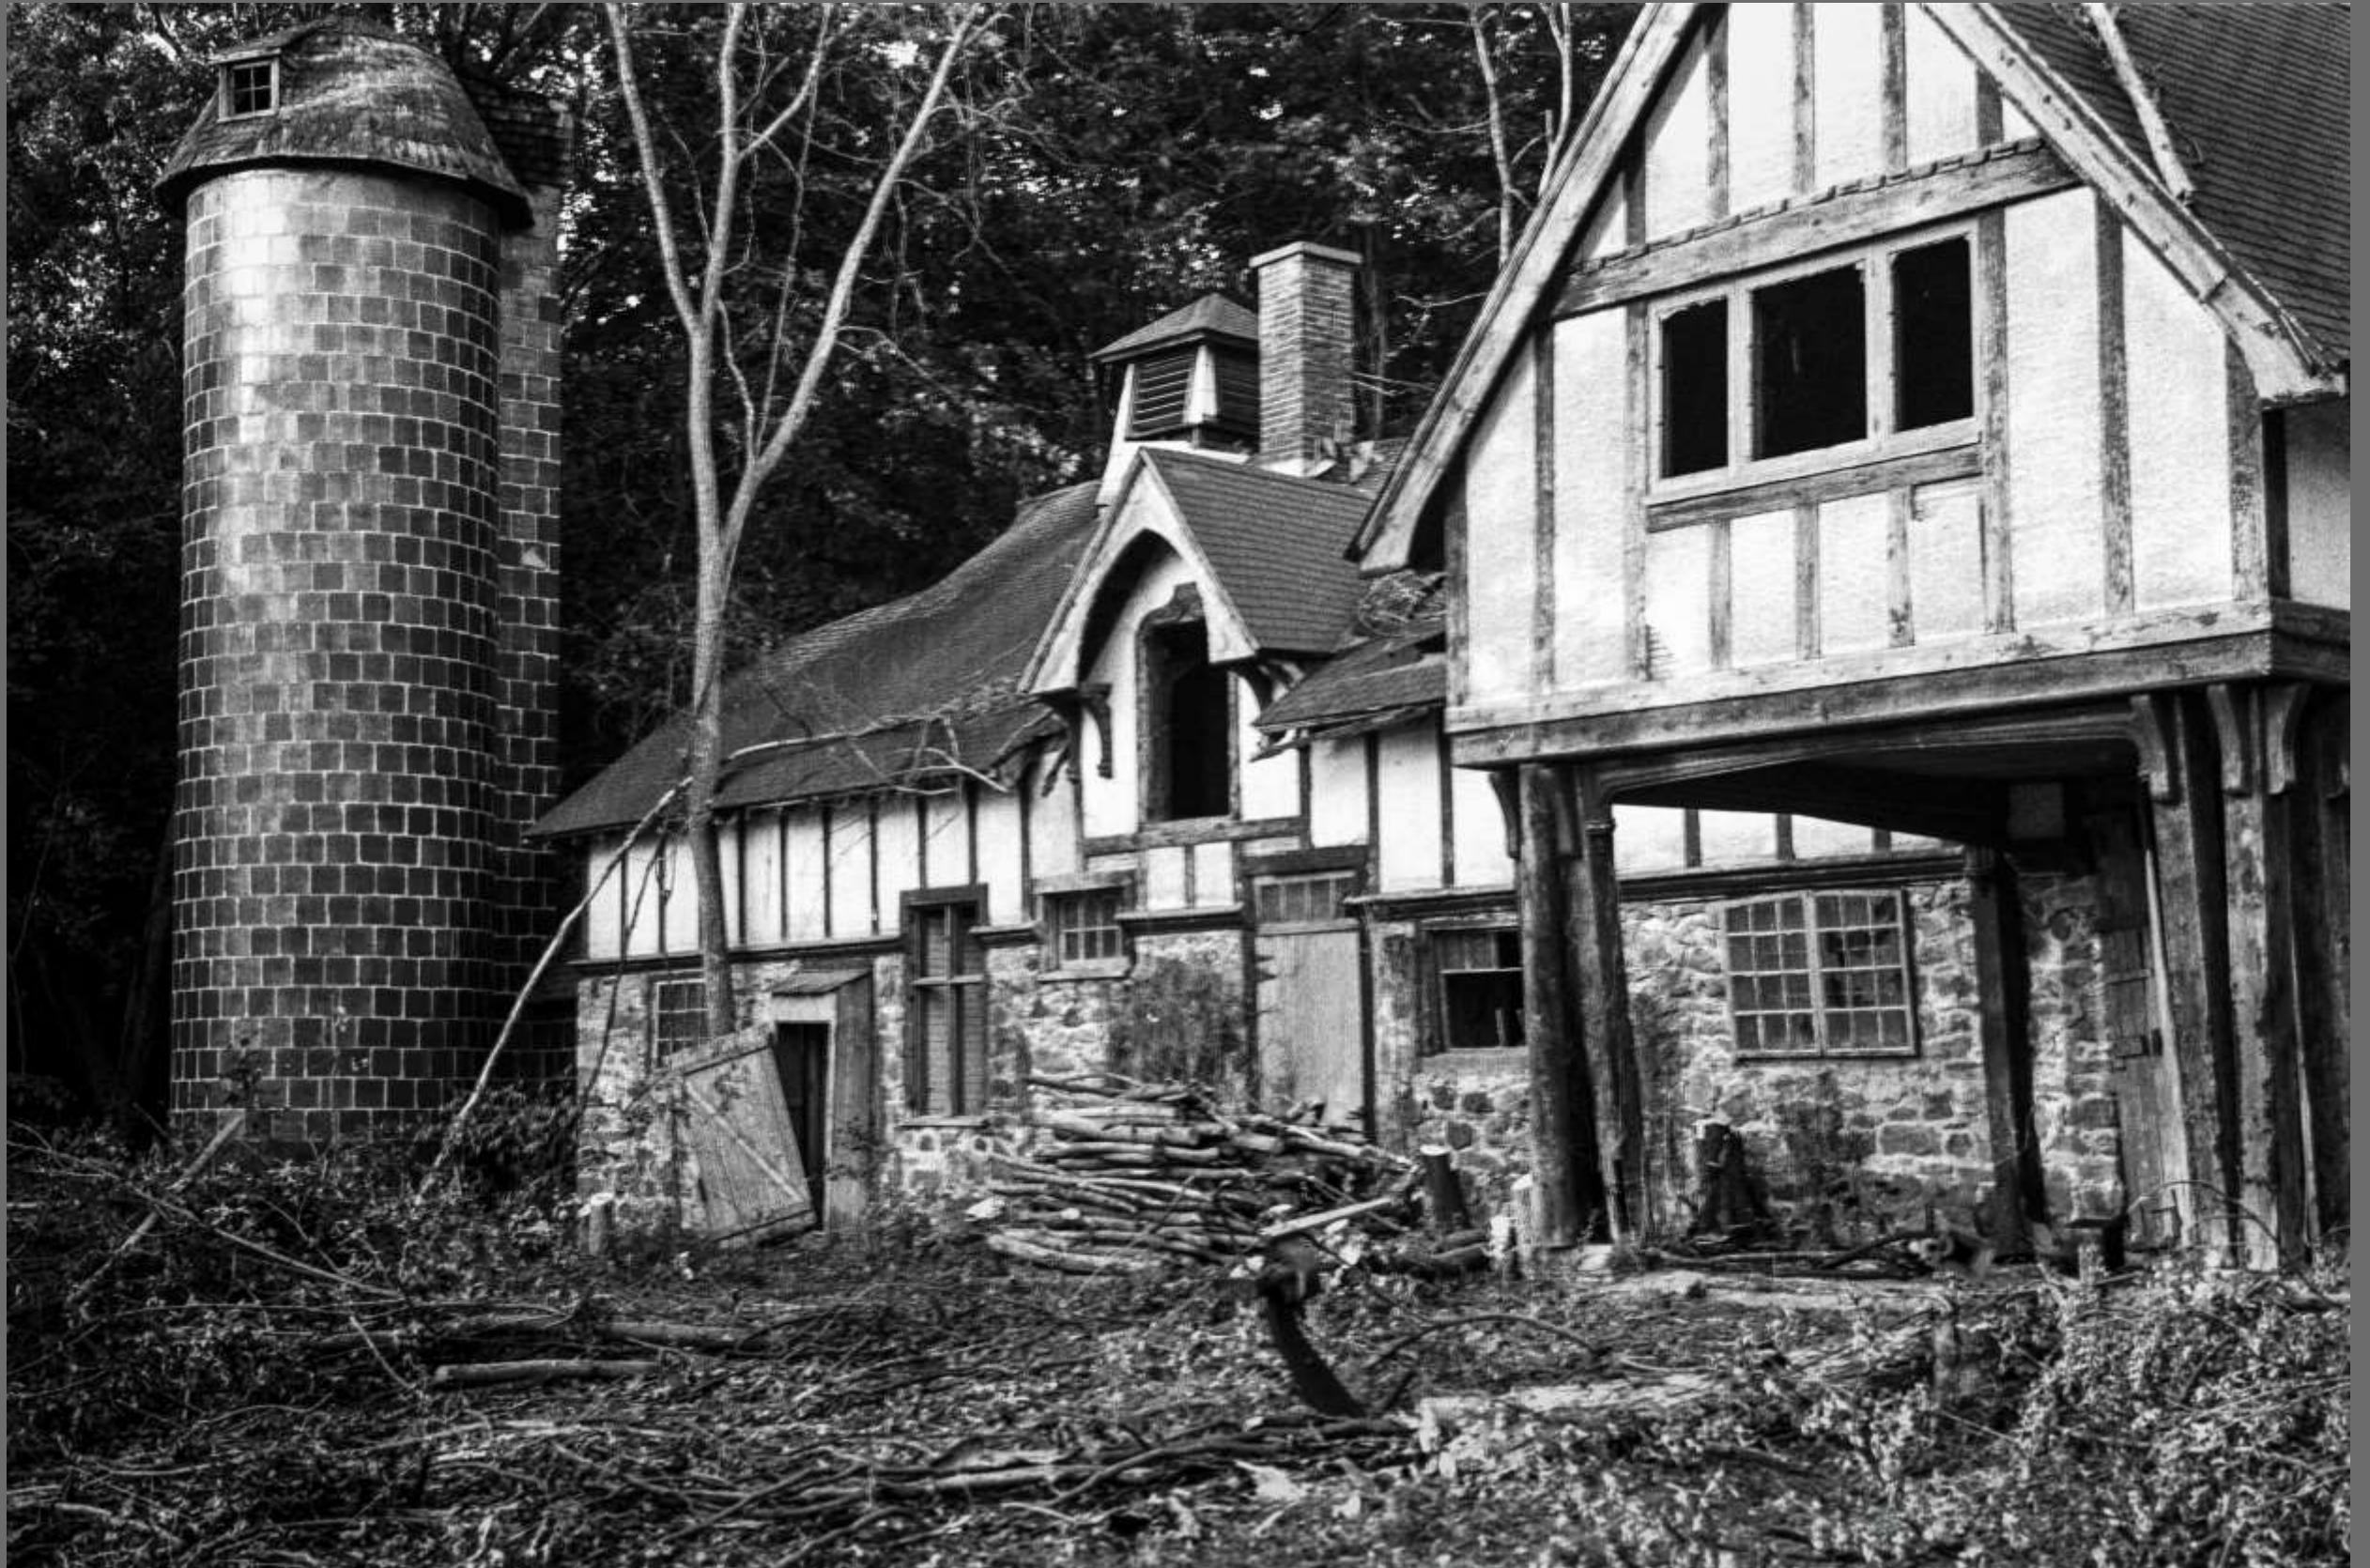
**The stable was 140 ft long, with the towering silo on the left end. The stable interior was lined with glazed white brick, and the ceiling appeared to be redwood.**

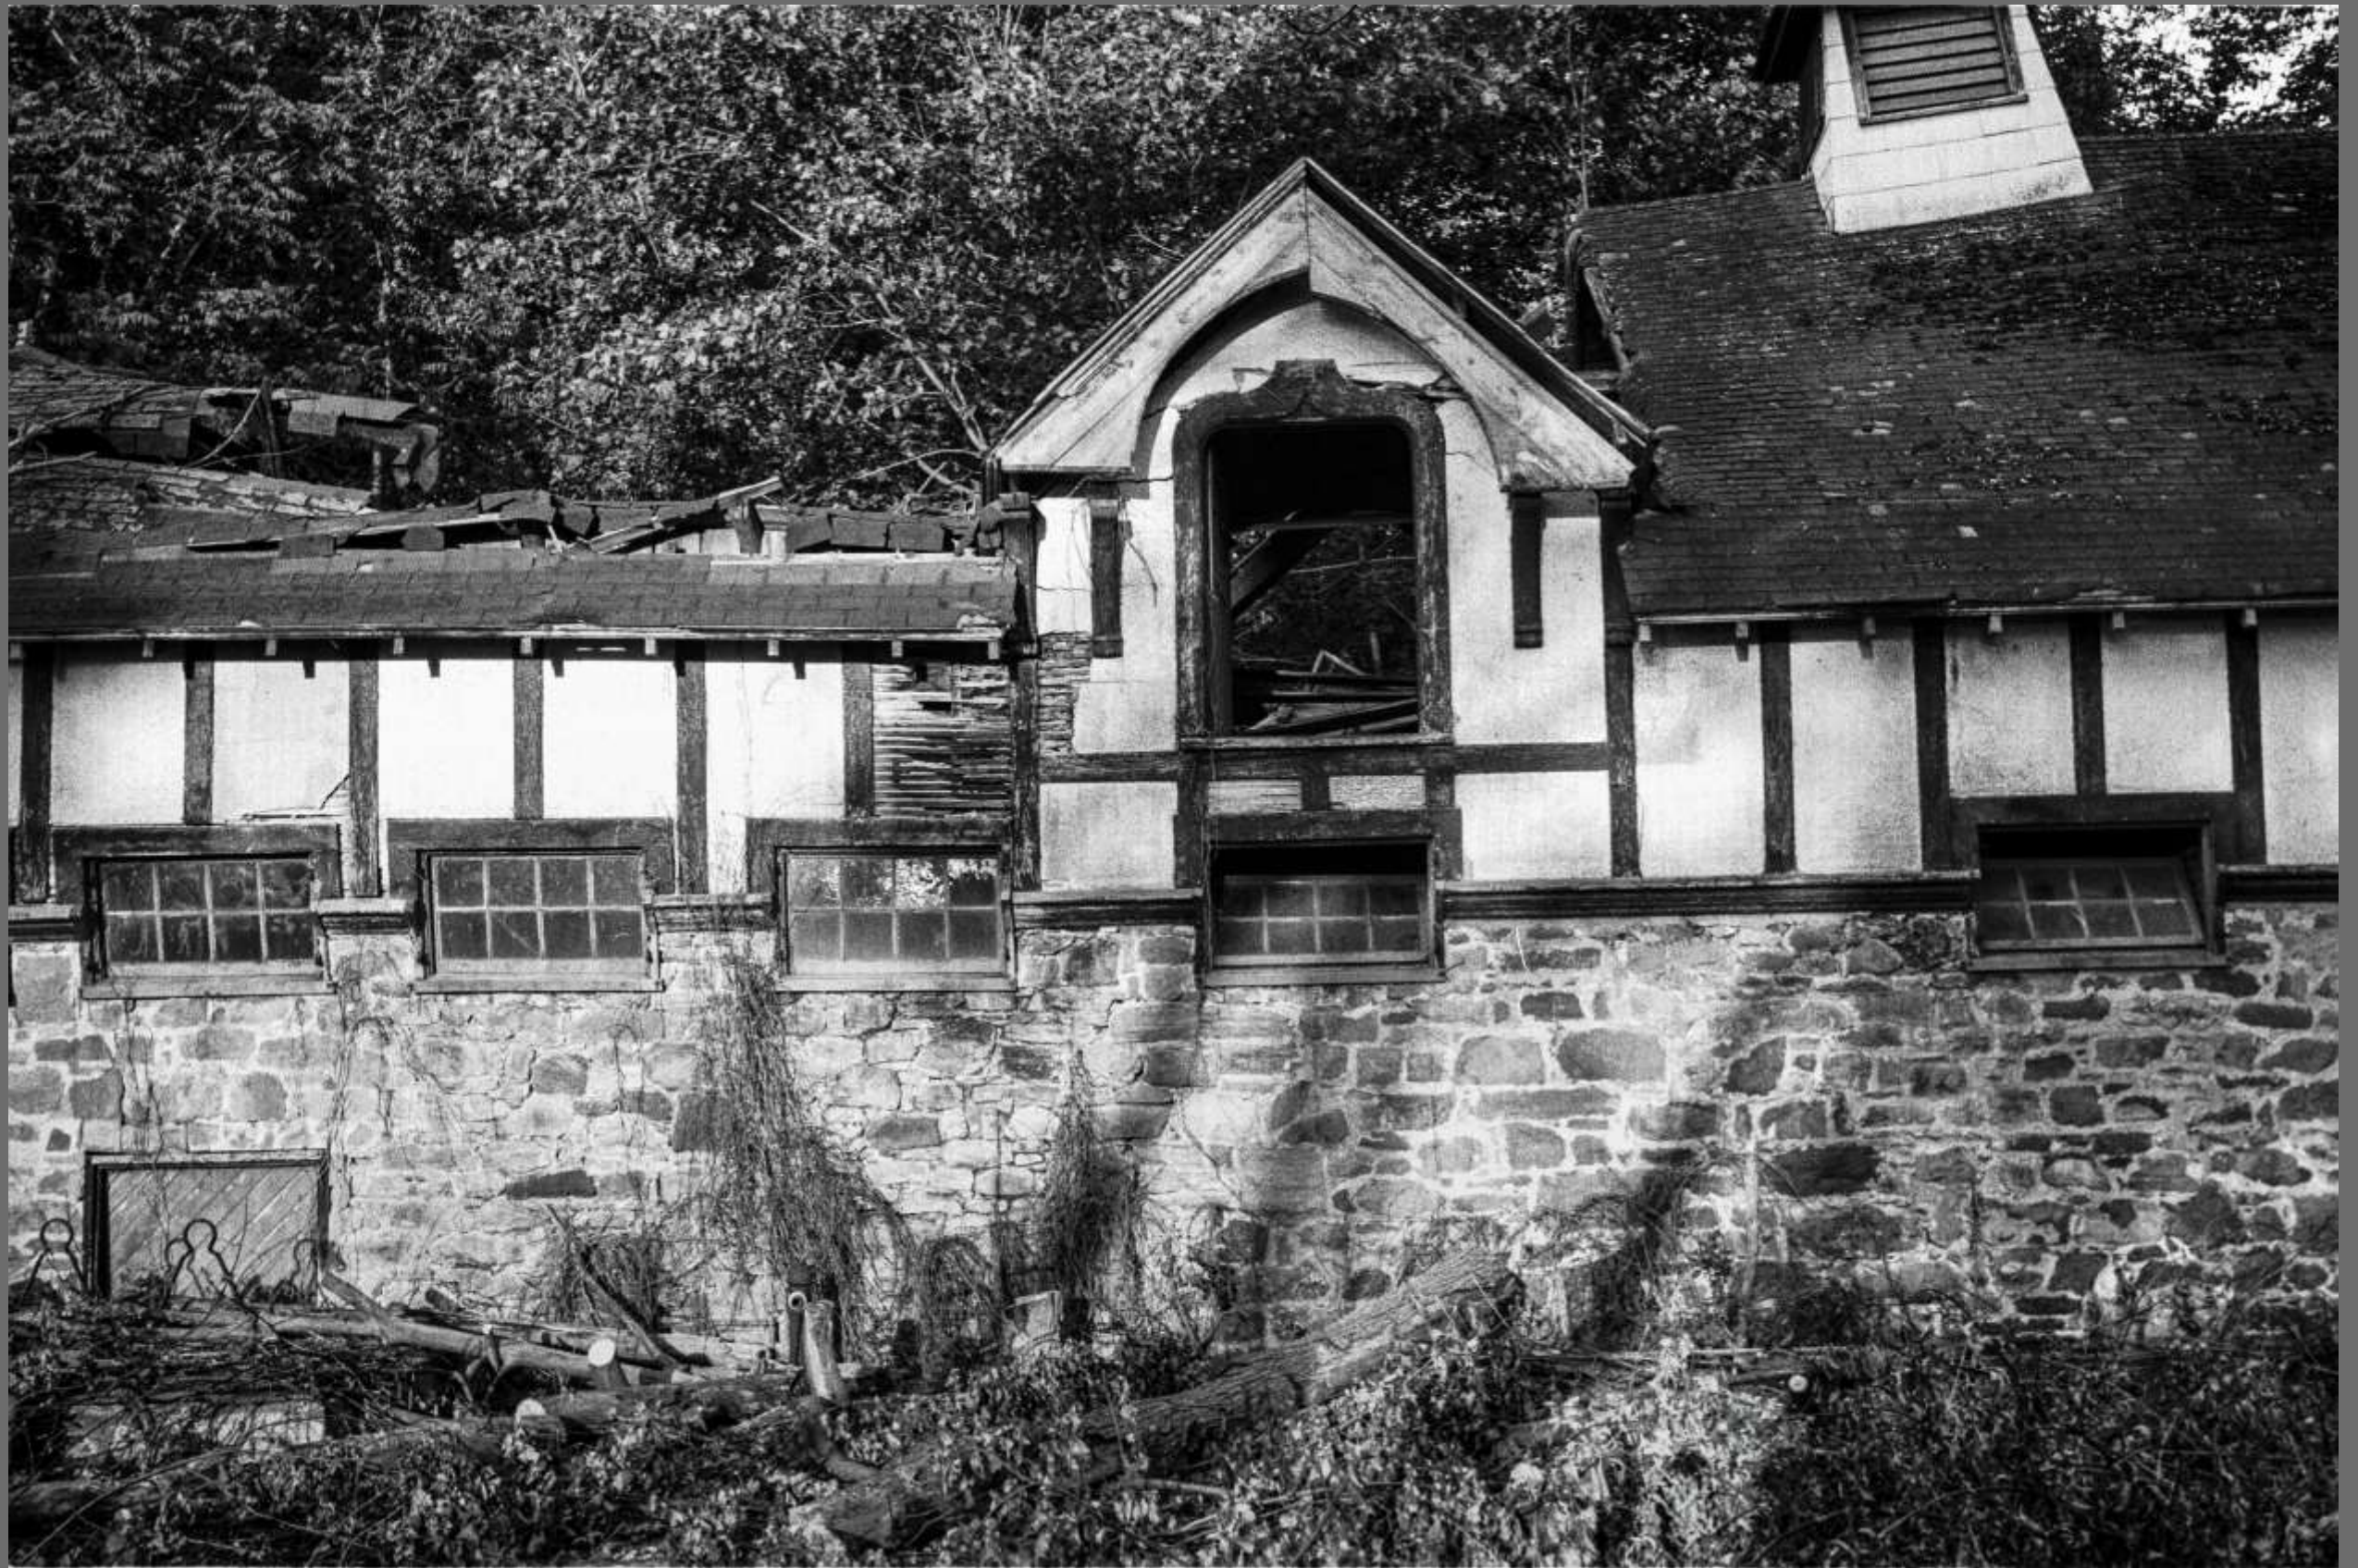
**Sadly, the building was beyond repair.  
The rear foundation wall had collapsed inward, which then caused everything else to break up.  
We did save the stone foundation wall and it was incorporated into the new design  
with the new garage and studio space positioned behind it.**

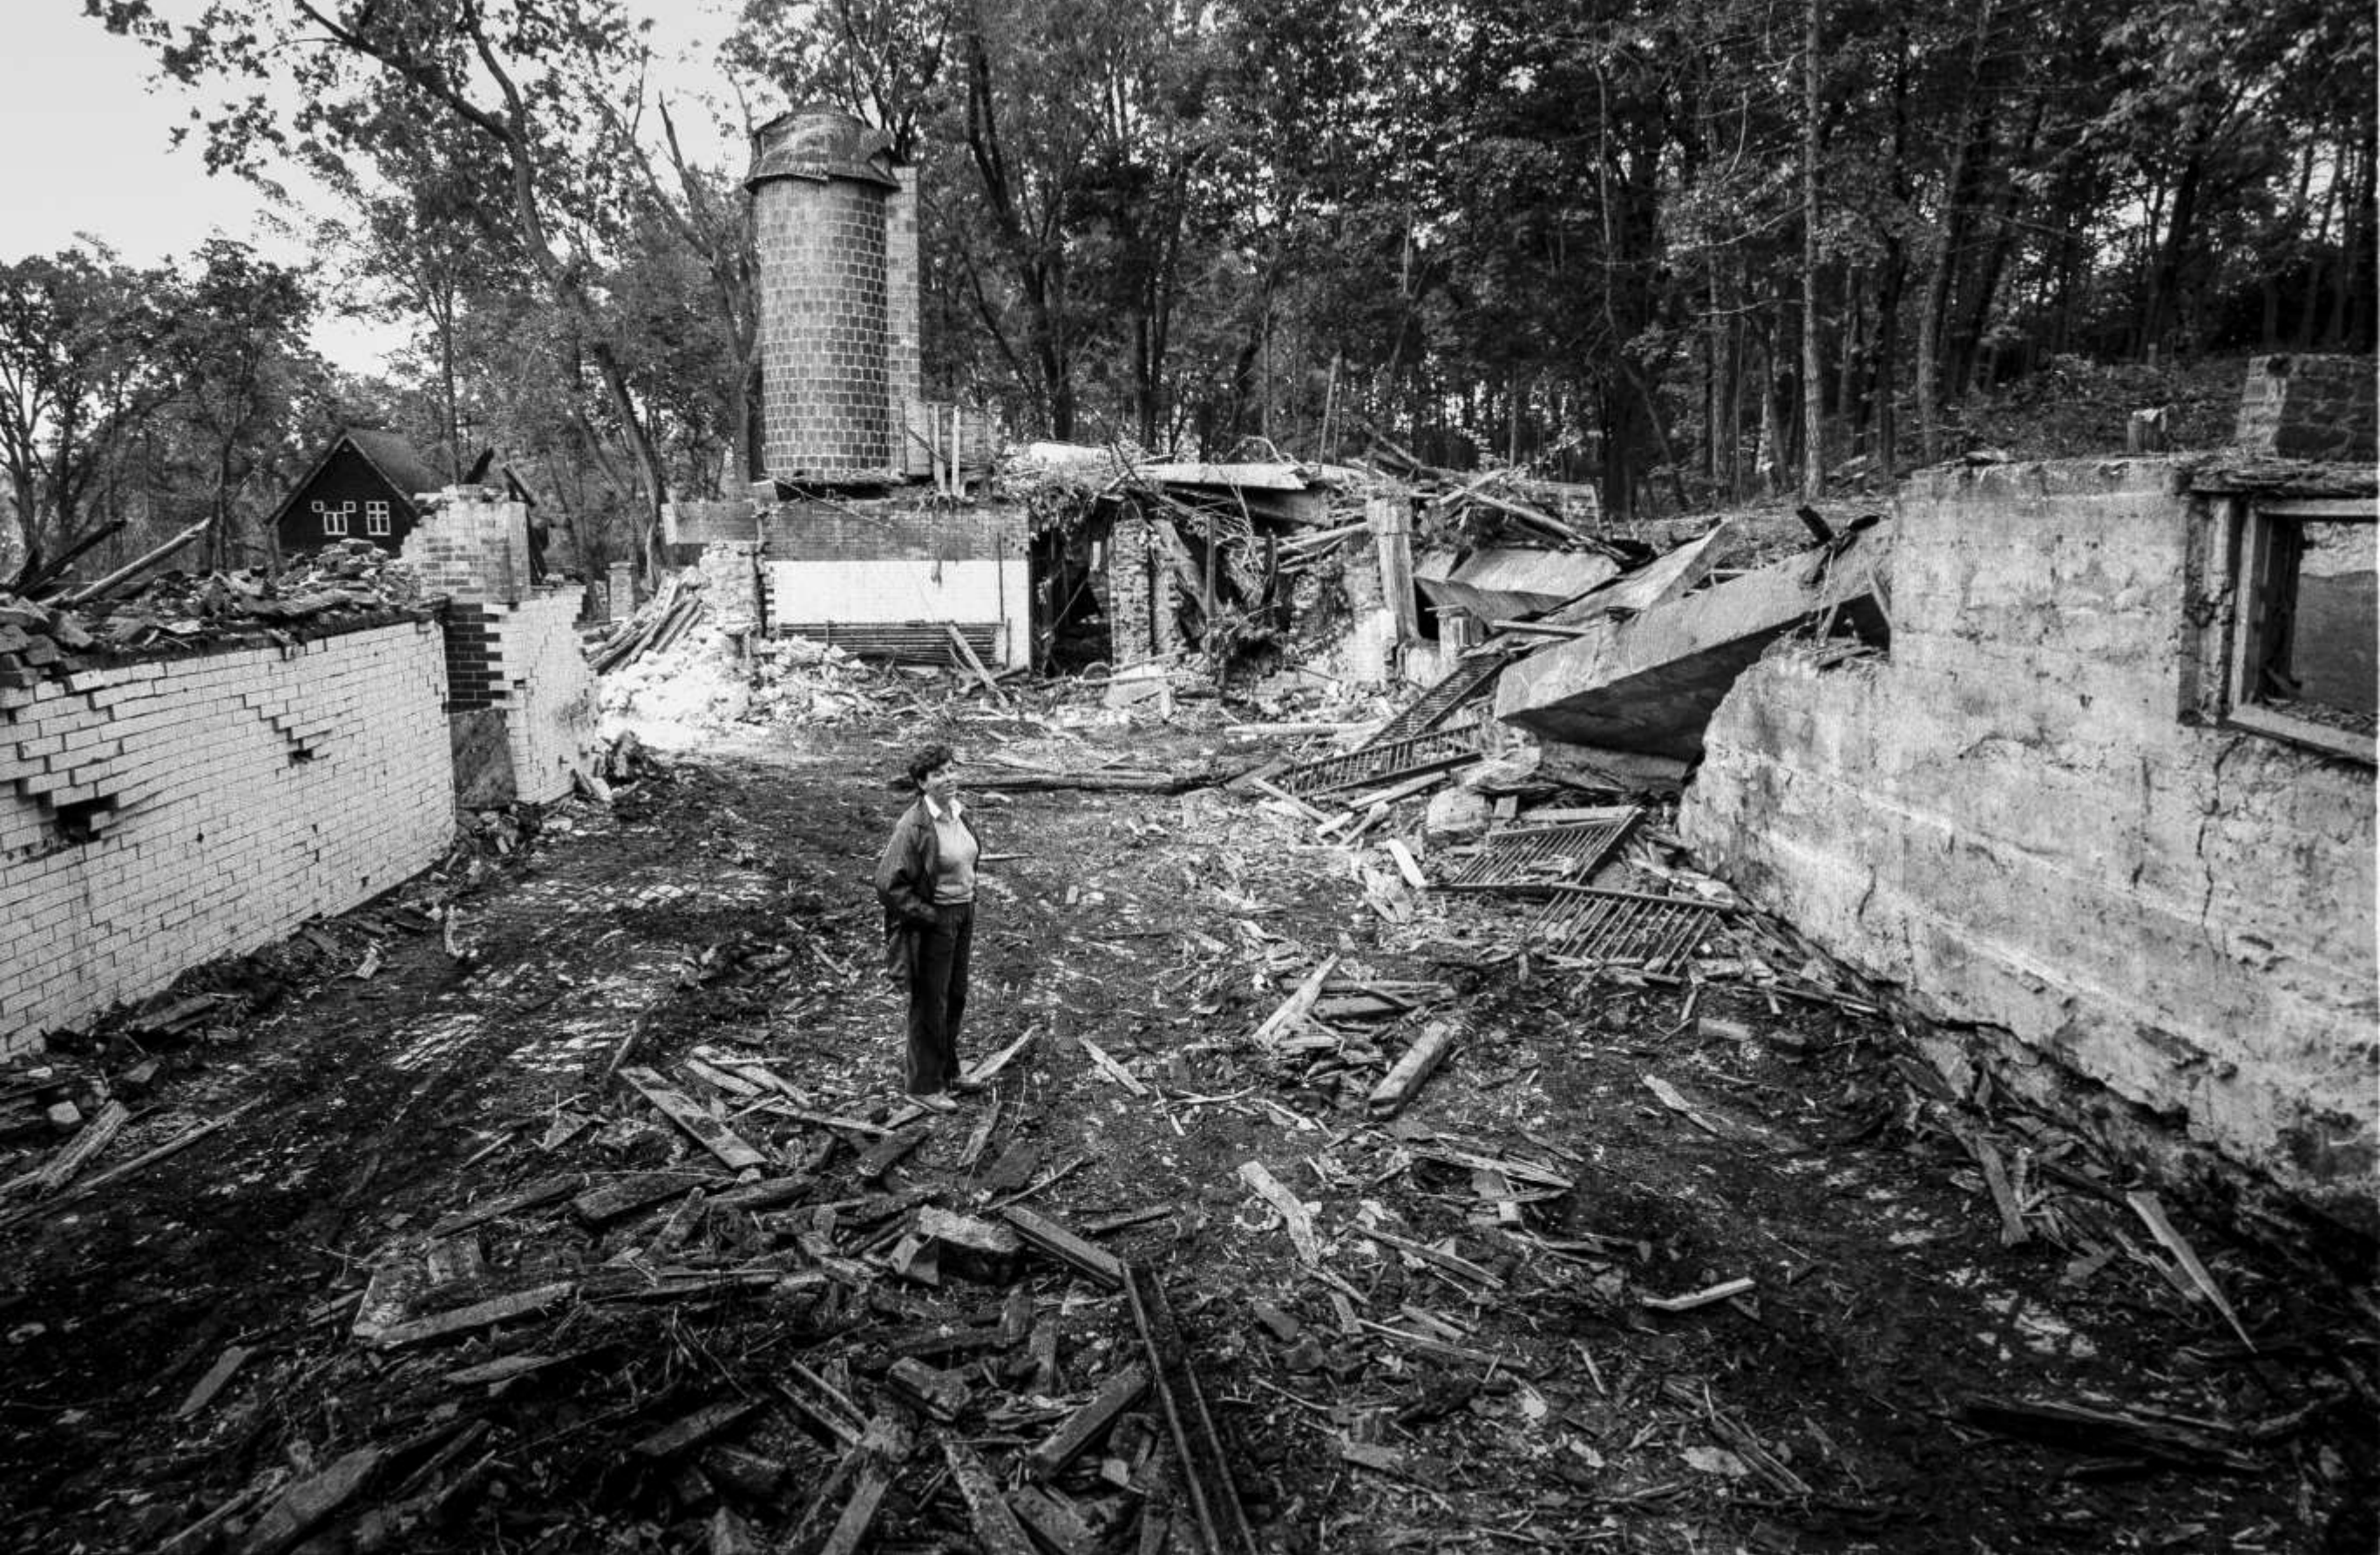
**The retaining wall to the rear cracked open and smashed into the foundation wall causing it to rupture as well. Unfortunately, they were not making use of steel reinforced concrete in those days.**
