FADED FOOTPRINTS

*Part 1;*  
*The story of the clean up on a portion of the Boisbriant property*

*by*  
*Douglas Cameron Ball*

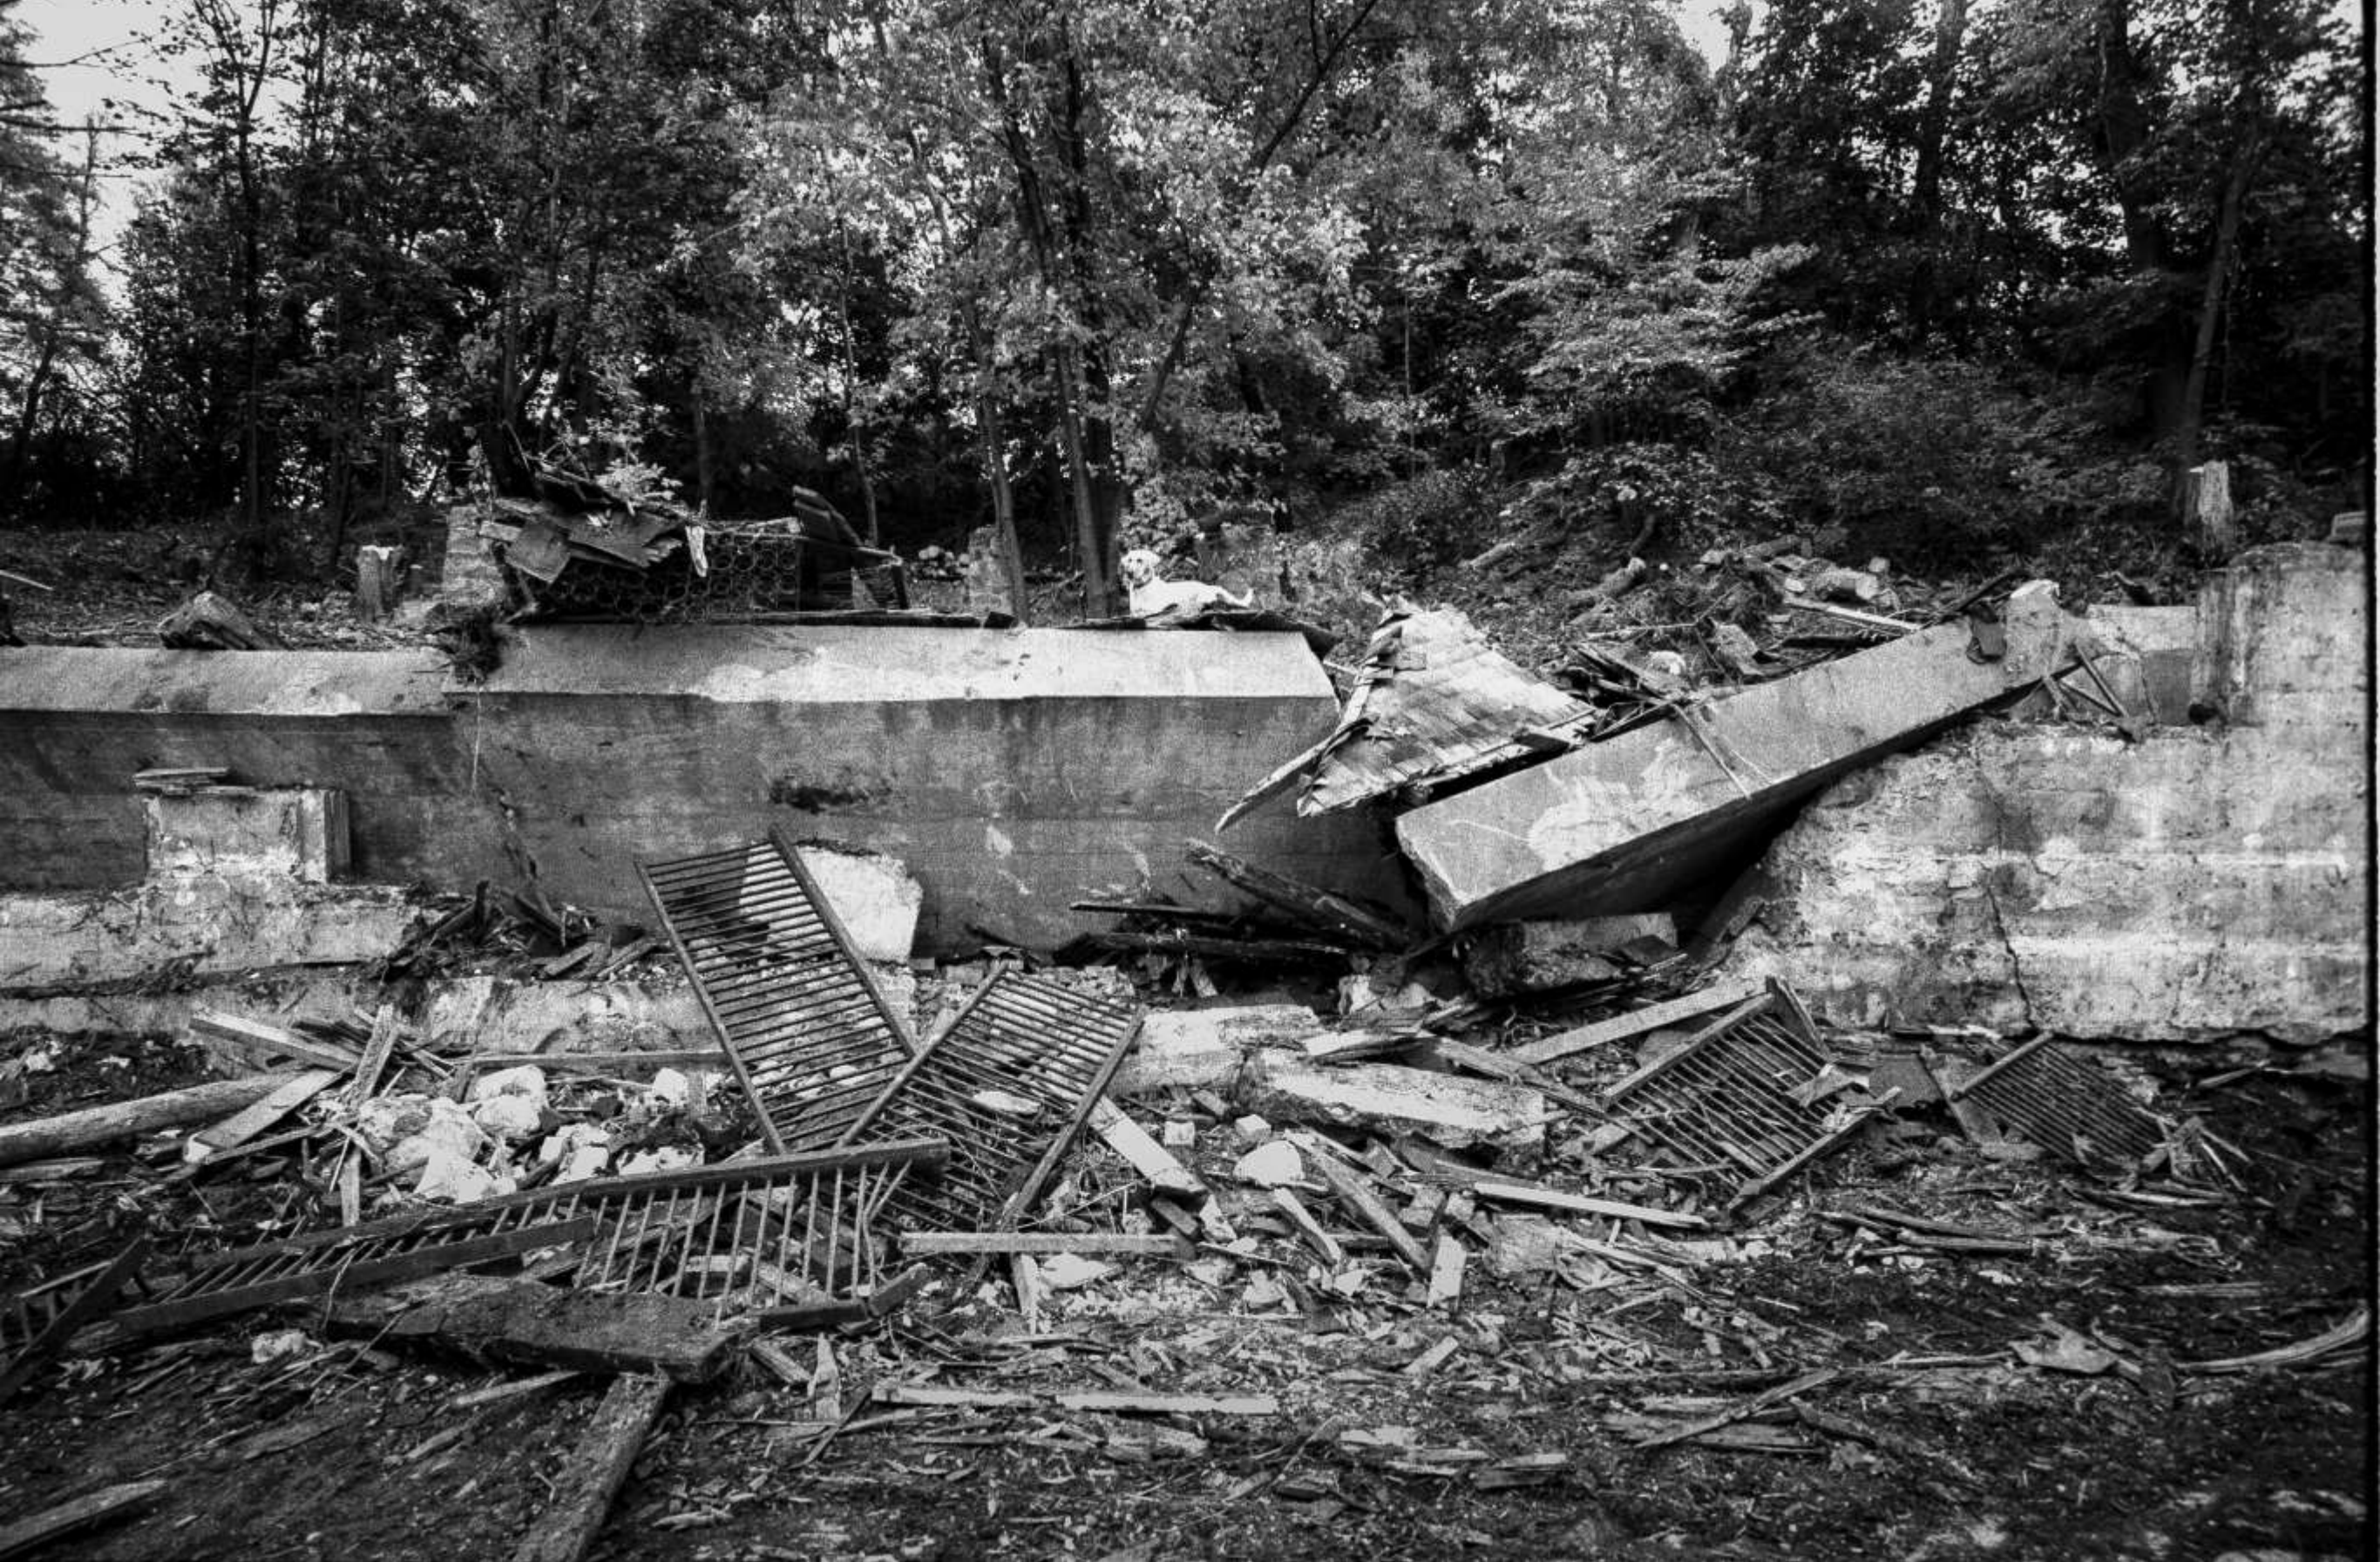
The presence of the hill behind caused water to accumulate by the retaining wall and freezing temperatures would cause serious cracking of the wall to occur. It was too much, and eventually the building was lost.

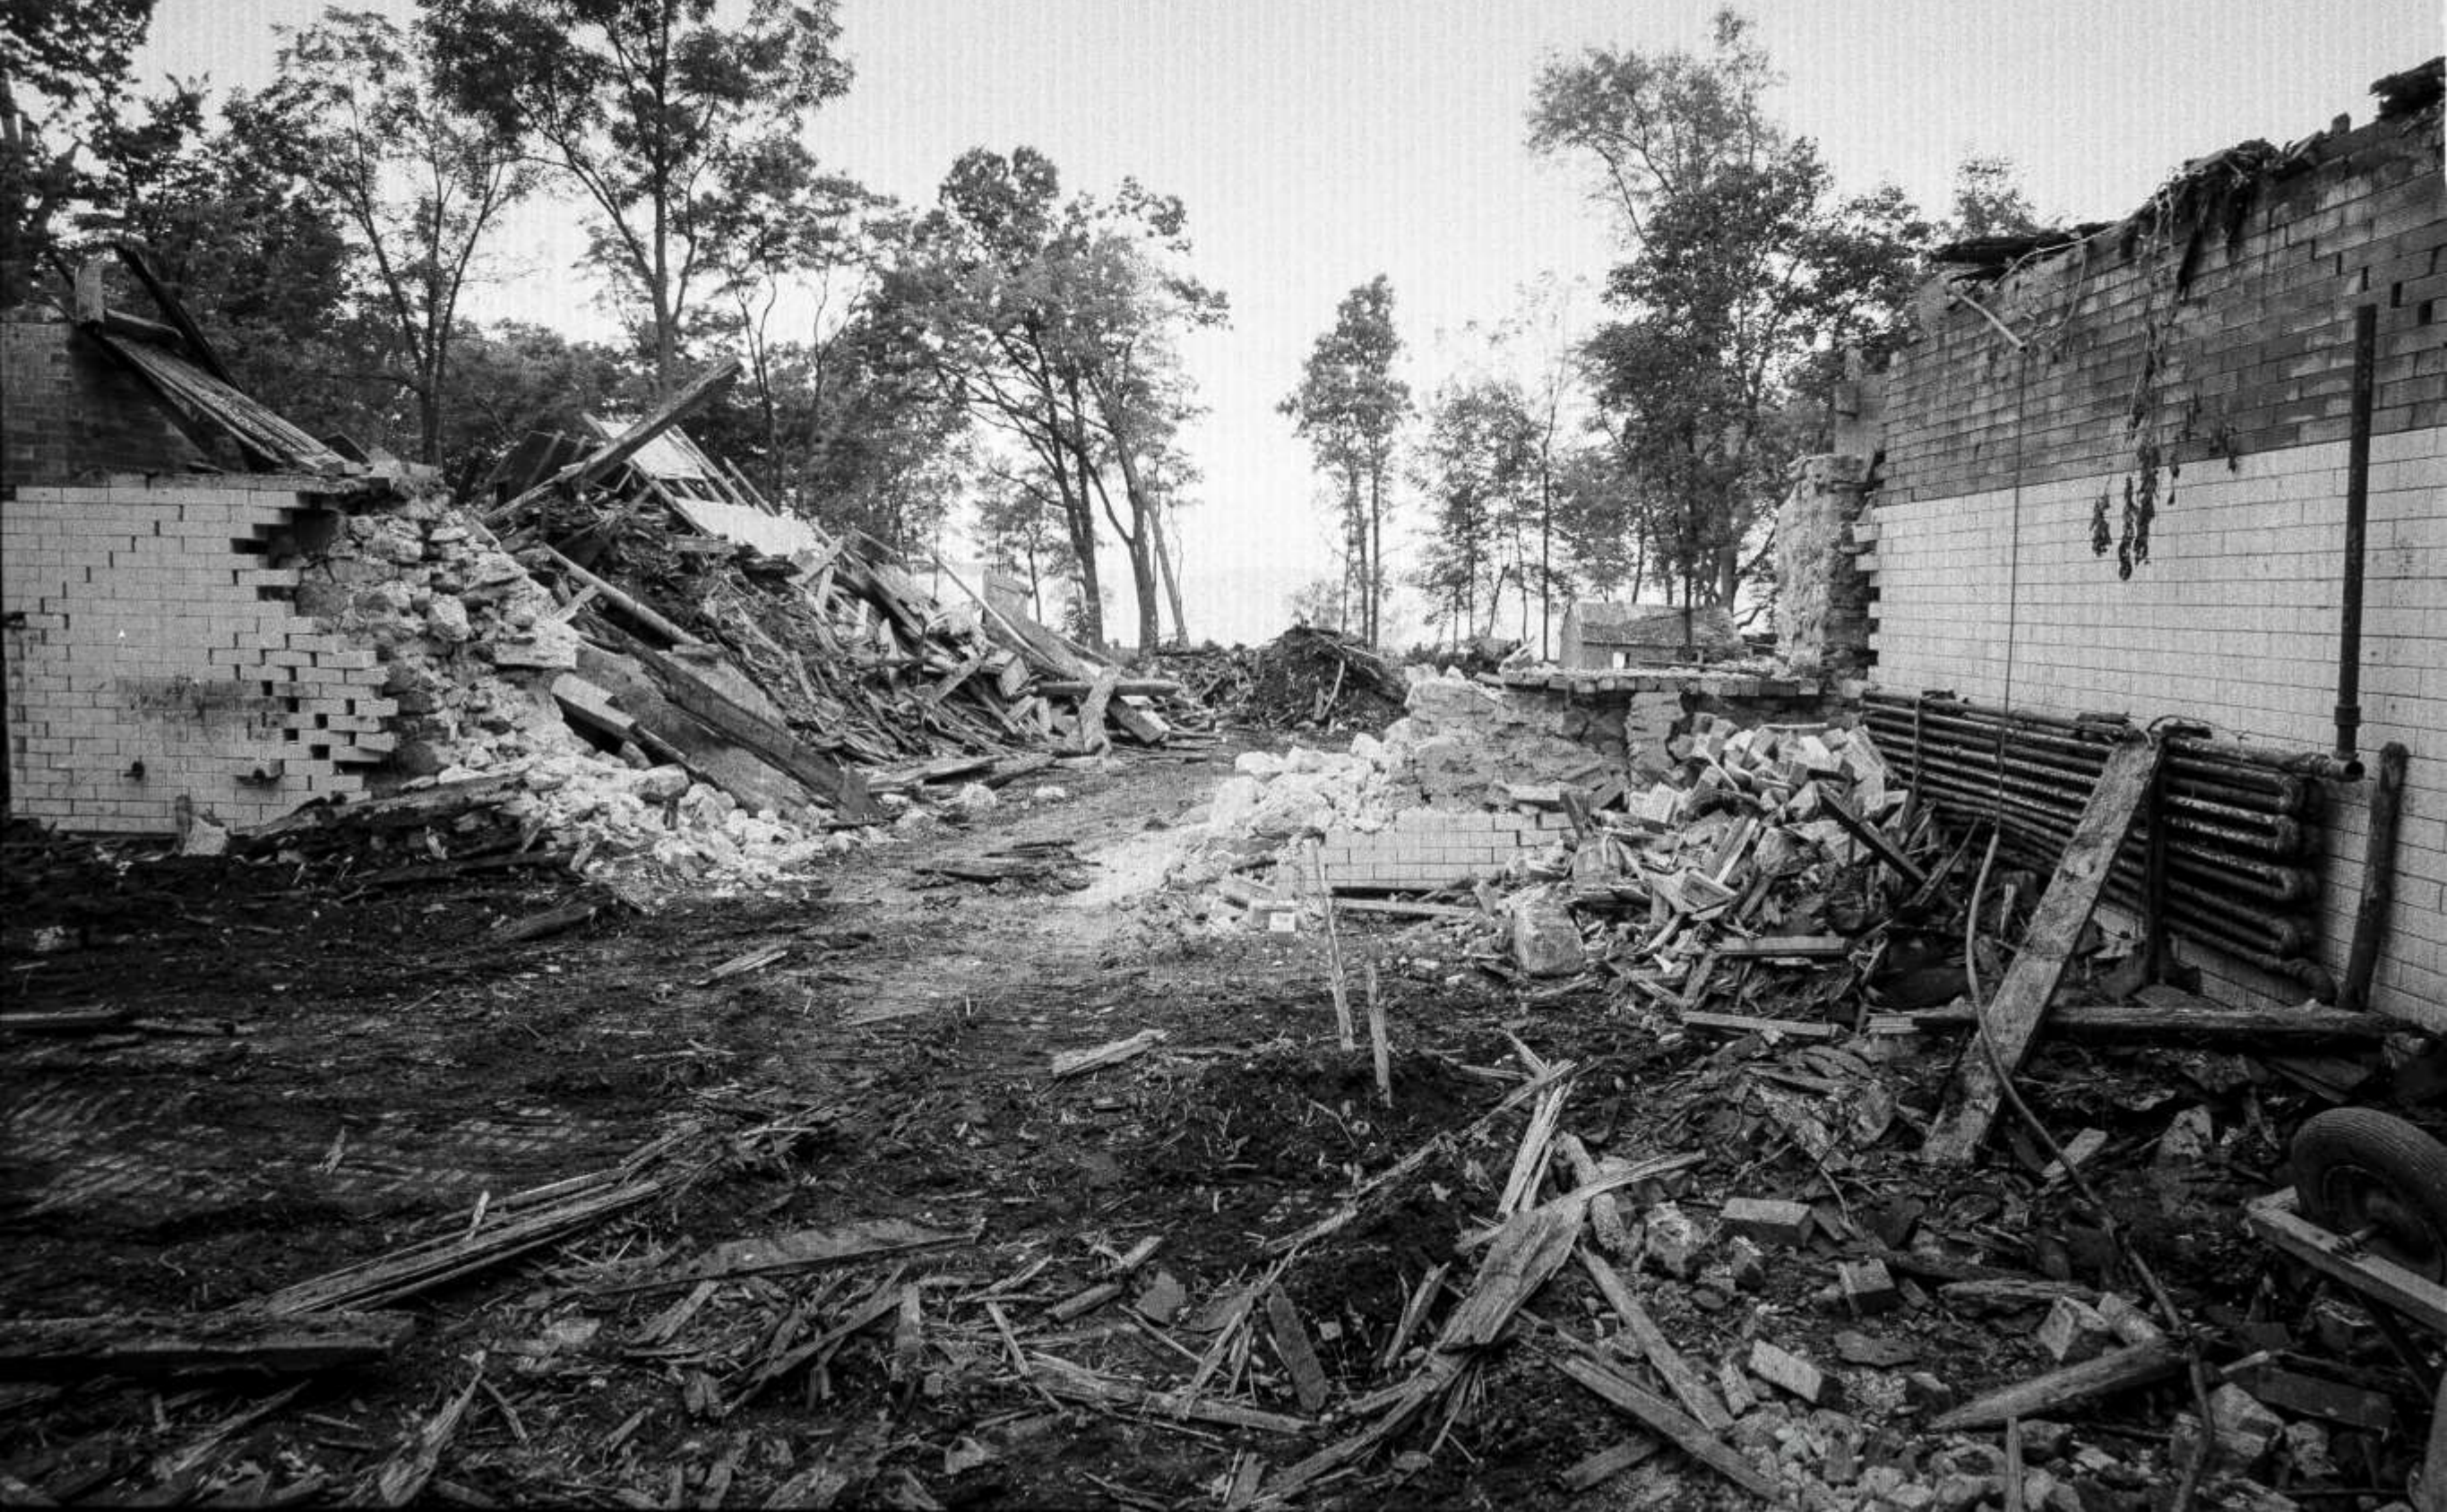
**With a view towards the water one can see the glazed white bricks on what is left of the walls. The foundation wall was rebuilt and offered protection from the wind. The area to the left became a courtyard while the rest became a garage with studio space above.**

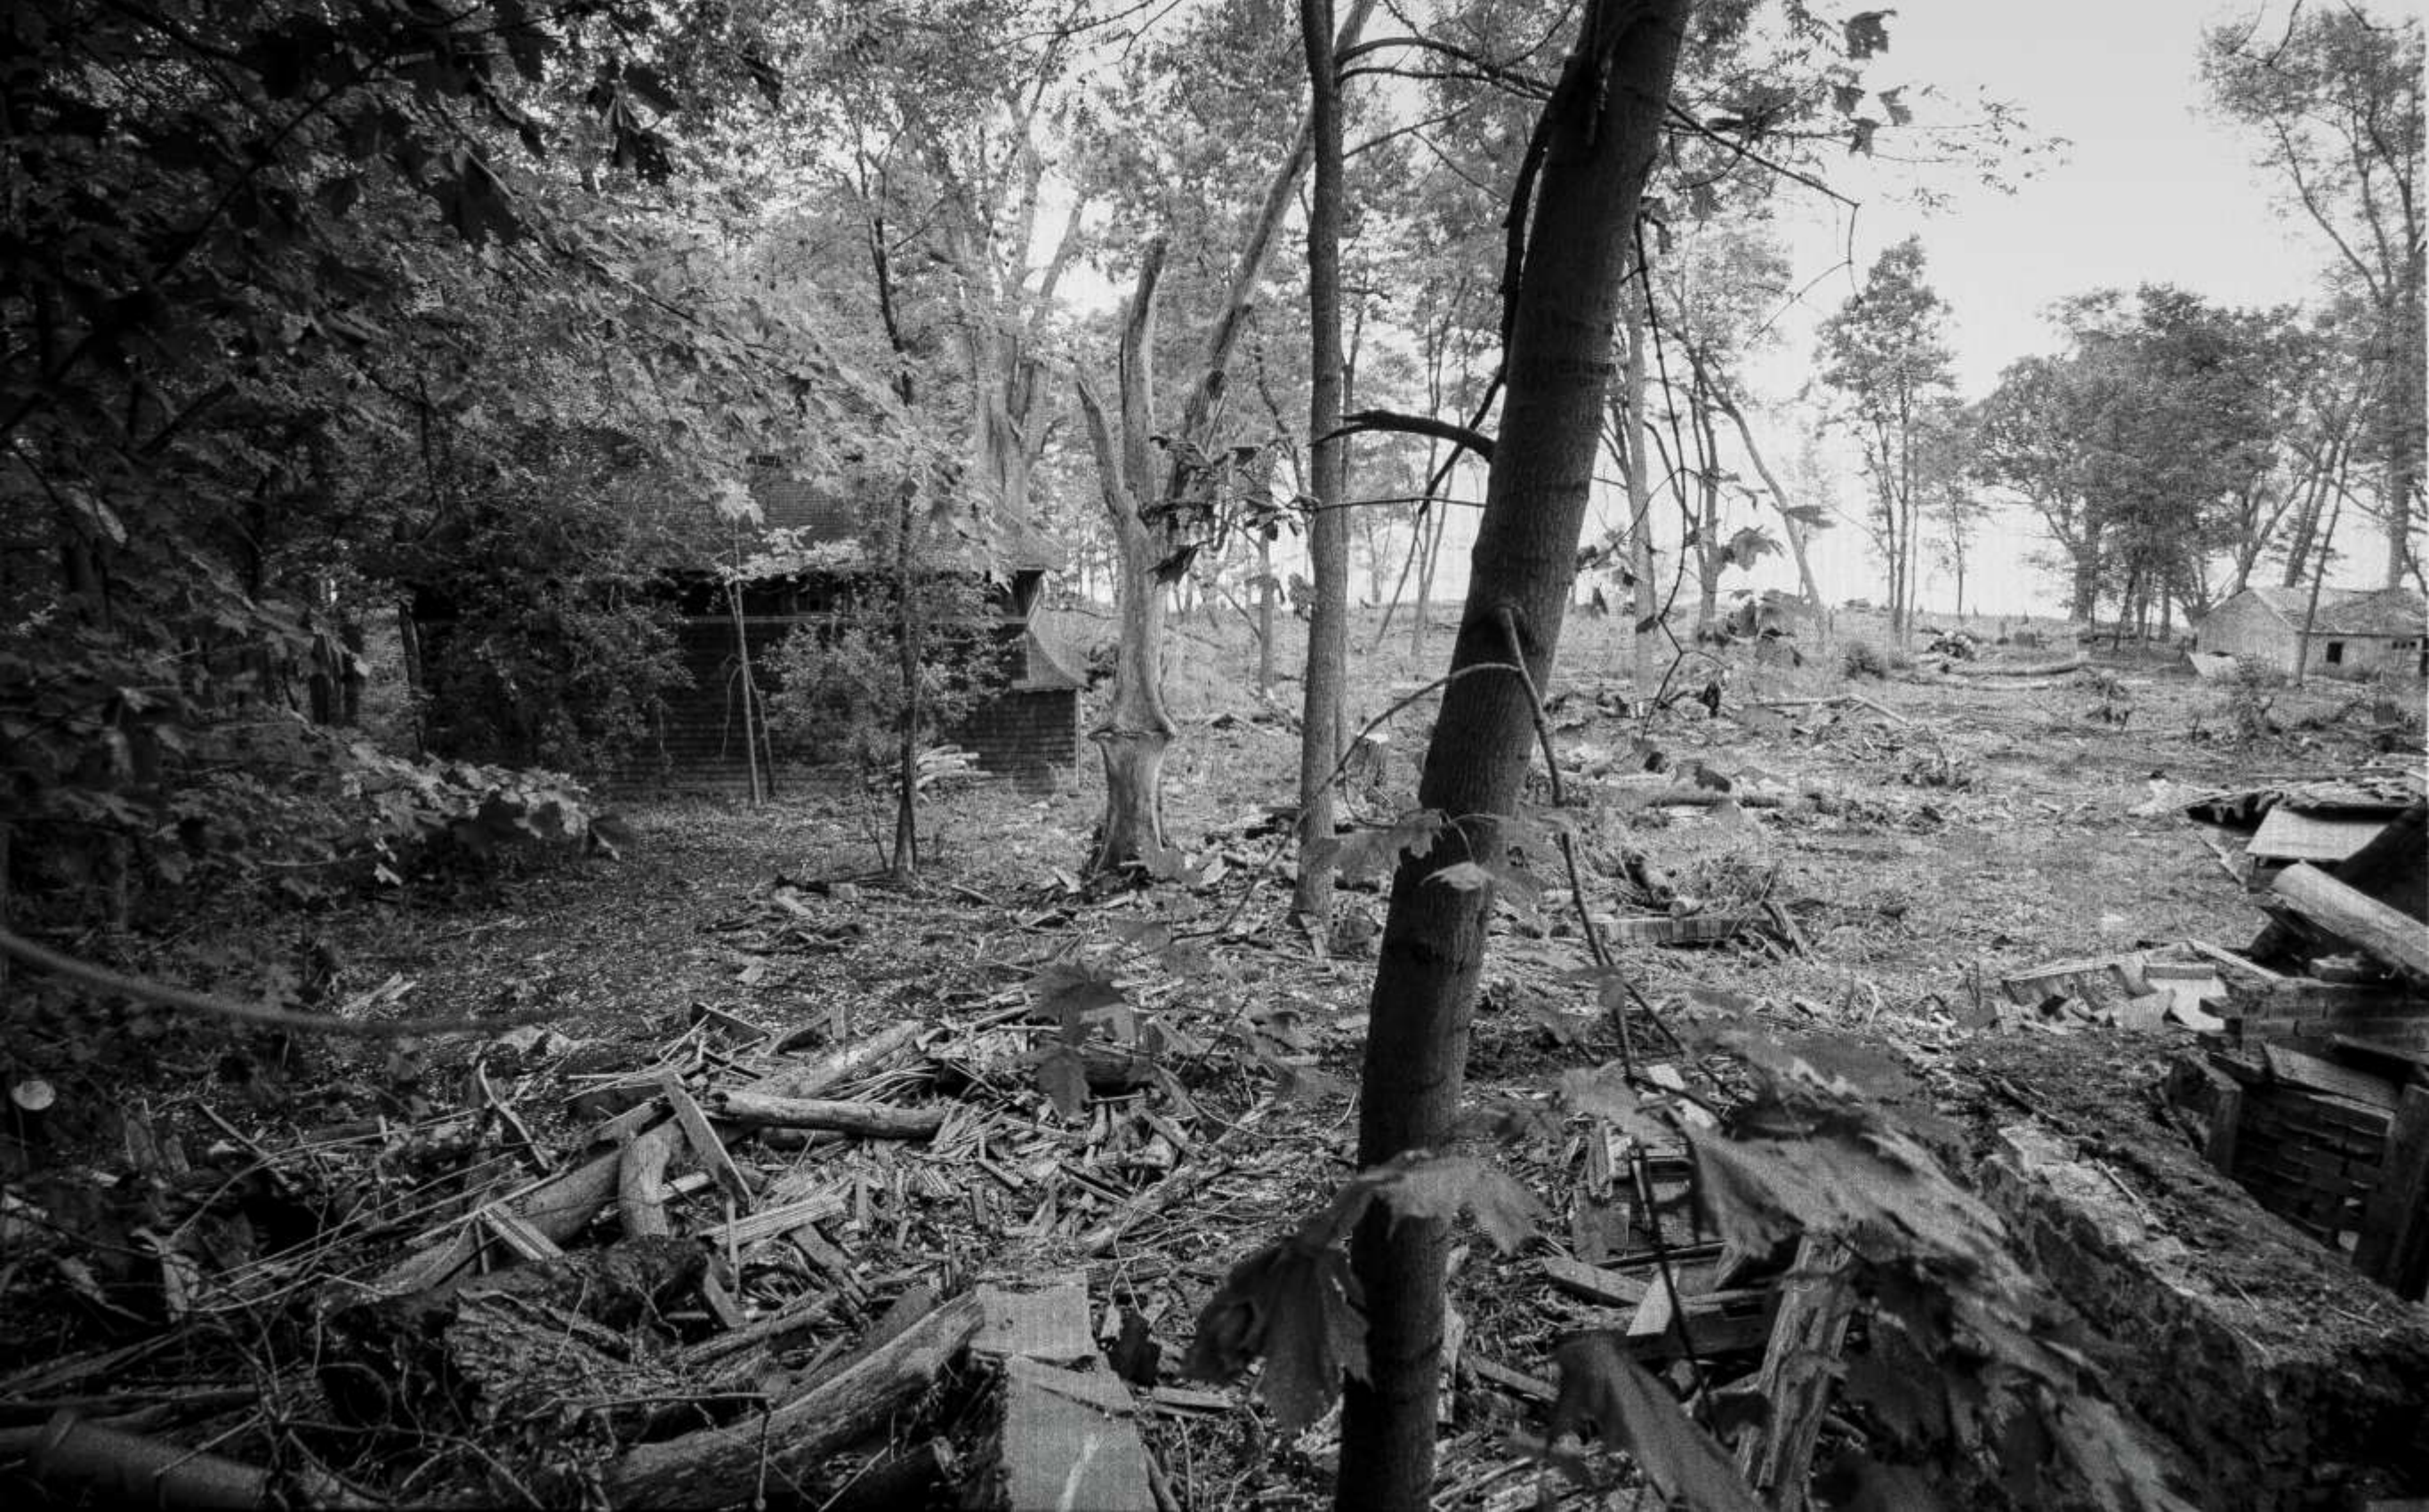
**Hiding behind the trees, at centre left, you can see the Squash Court building. We had high hopes of saving it, but as the project progressed, the sills started to go. It was a simple little building made entirely out of cedar, and with no foundation to speak of. The building just sat on the ground and finally the rot set in.**

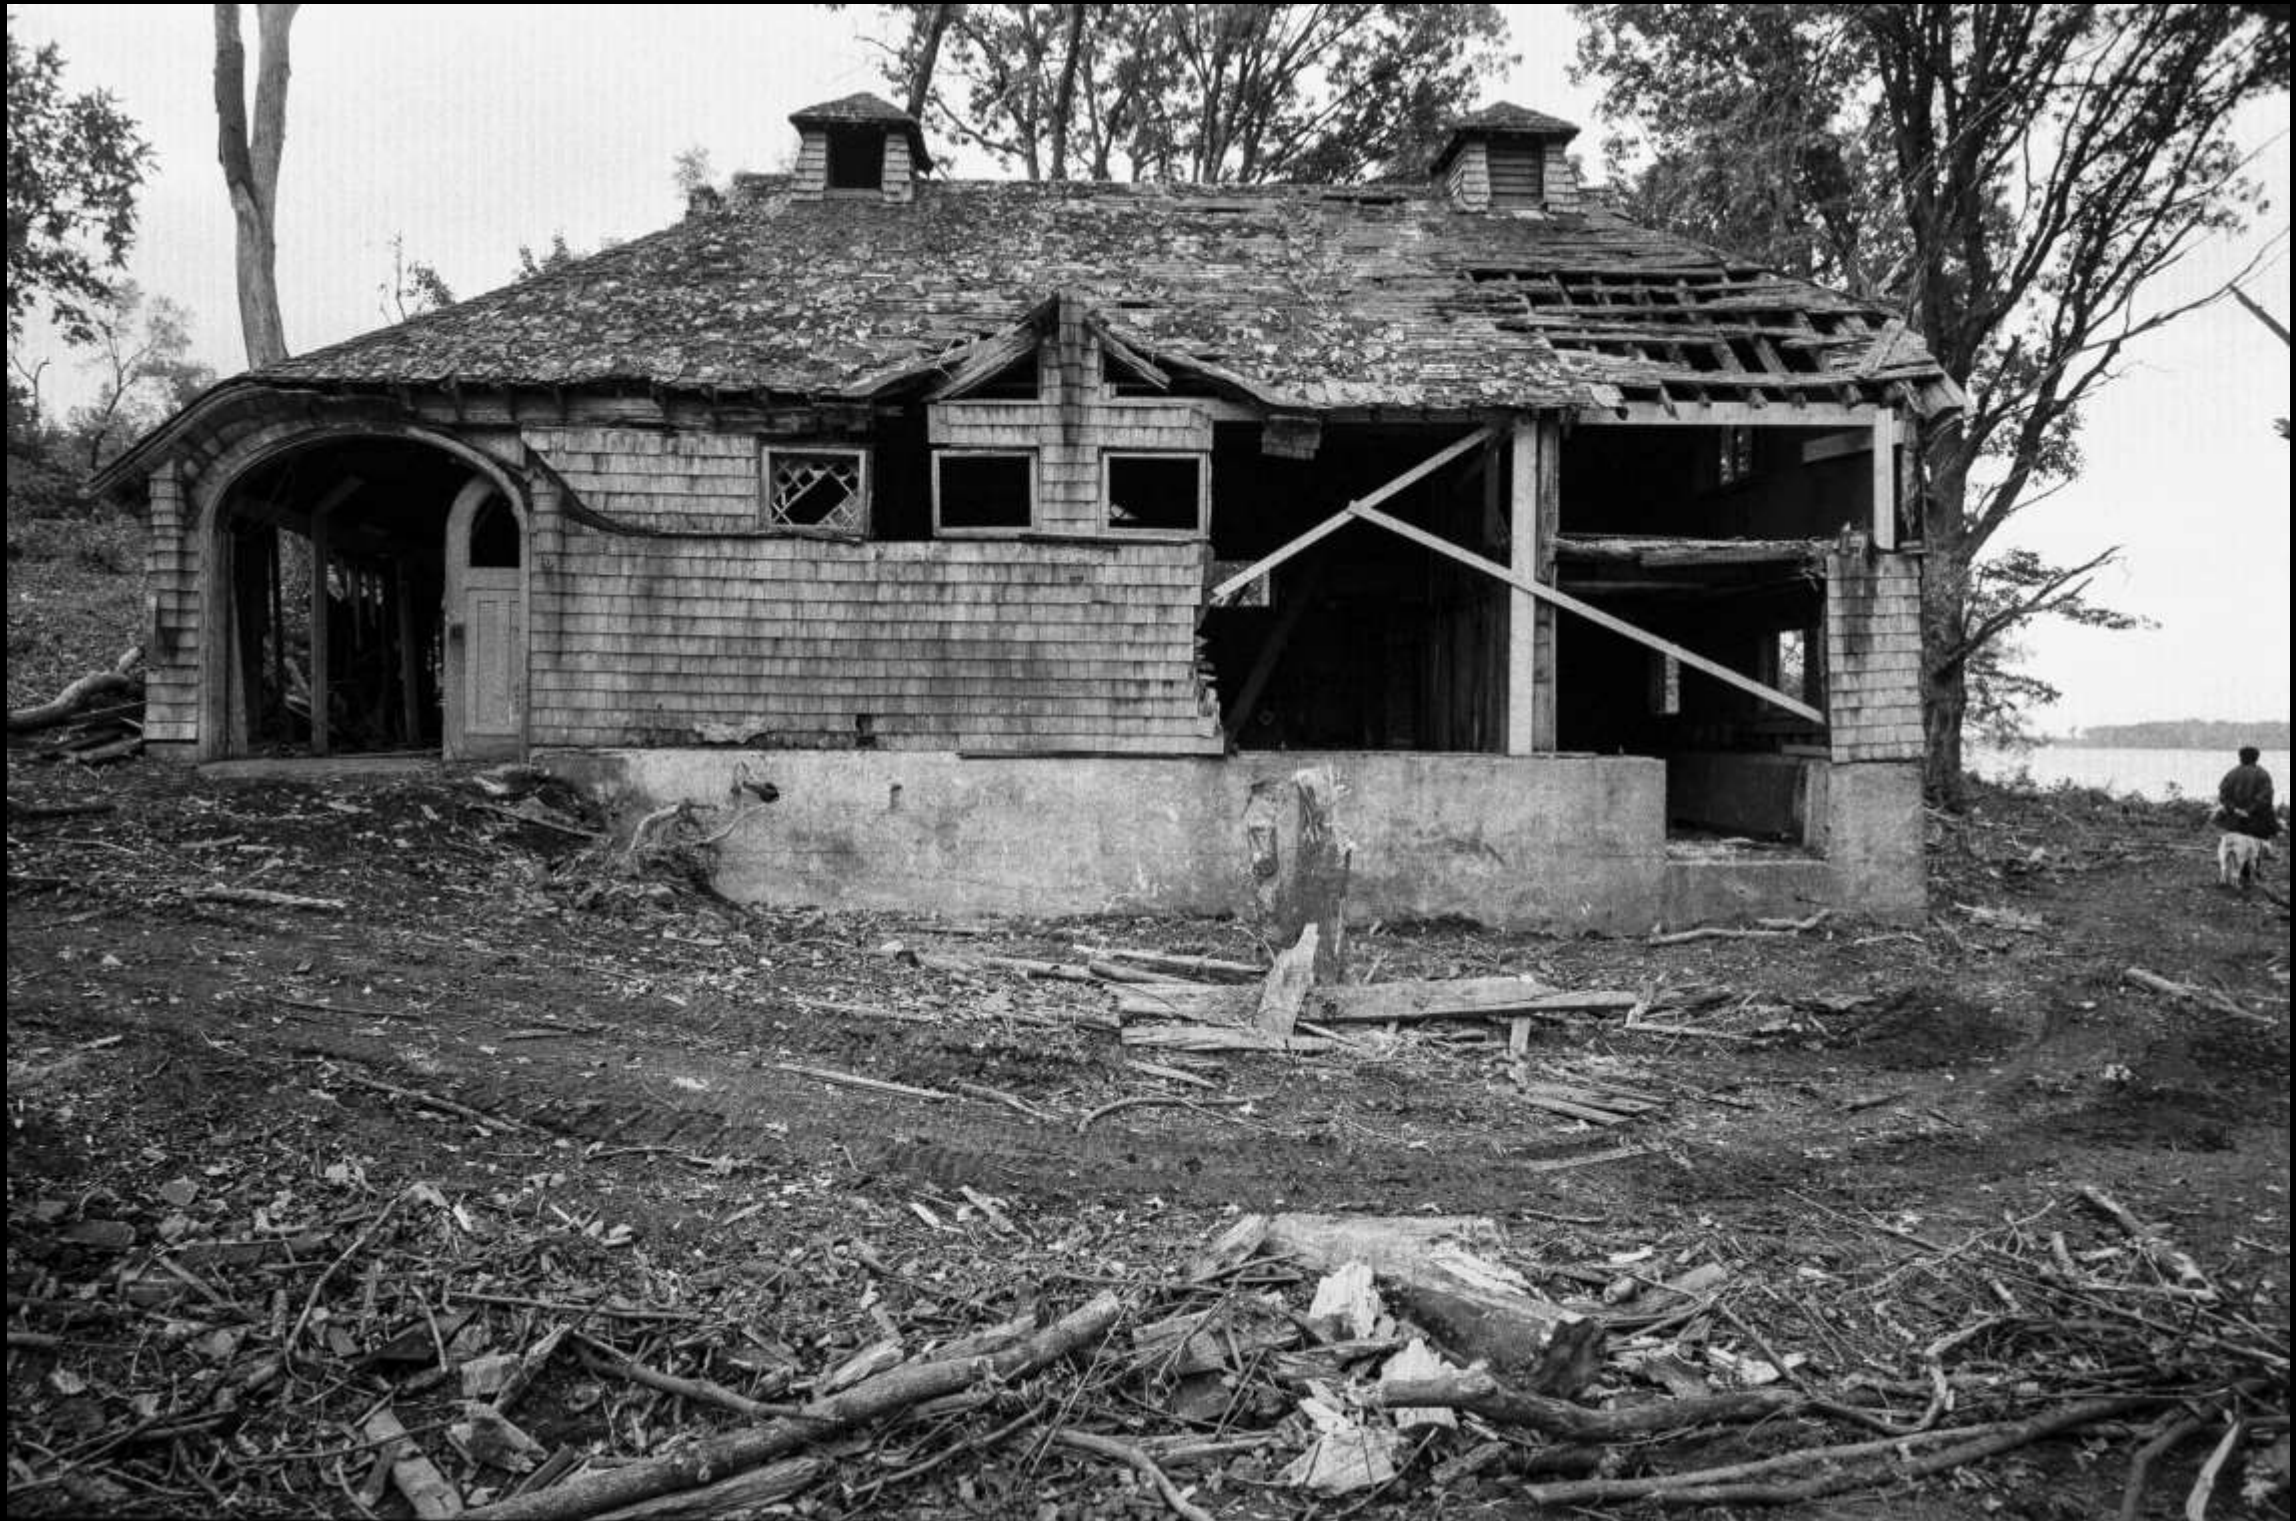
**It contained a massive engine and pump system to move water to a reservoir on top of the hill, and to supply the fire hydrants on site. The engine must have also been used to charge up batteries, made from large glass jars filled with acid. We found most of the jars had been smashed, and only a couple remained intact.**

**Luckily for us there was enough of this exquisite shingle detailing left to guide us in the restoration. You can see traces of the curved eyebrow over the doorway, and the icicle hanging down on each side. It was such a remarkable design.**
