The Bois de la Roche stables at 292 Senneville Road, are on the endangered list compiled by Heritage Montreal. The wooden horse barn, built between 1880 and 1900, and enlarged in 1902, was part of the country estate of Senator Louis-Joseph Forget, whose property was acquired by the Montreal Urban Community in 1991. These stables were enlarged by architects Edward and William Maxwell.

Portions of these stables are threatened, and there has been a collapse of one section in the past few years. A temporary structure has recently been put in place to hopefully prevent further damage.

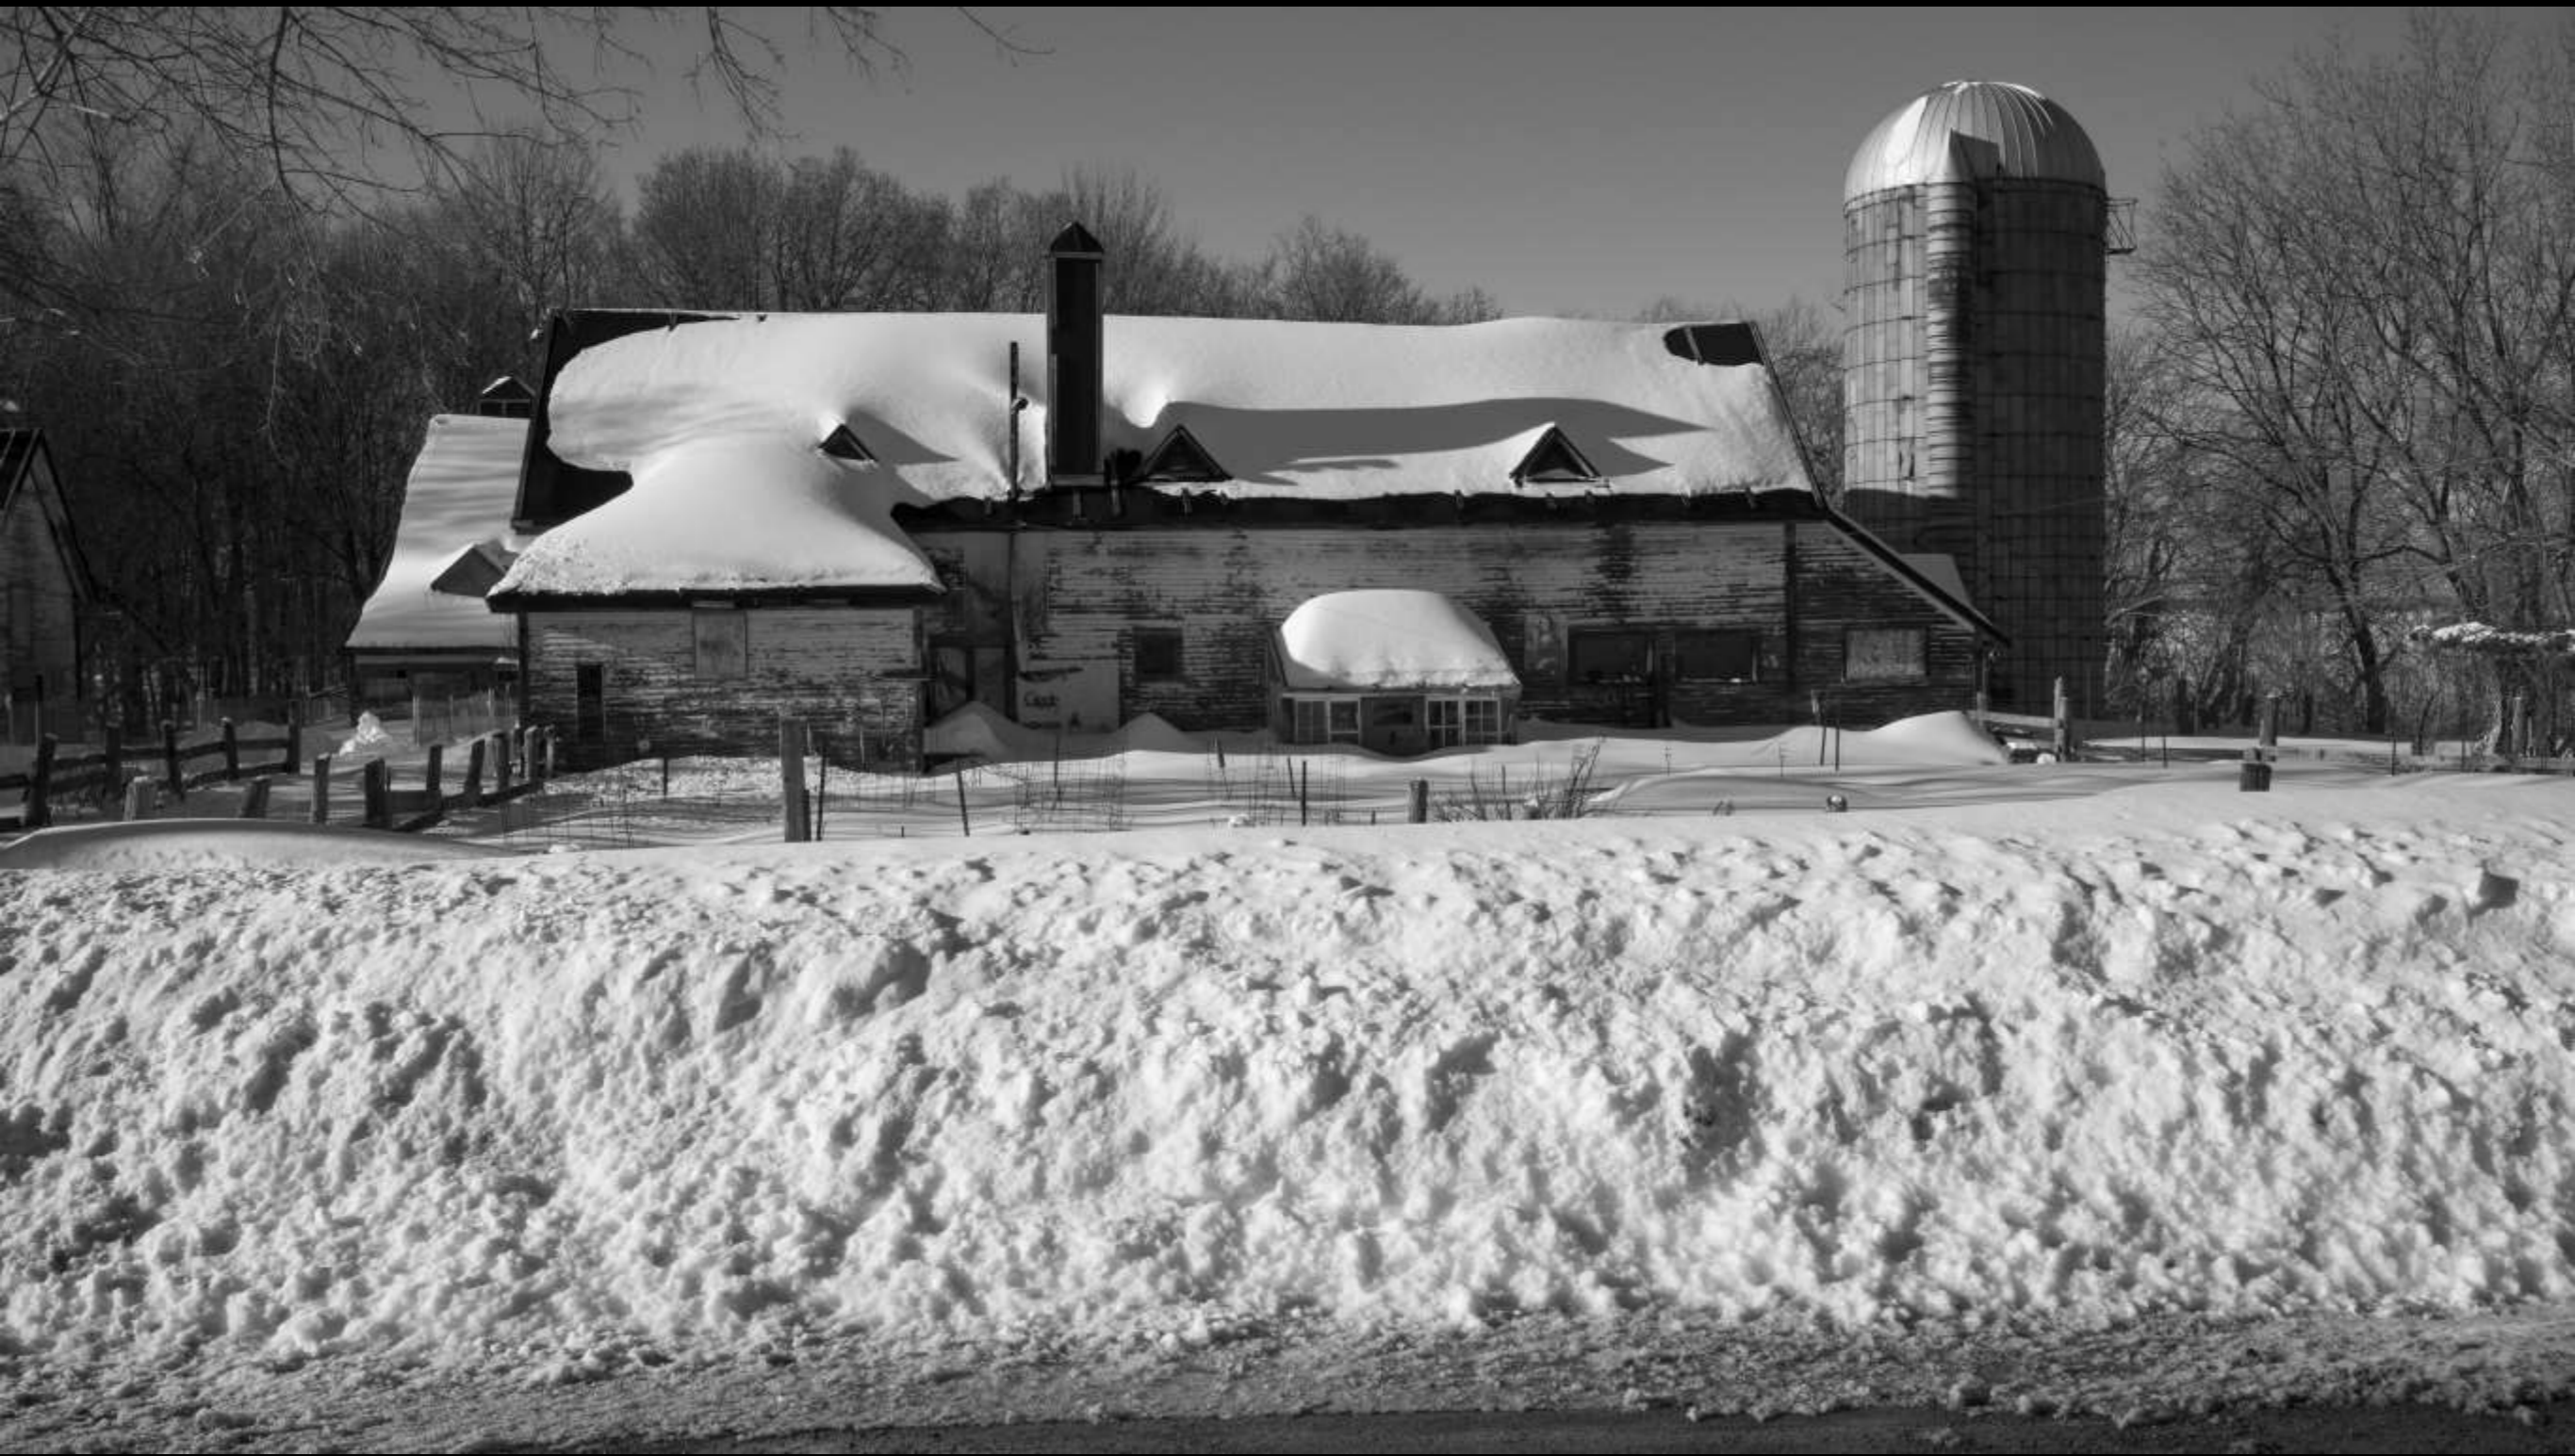
The new Maxwell extension and silo in the foreground with the original horse barn peeking out from the rear, (left side).

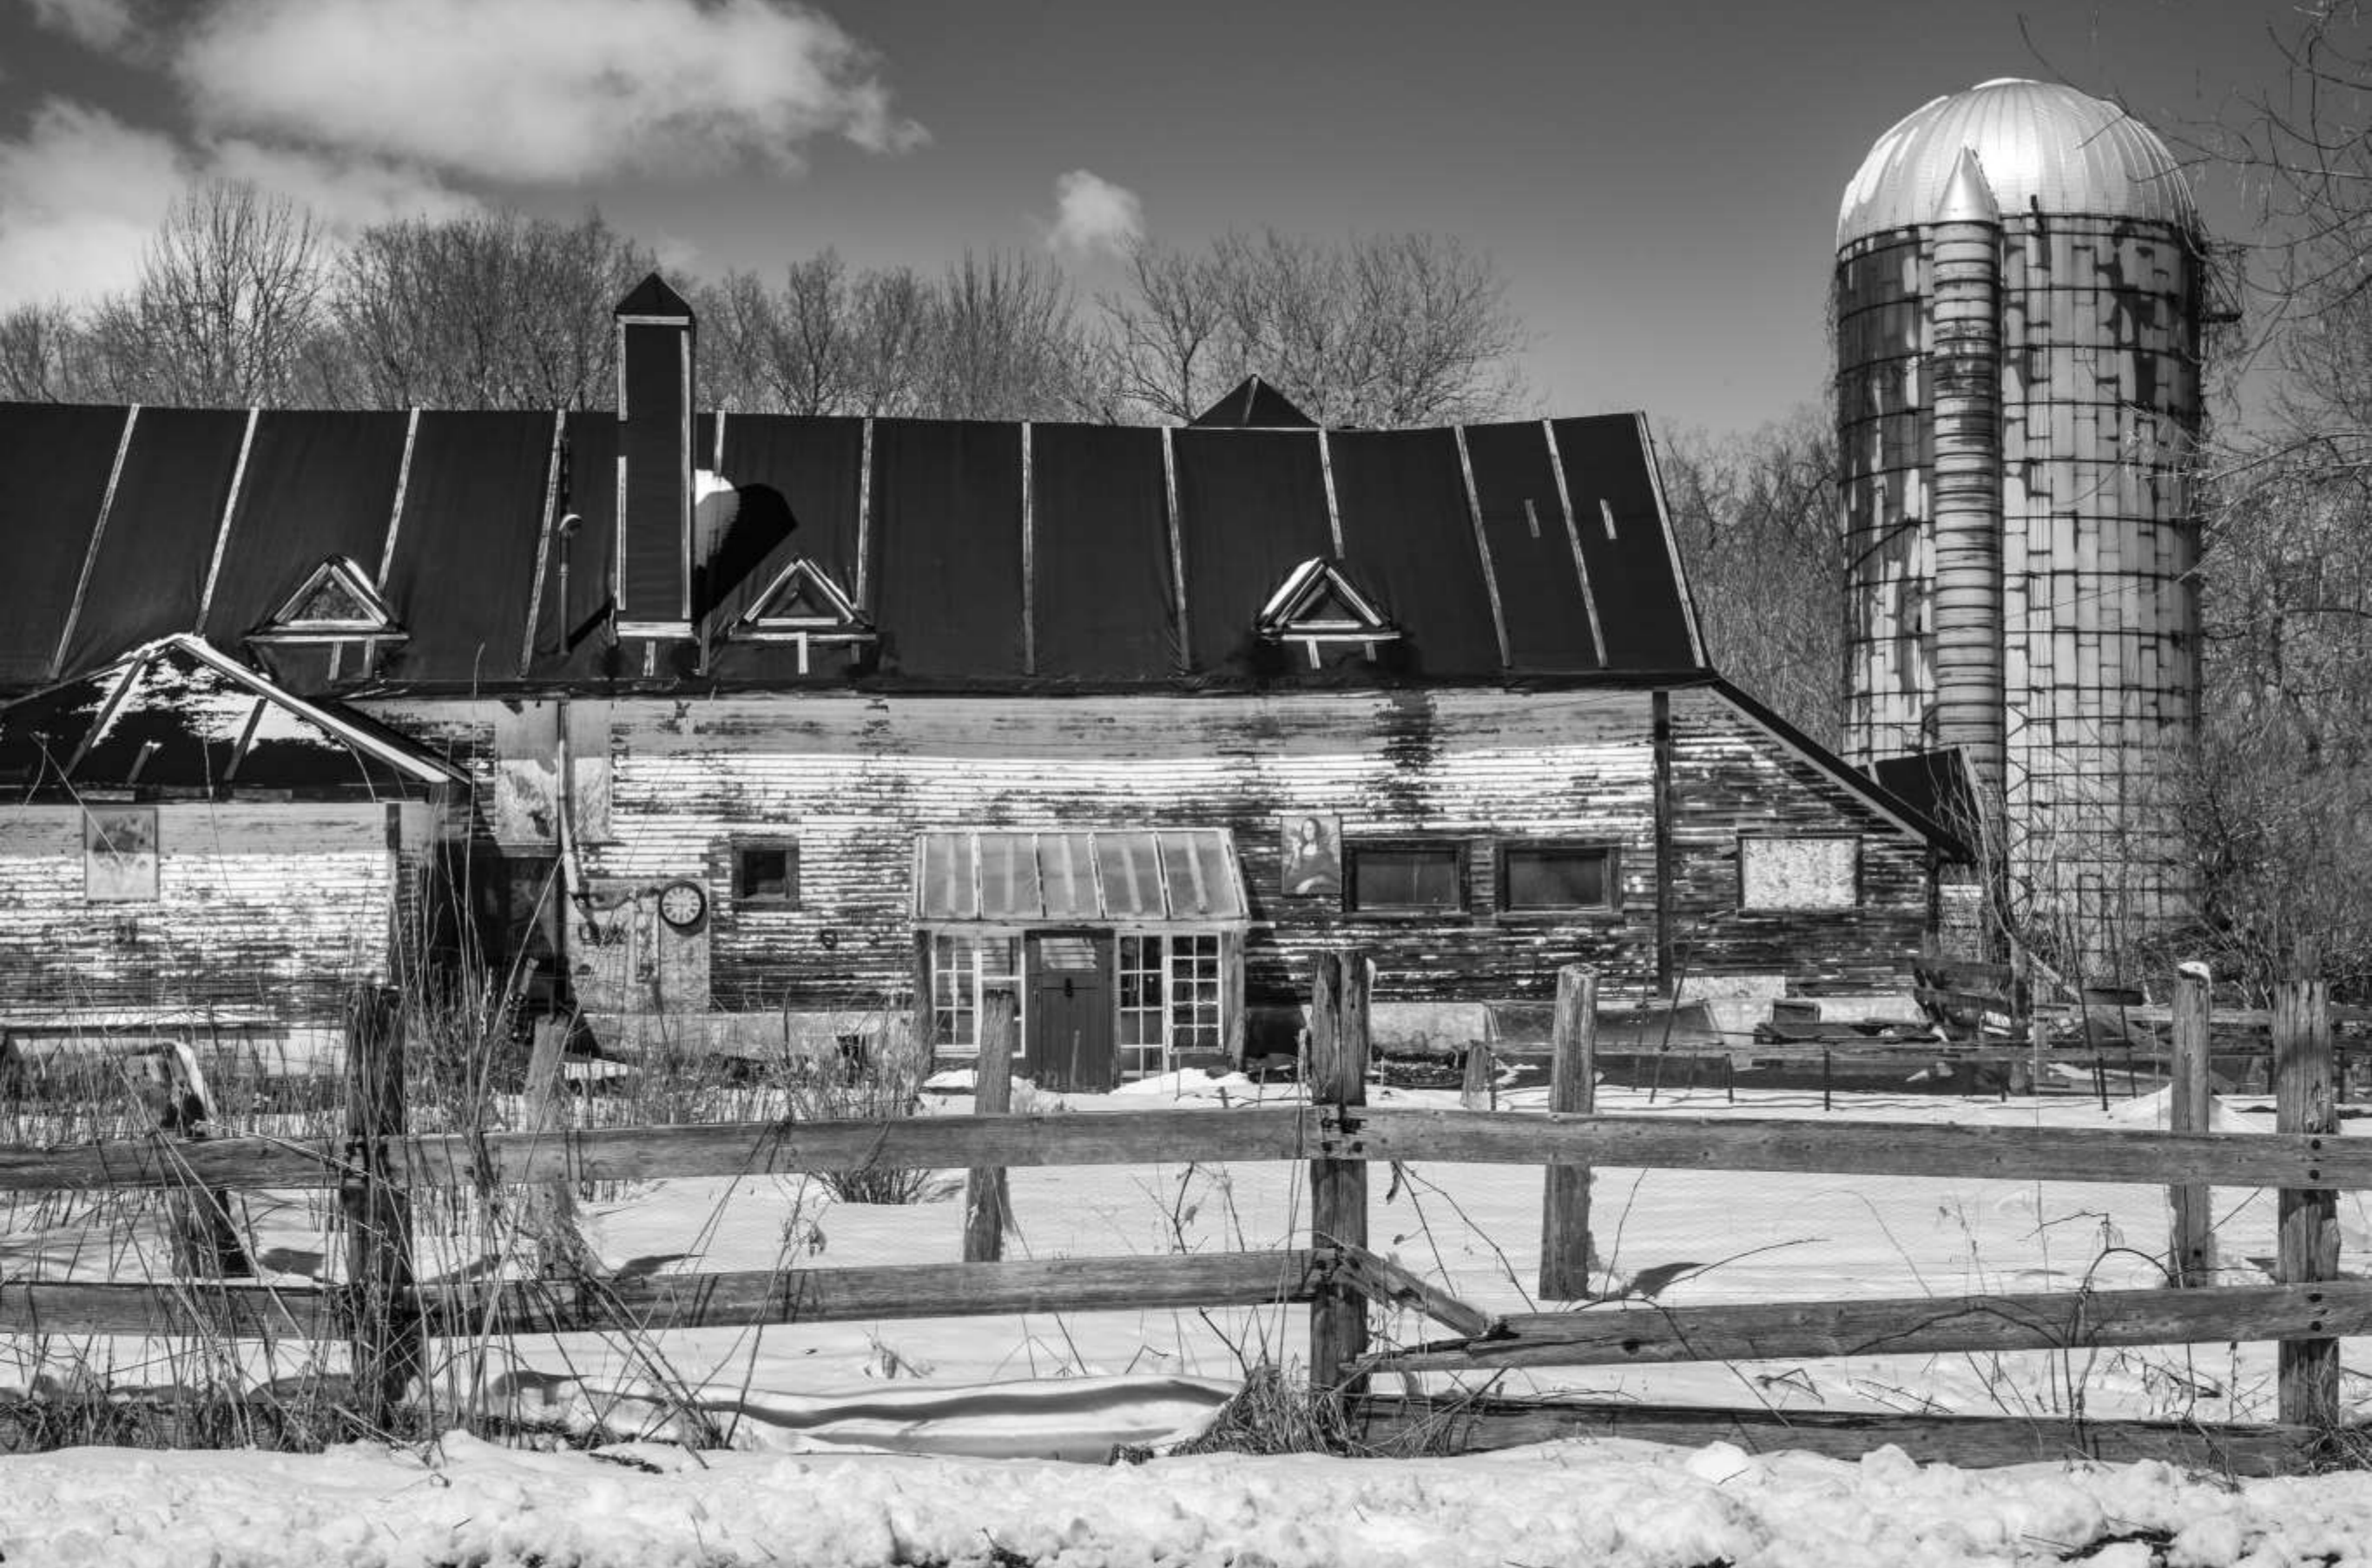
This is the main structure one sees from the road. It is magnificent even with the plastic covered roof and vent towers that was done to protect the structure from the elements.

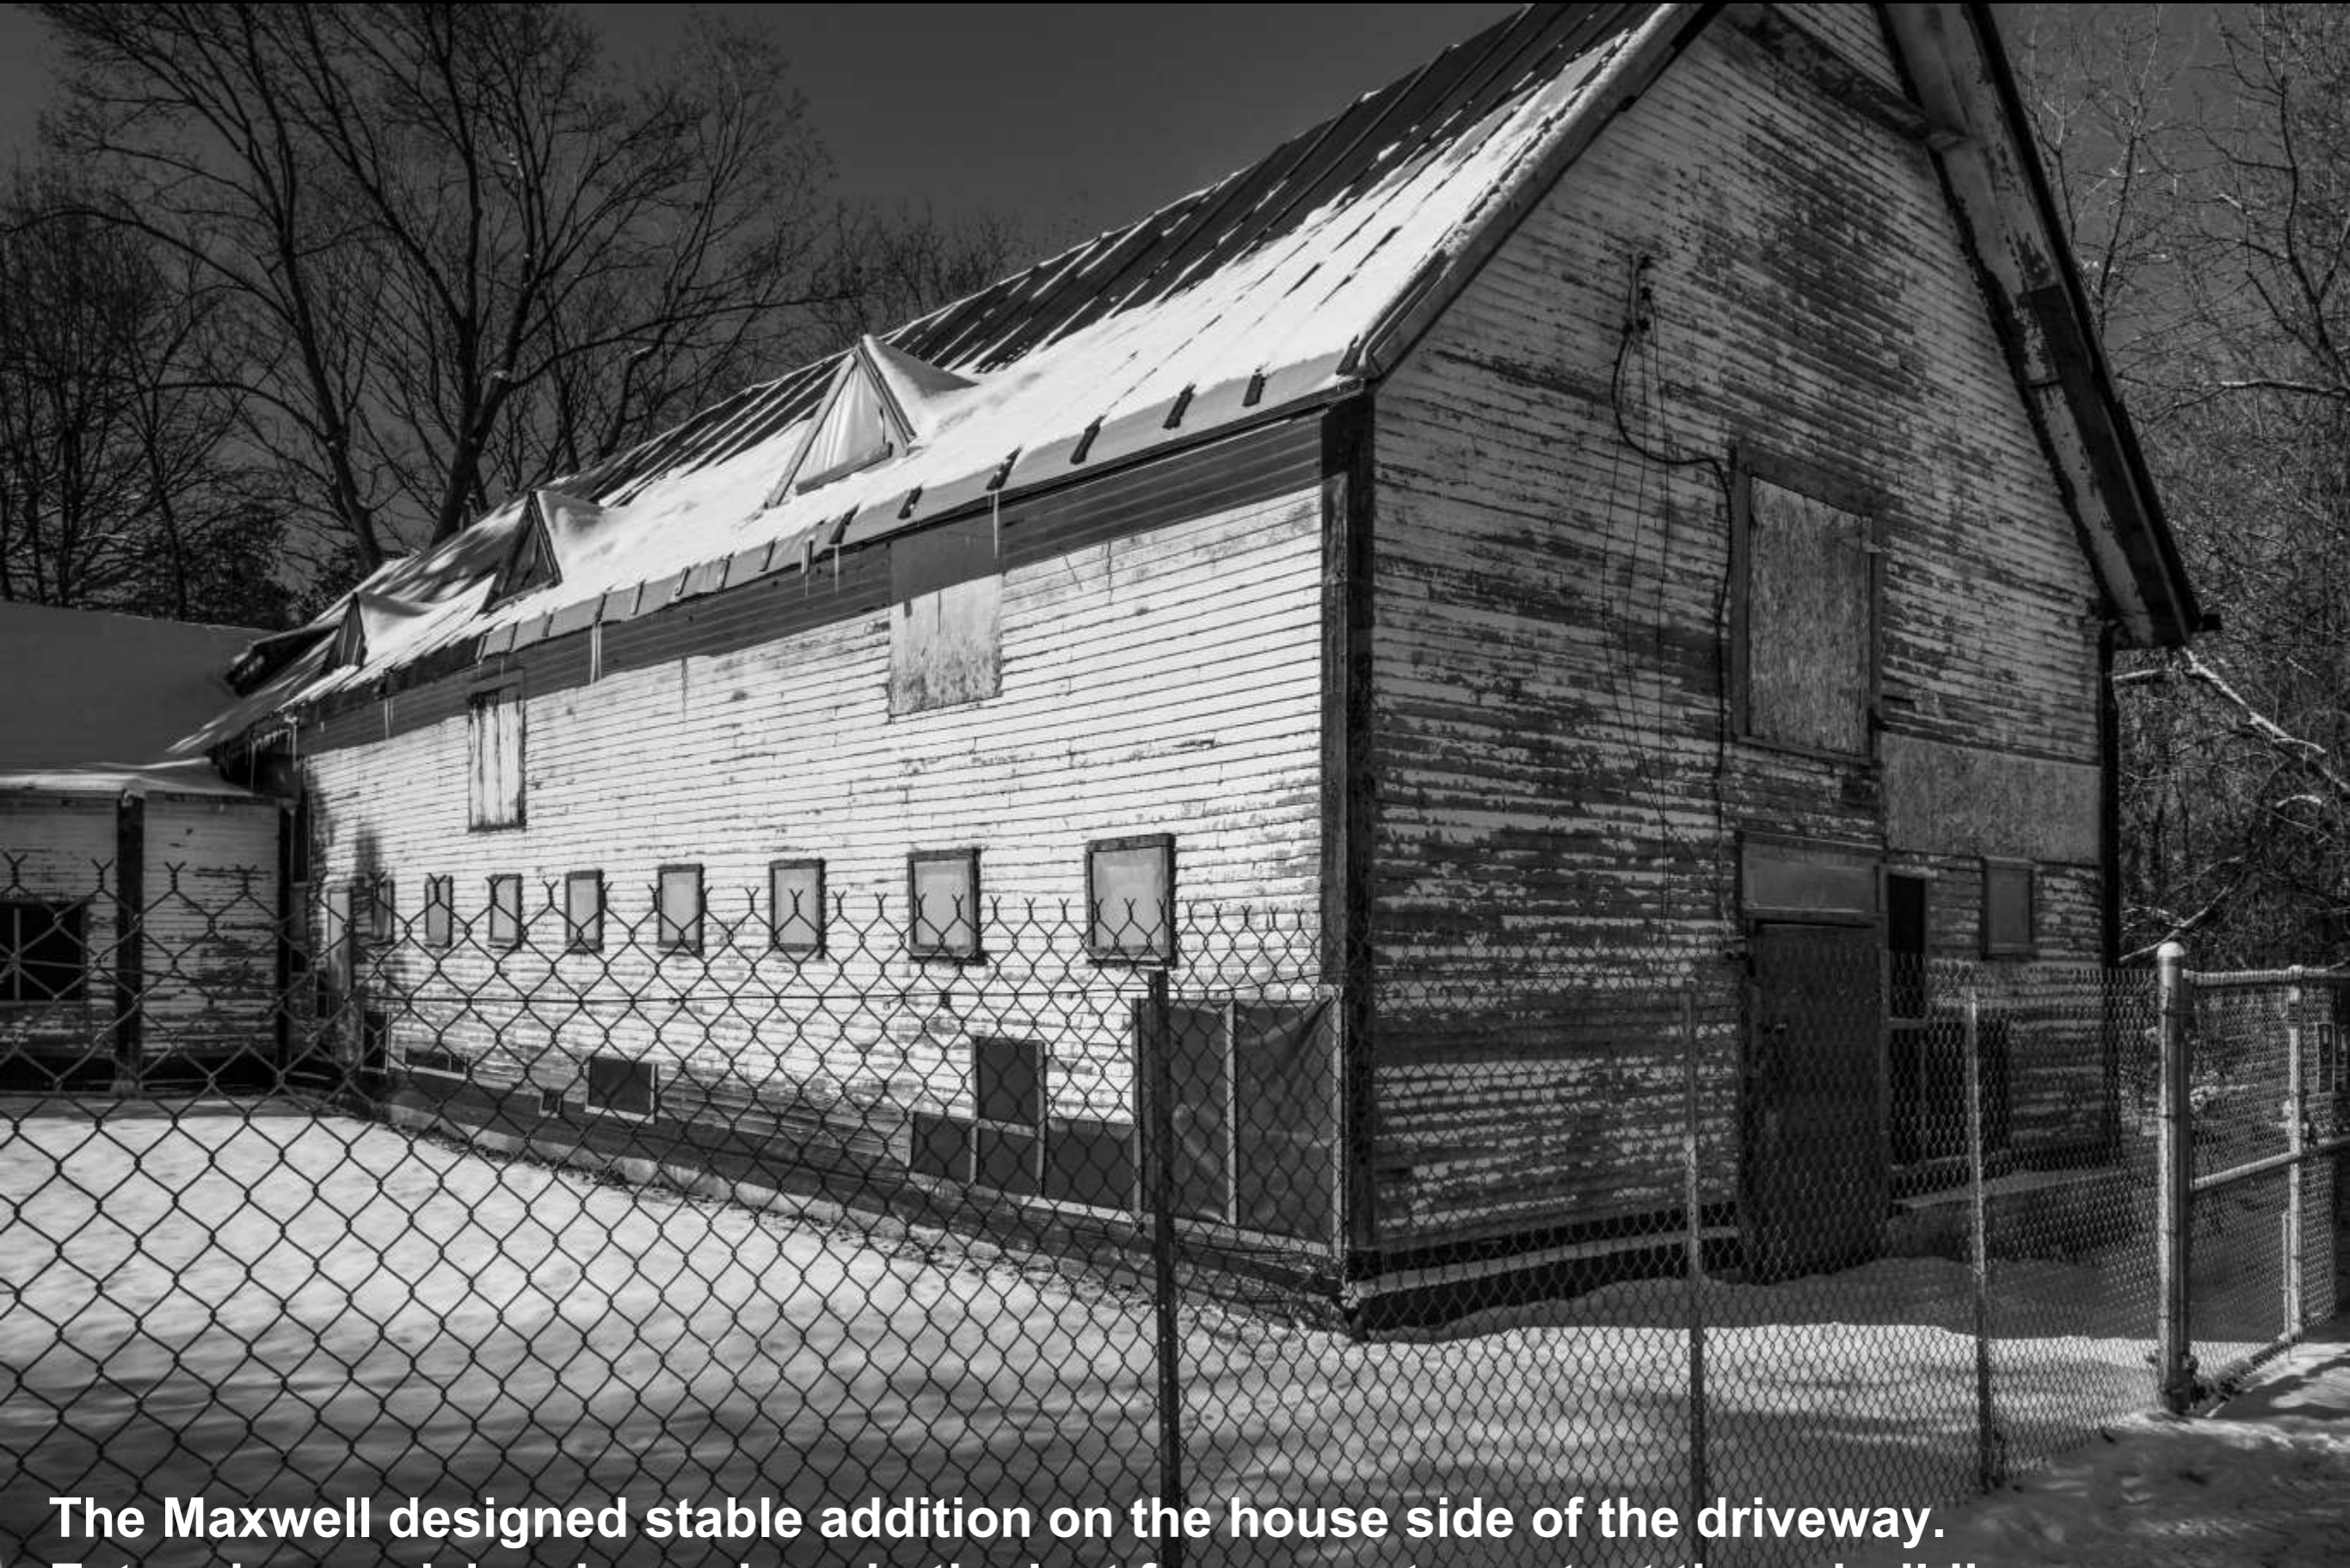
The Maxwell designed stable addition on the house side of the driveway. Extensive work has been done in the last few years to protect these buildings. The roof has been covered with heavy plastic material as well as all of the doors & windows.

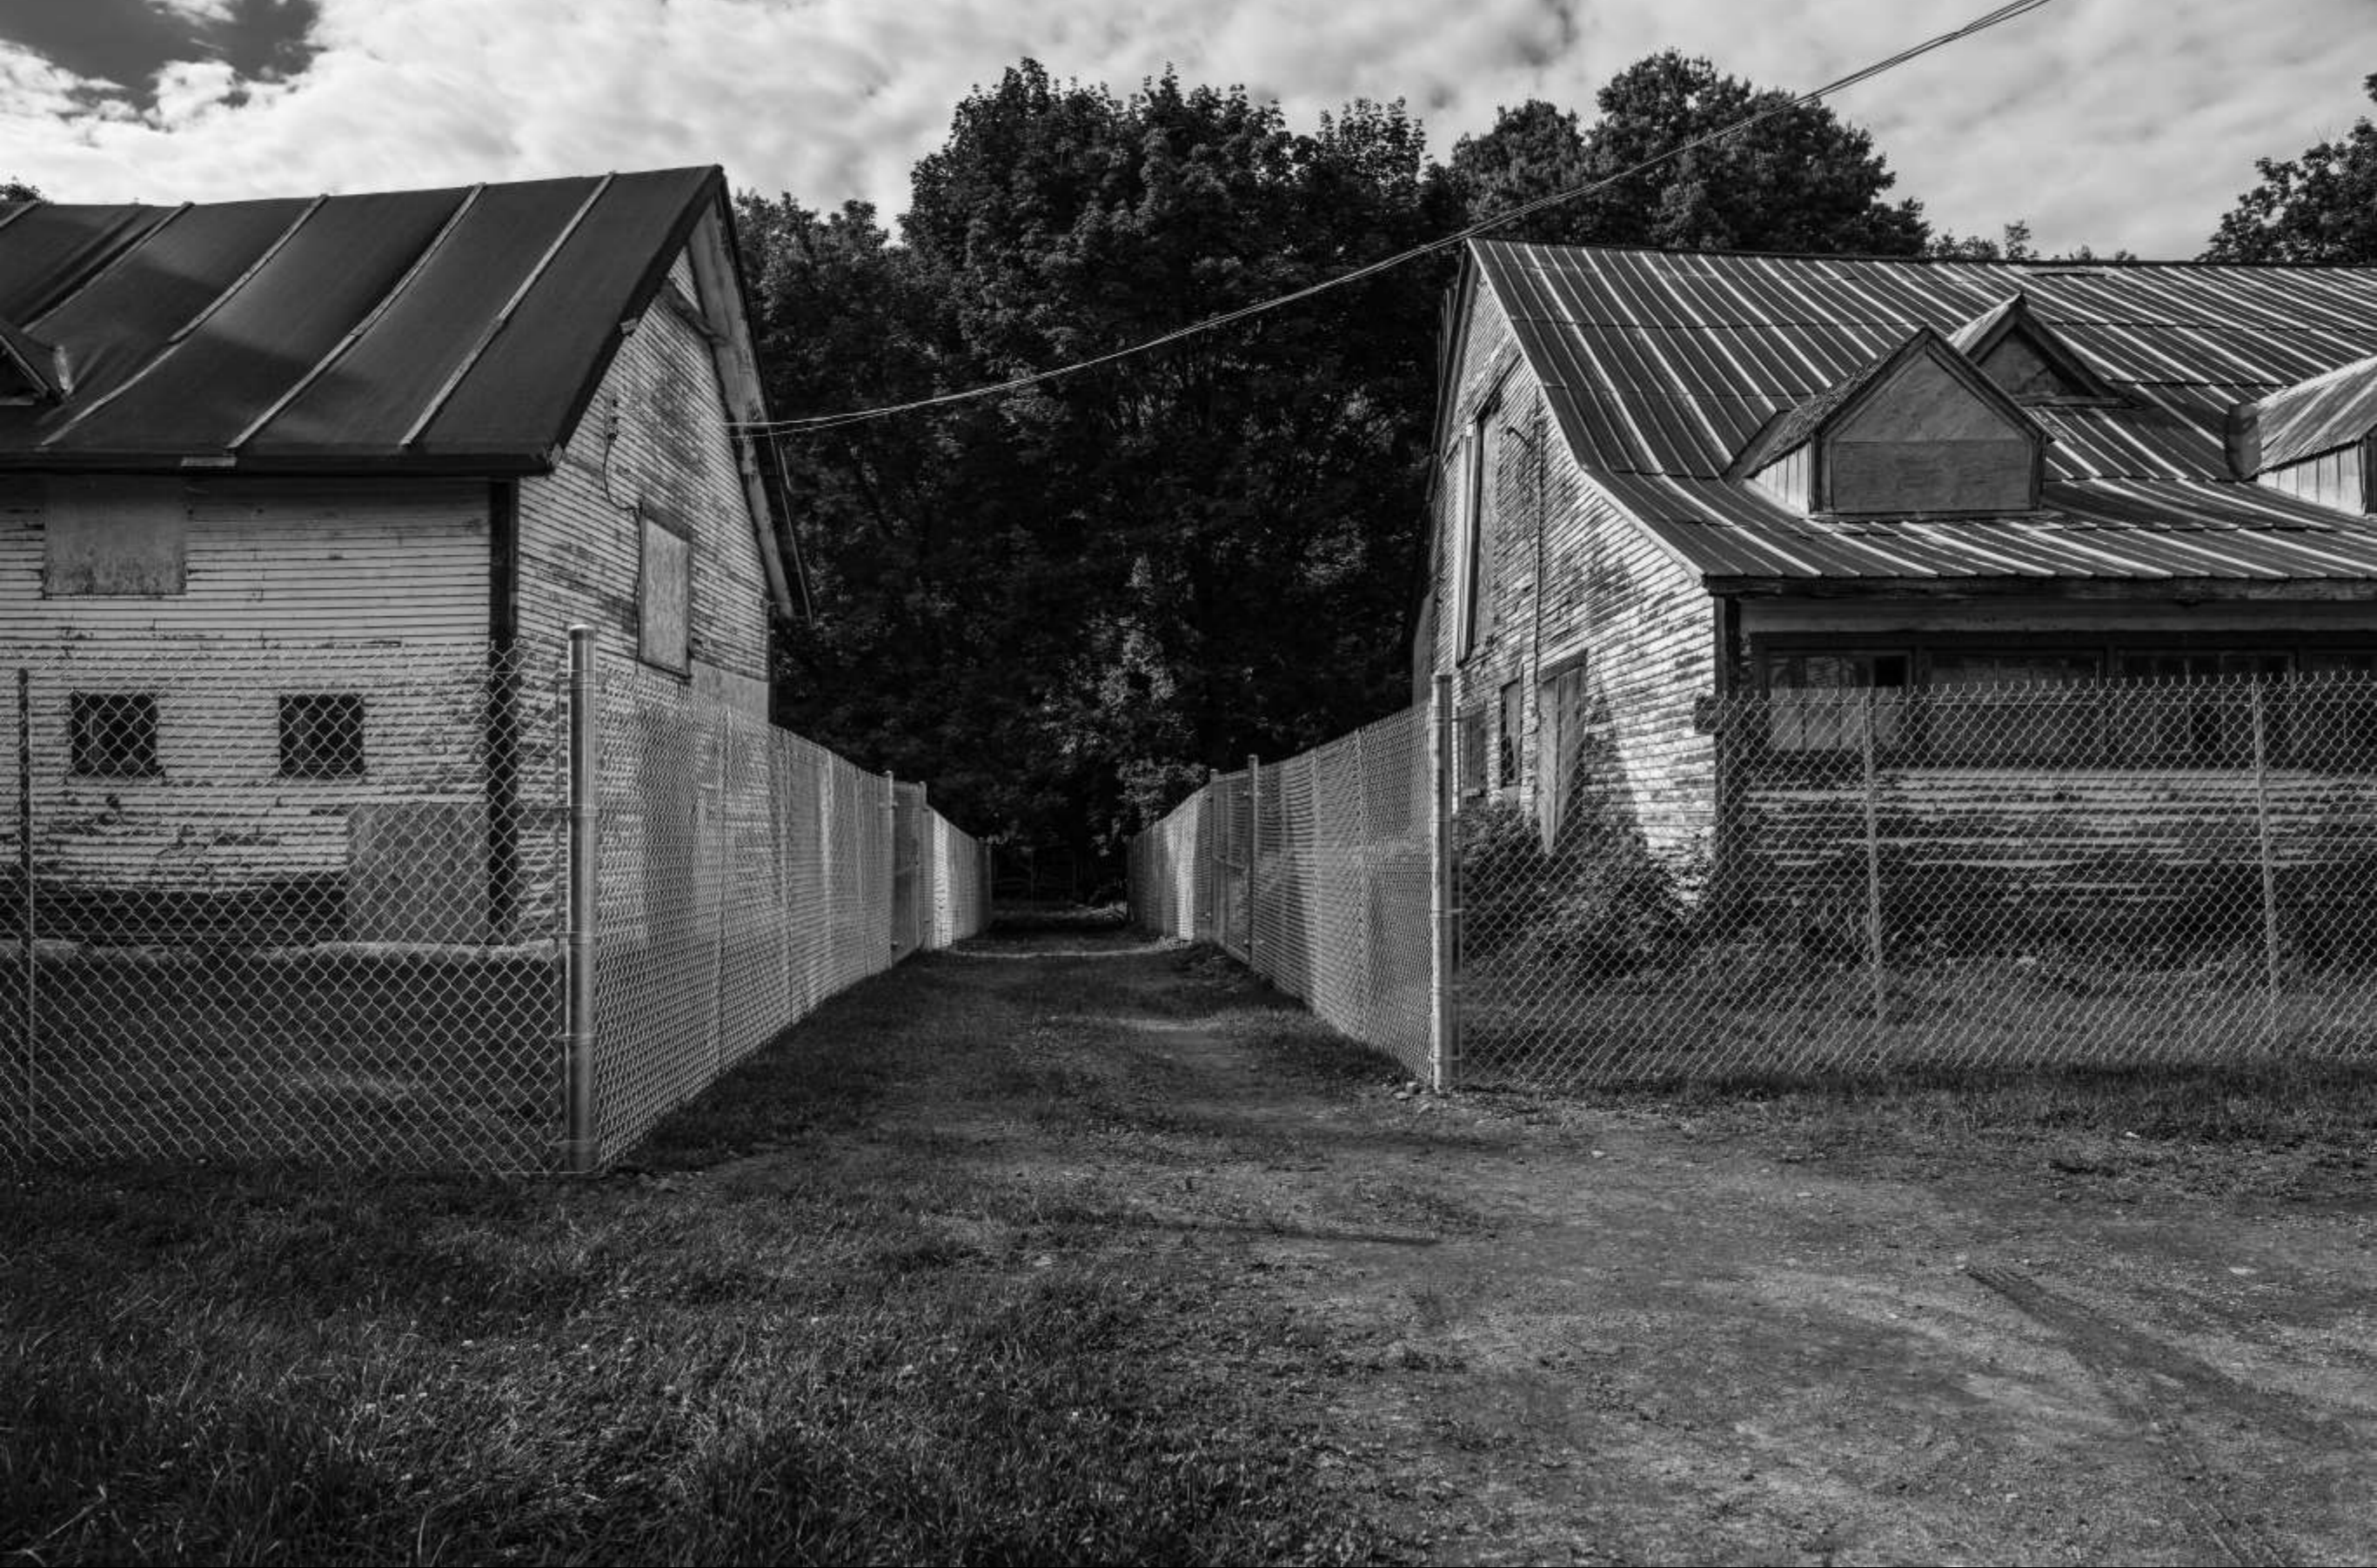
The Maxwell building is on the left and the original horse barn is on the right

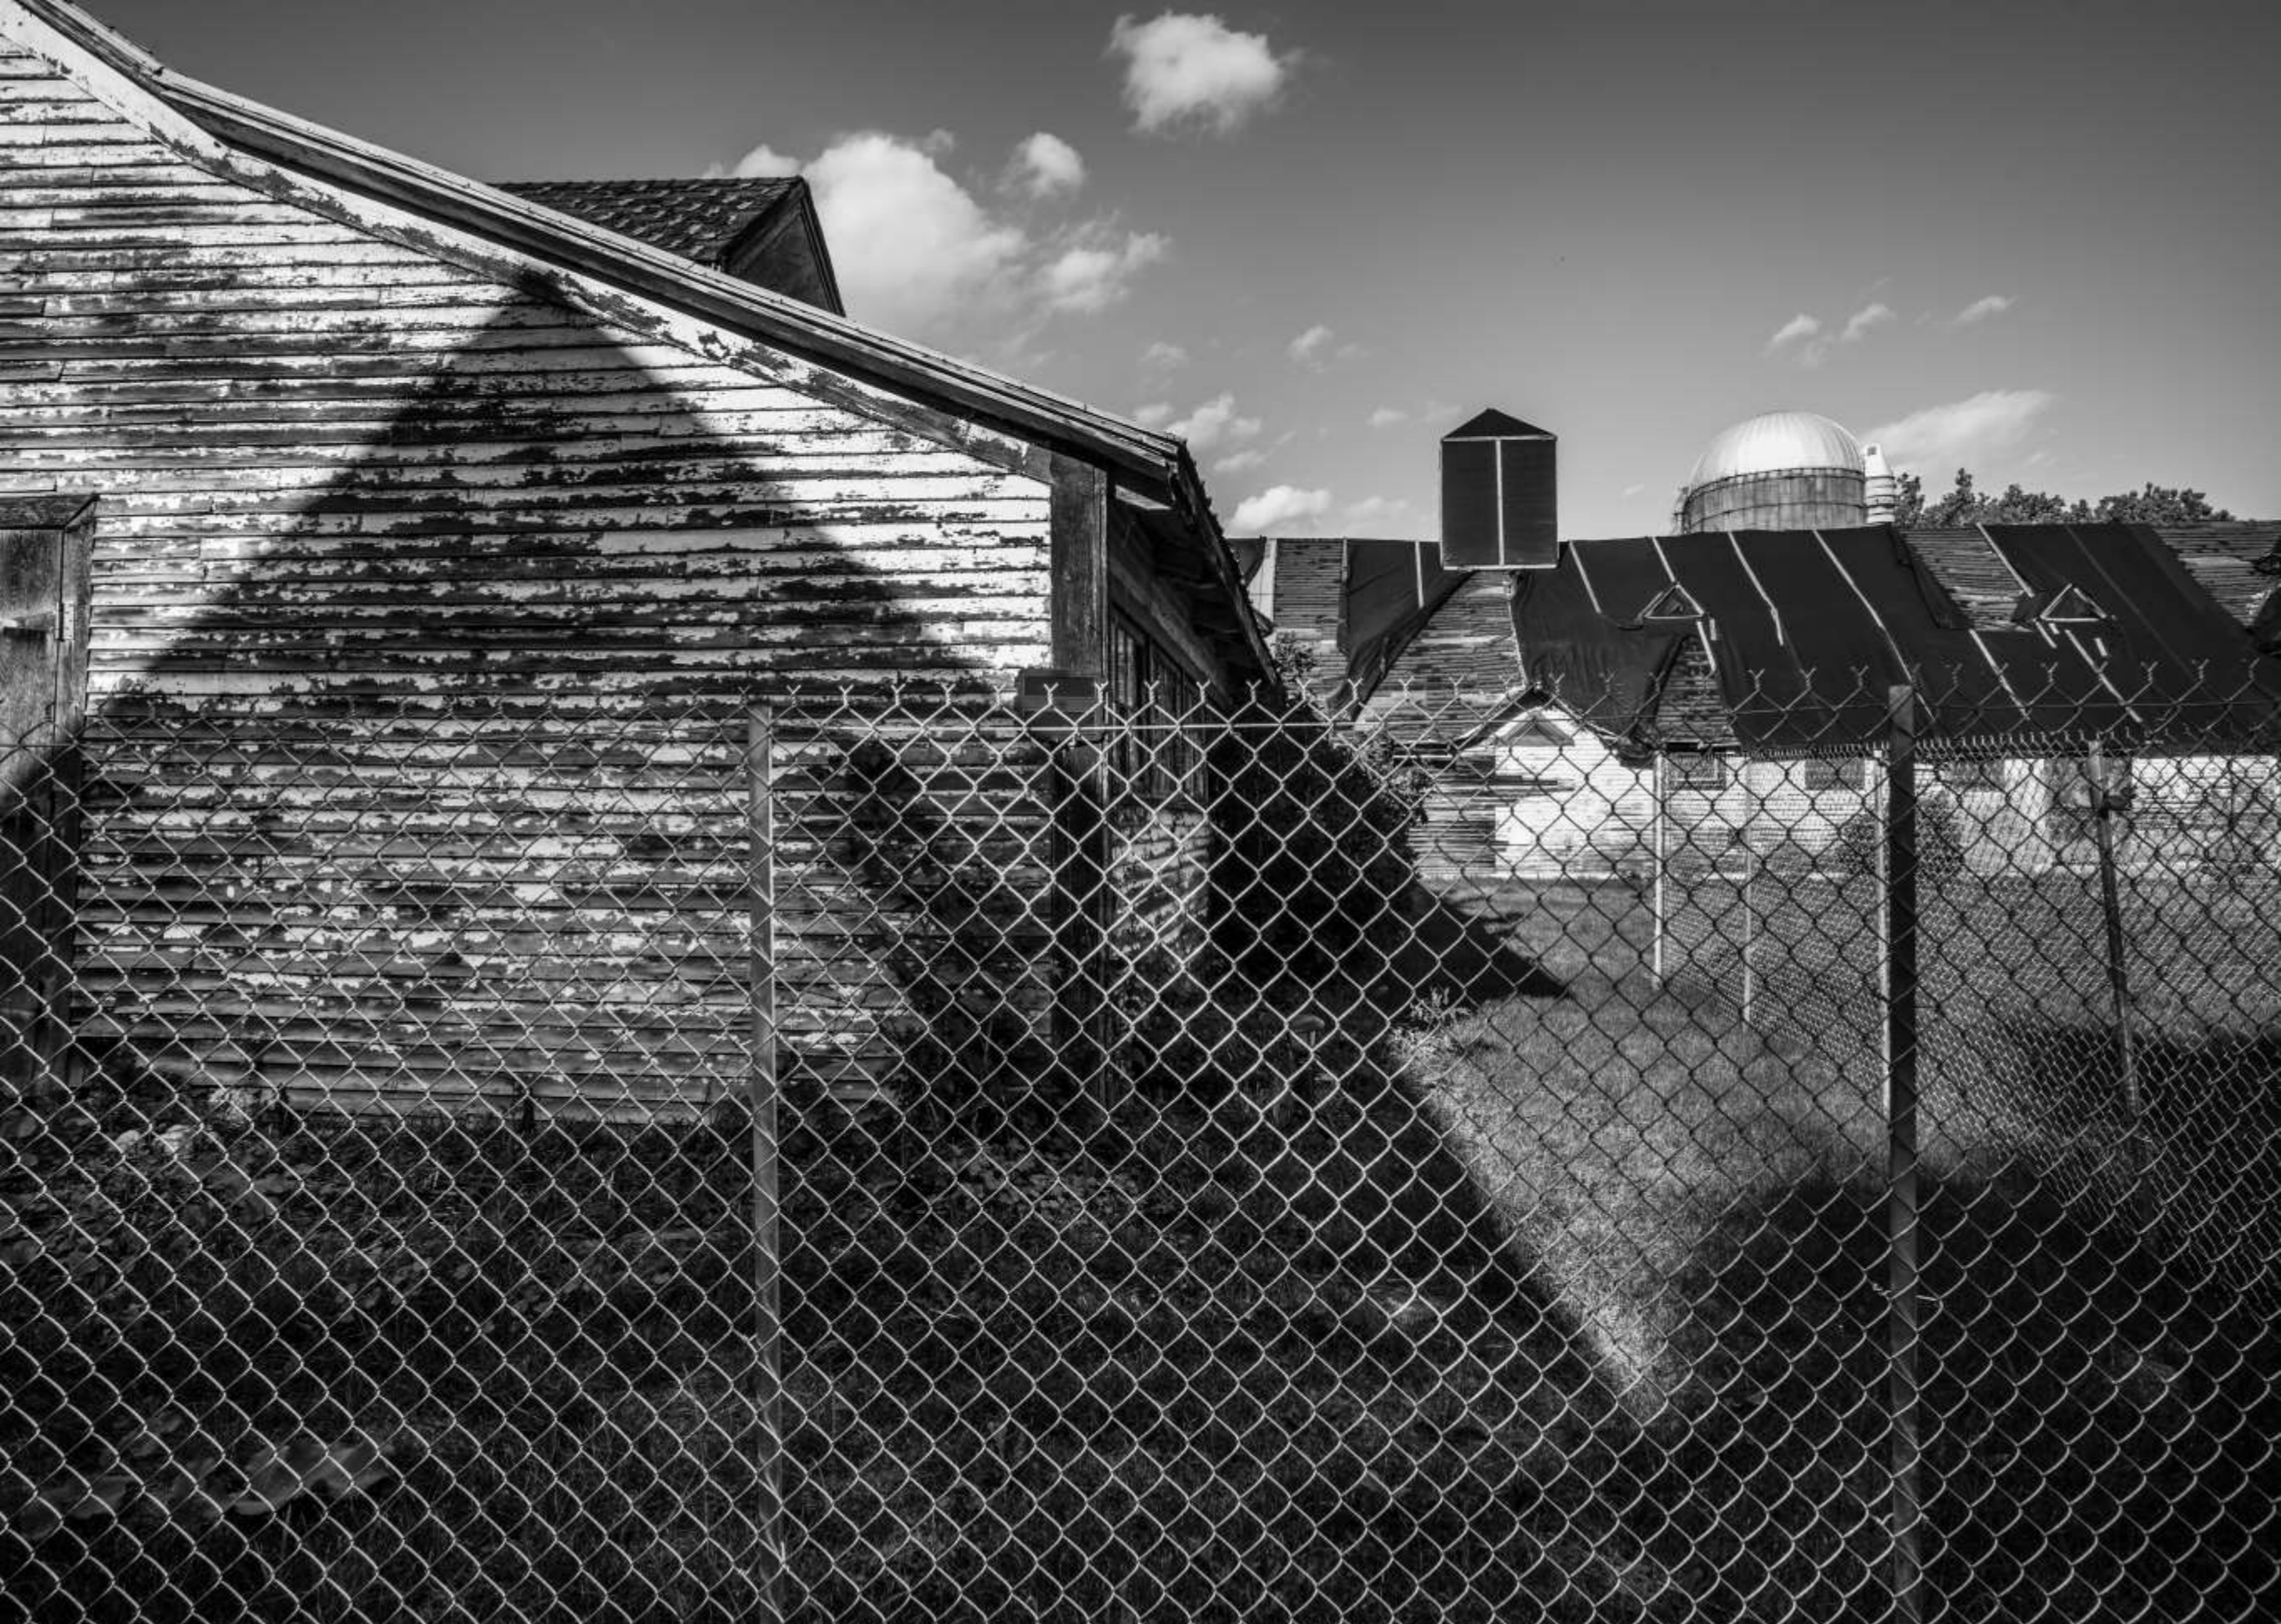
The Maxwell addition joins the original (shown at the rear) and continues to the front

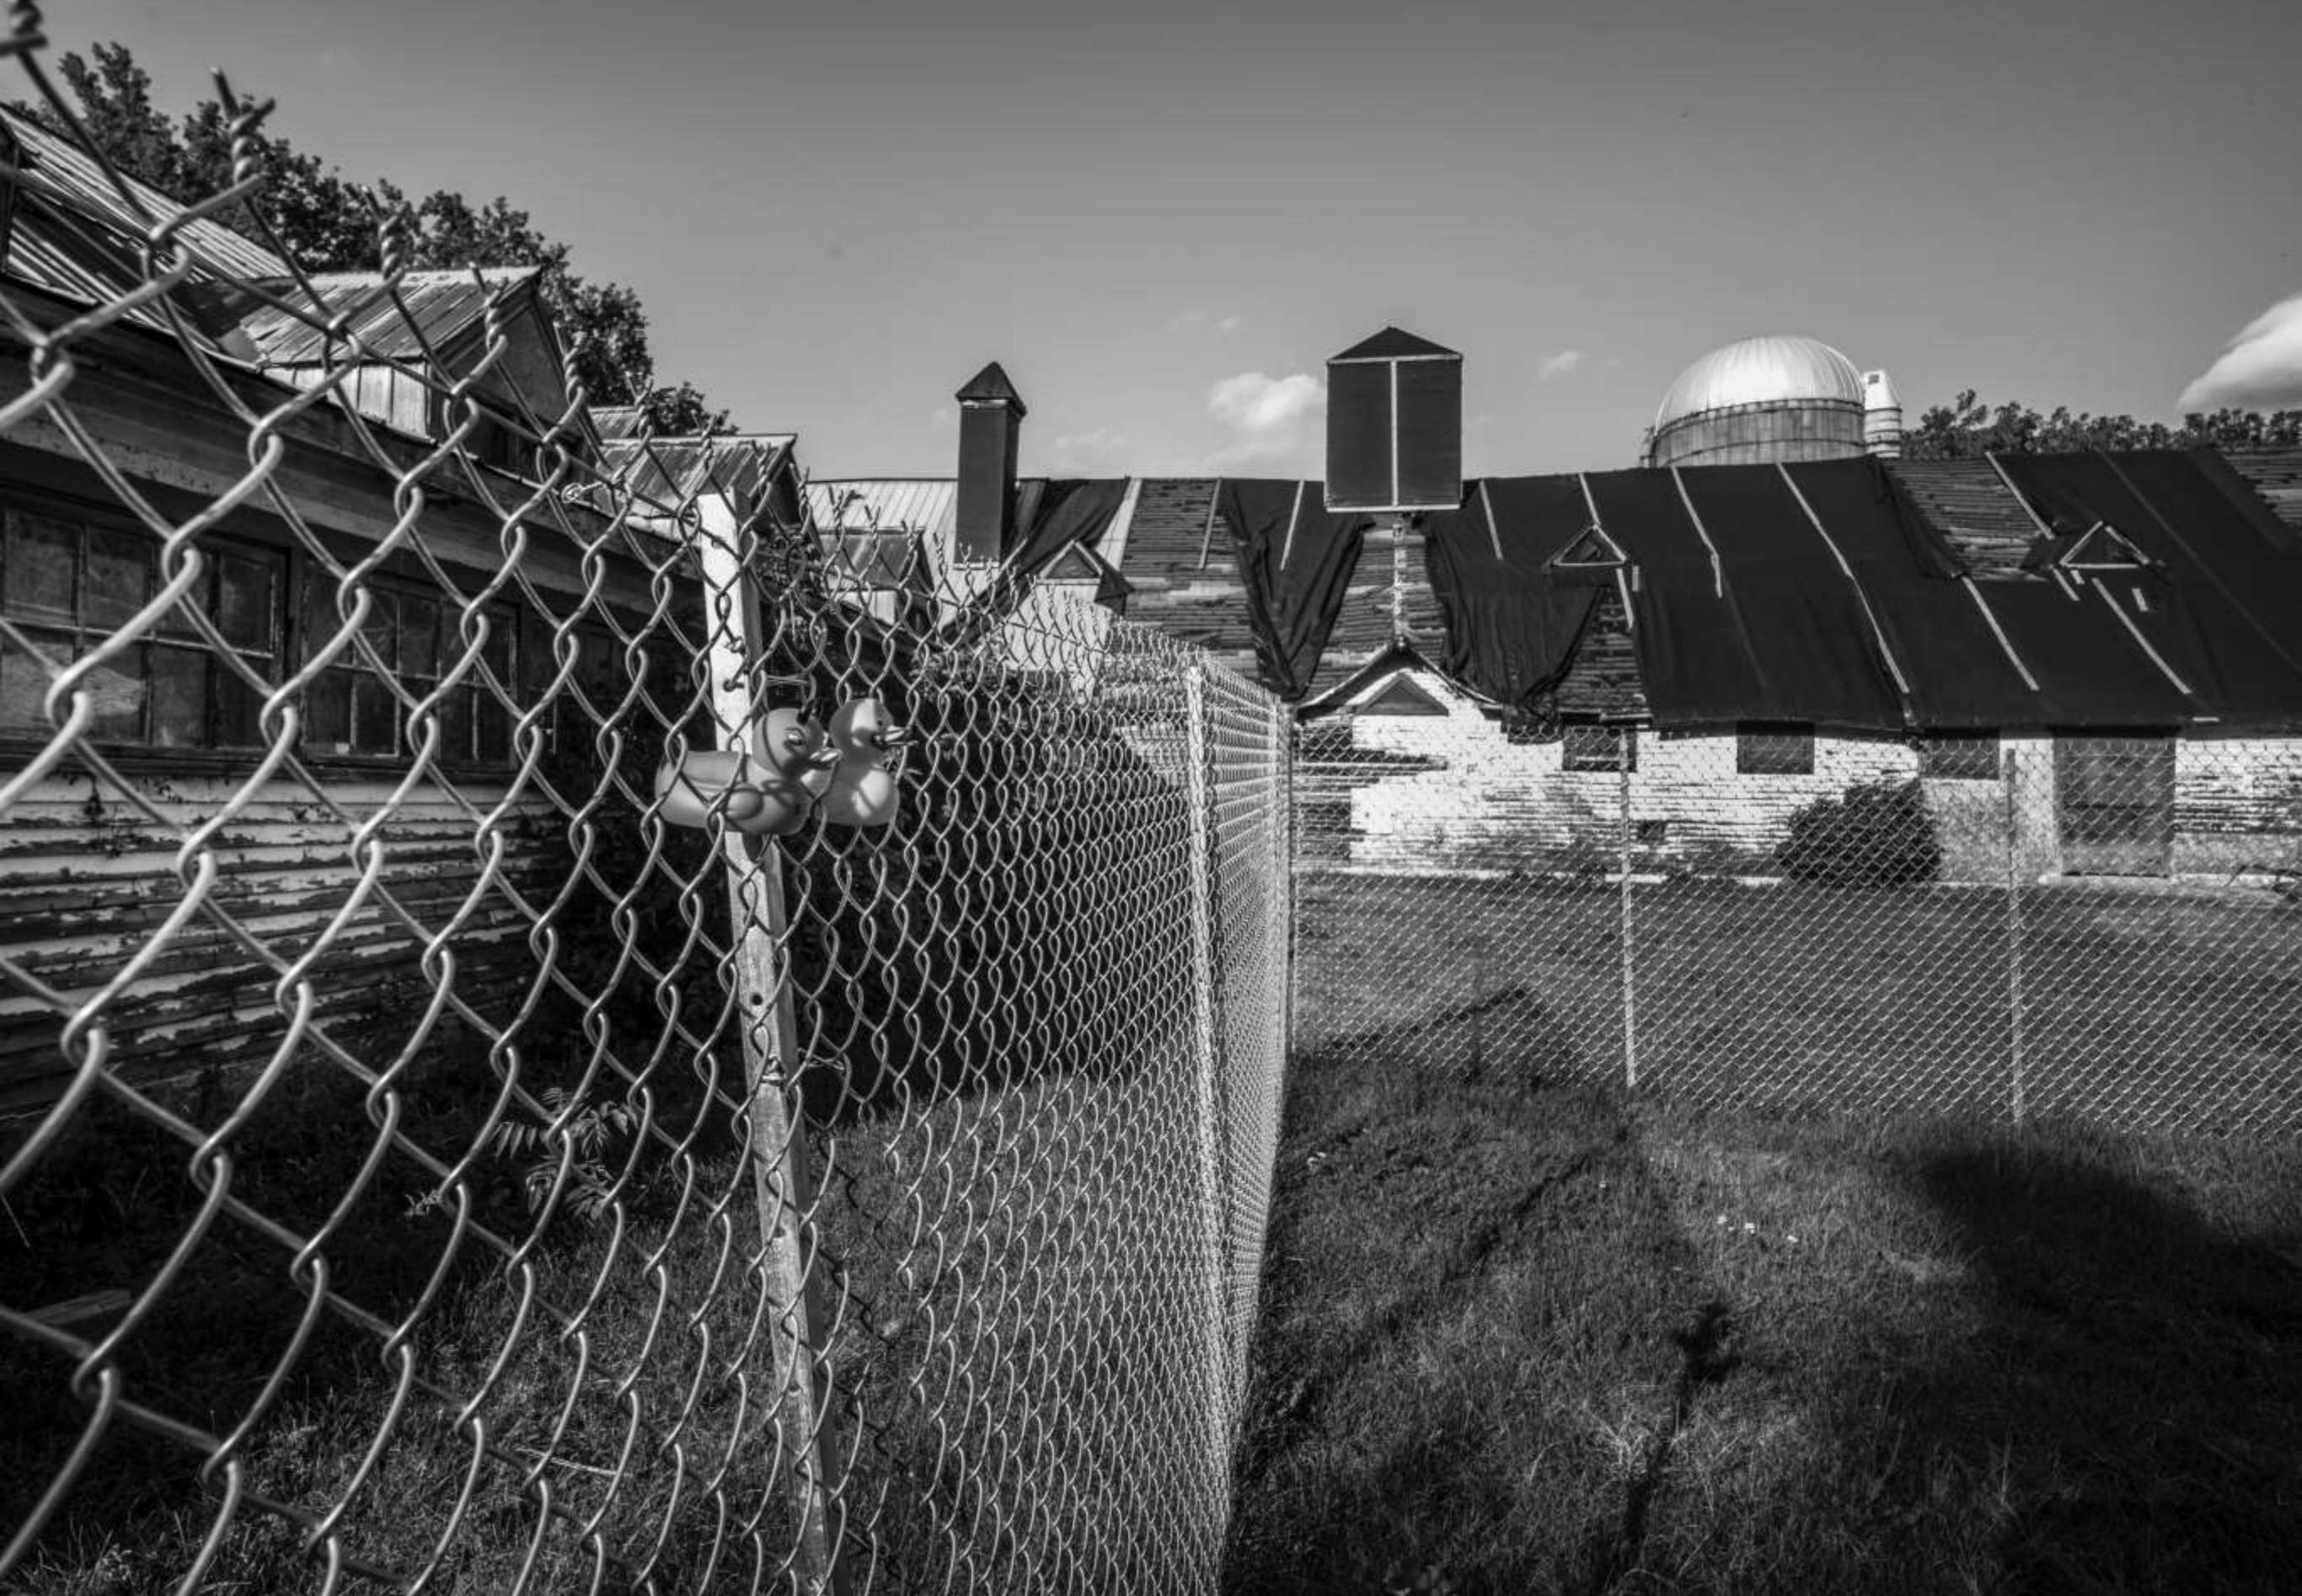
The protective plastic covering has come loose in places. It is possible that the securing nails were driven into wood that was already starting to rot, and they simply did not hold
