The Bois de la Roche stables at 292 Senneville Road, are on the endangered list compiled by Heritage Montreal. The wooden horse barn, built between 1880 and 1900, and enlarged in 1902, was part of the country estate of Senator Louis-Joseph Forget, whose property was acquired by the Montreal Urban Community in 1991. These stables were enlarged by architects Edward and William Maxwell.

Portions of these stables are threatened, and there has been a collapse of one section in the past few years. A temporary structure has recently been put in place to hopefully prevent further damage.

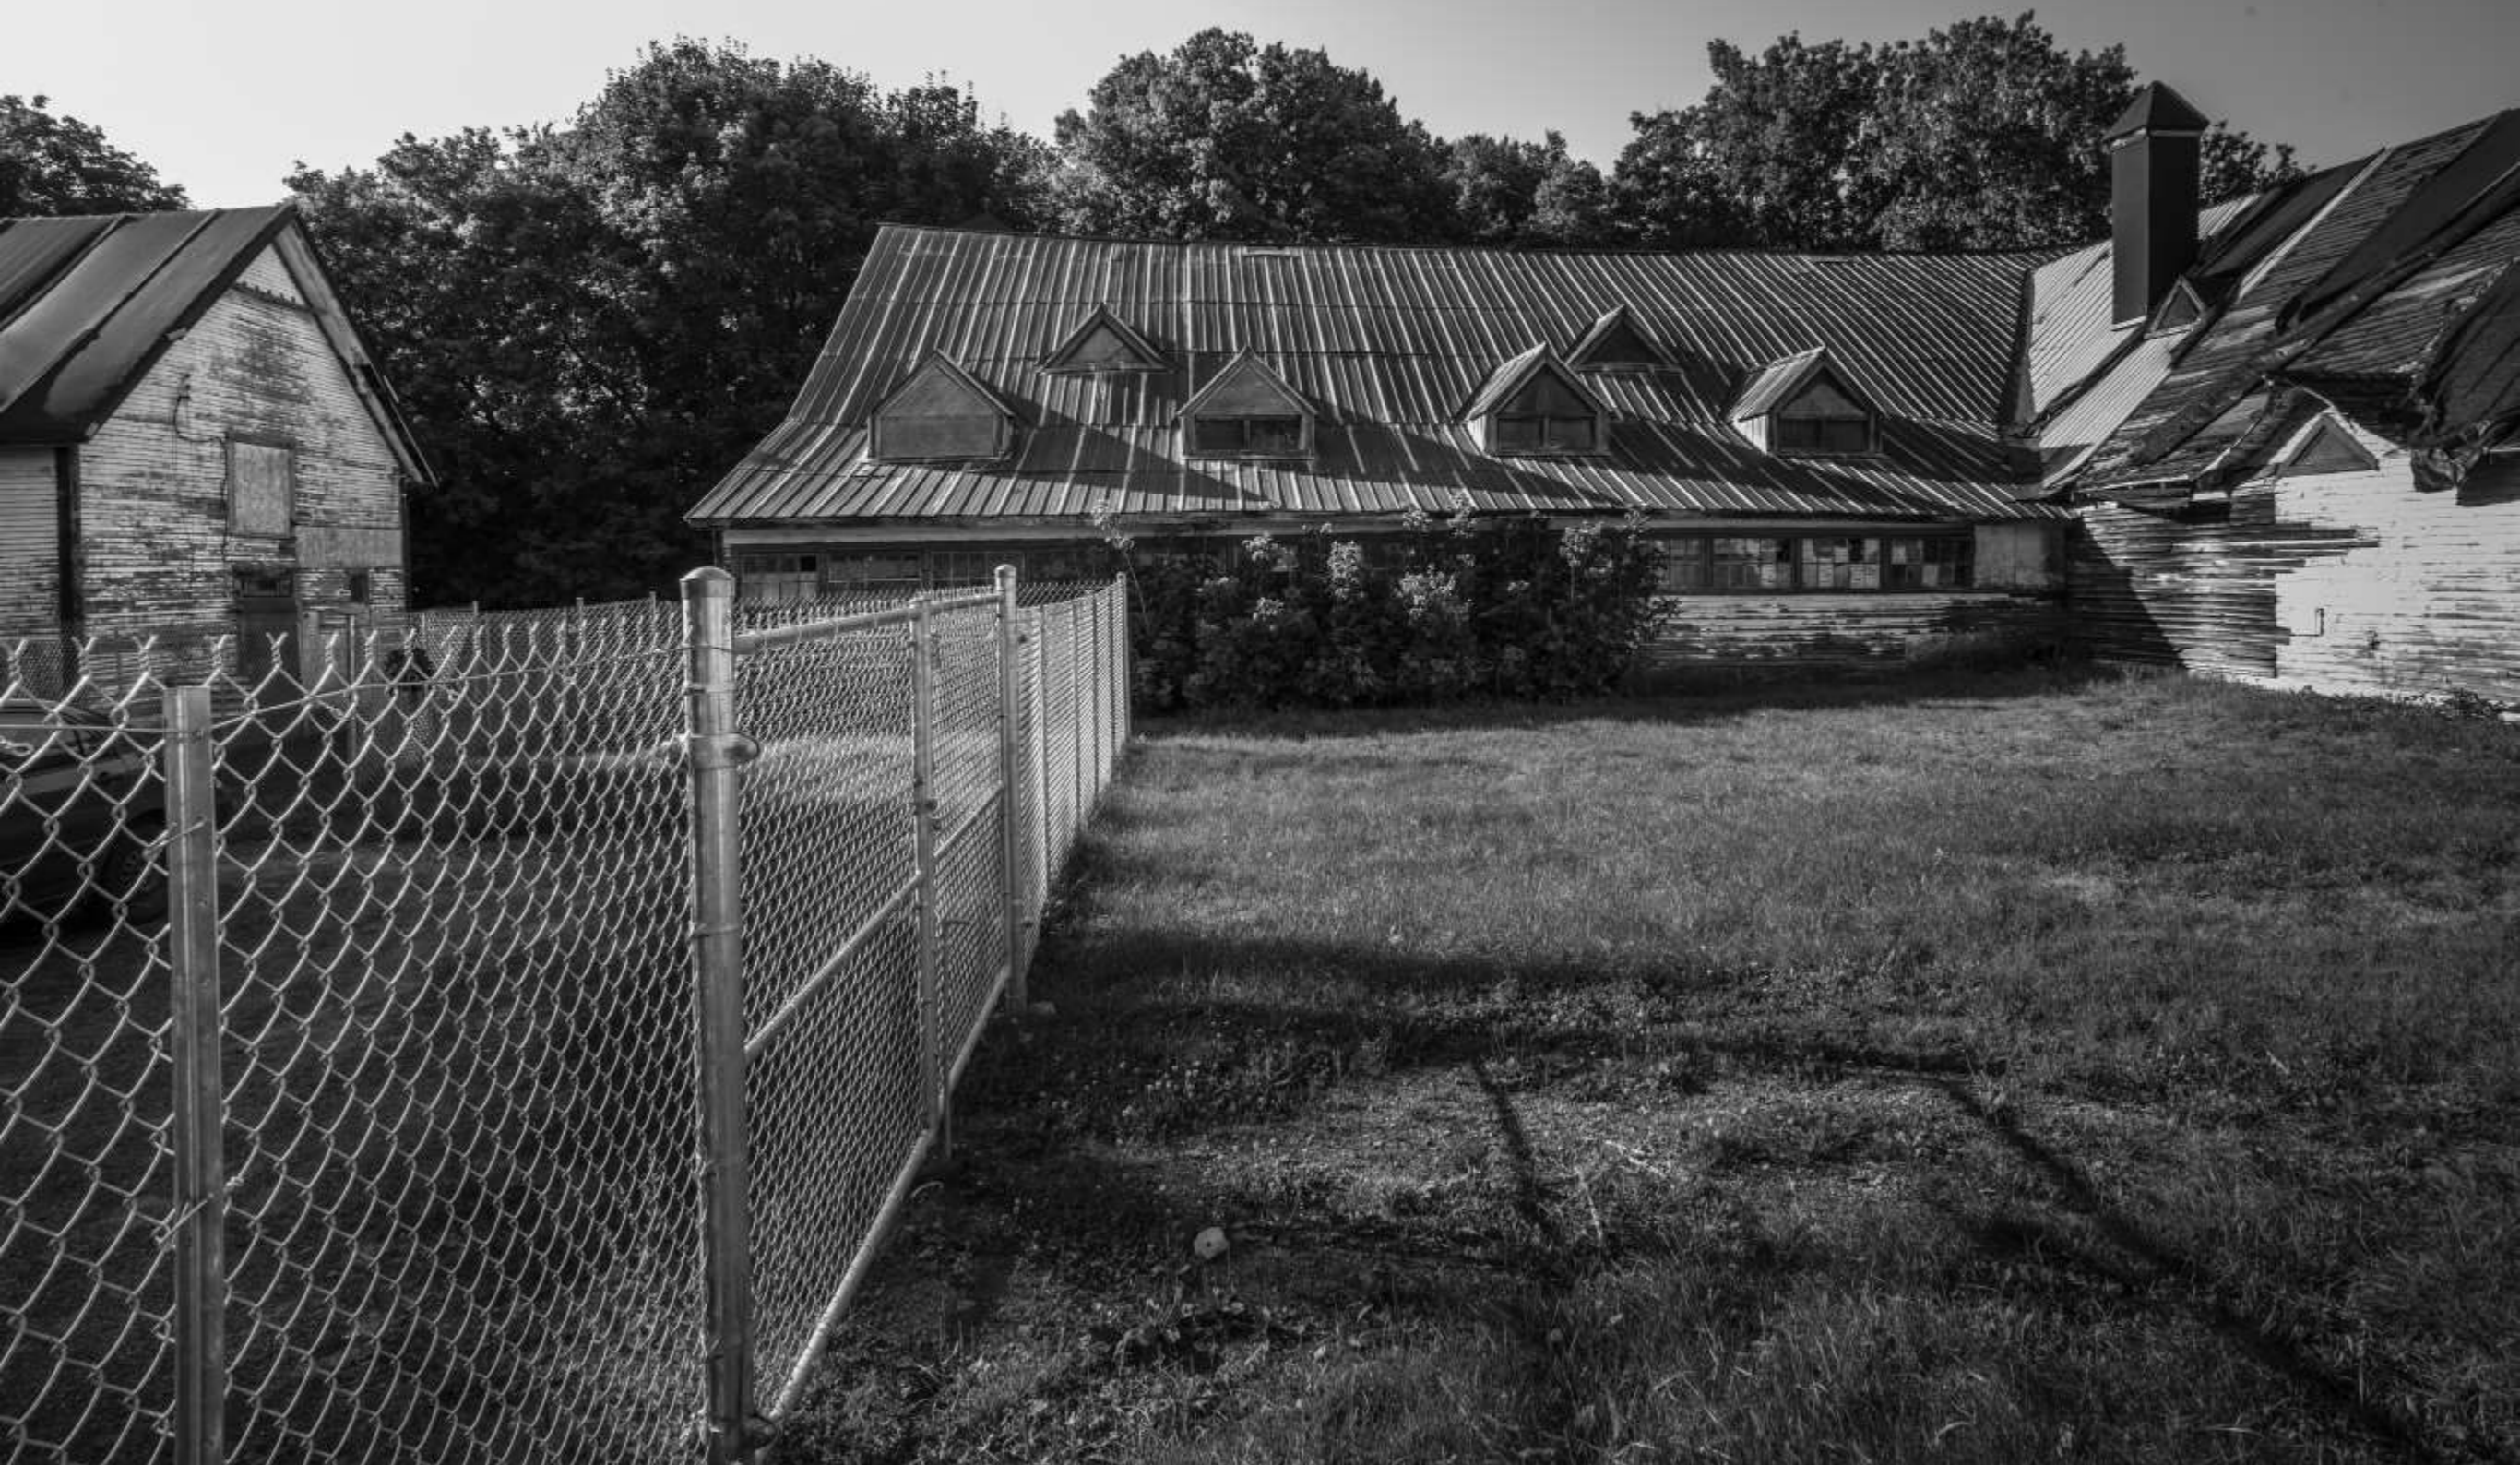
The original stable had a tin roof that was still in fairly decent condition, unlike the roof of the Maxwell addition on the right. There was a good chance that the asphalt singles replaced cedar shingles that Maxwell would have preferred during this time. It is also unlikely that the tin roof was the original material.

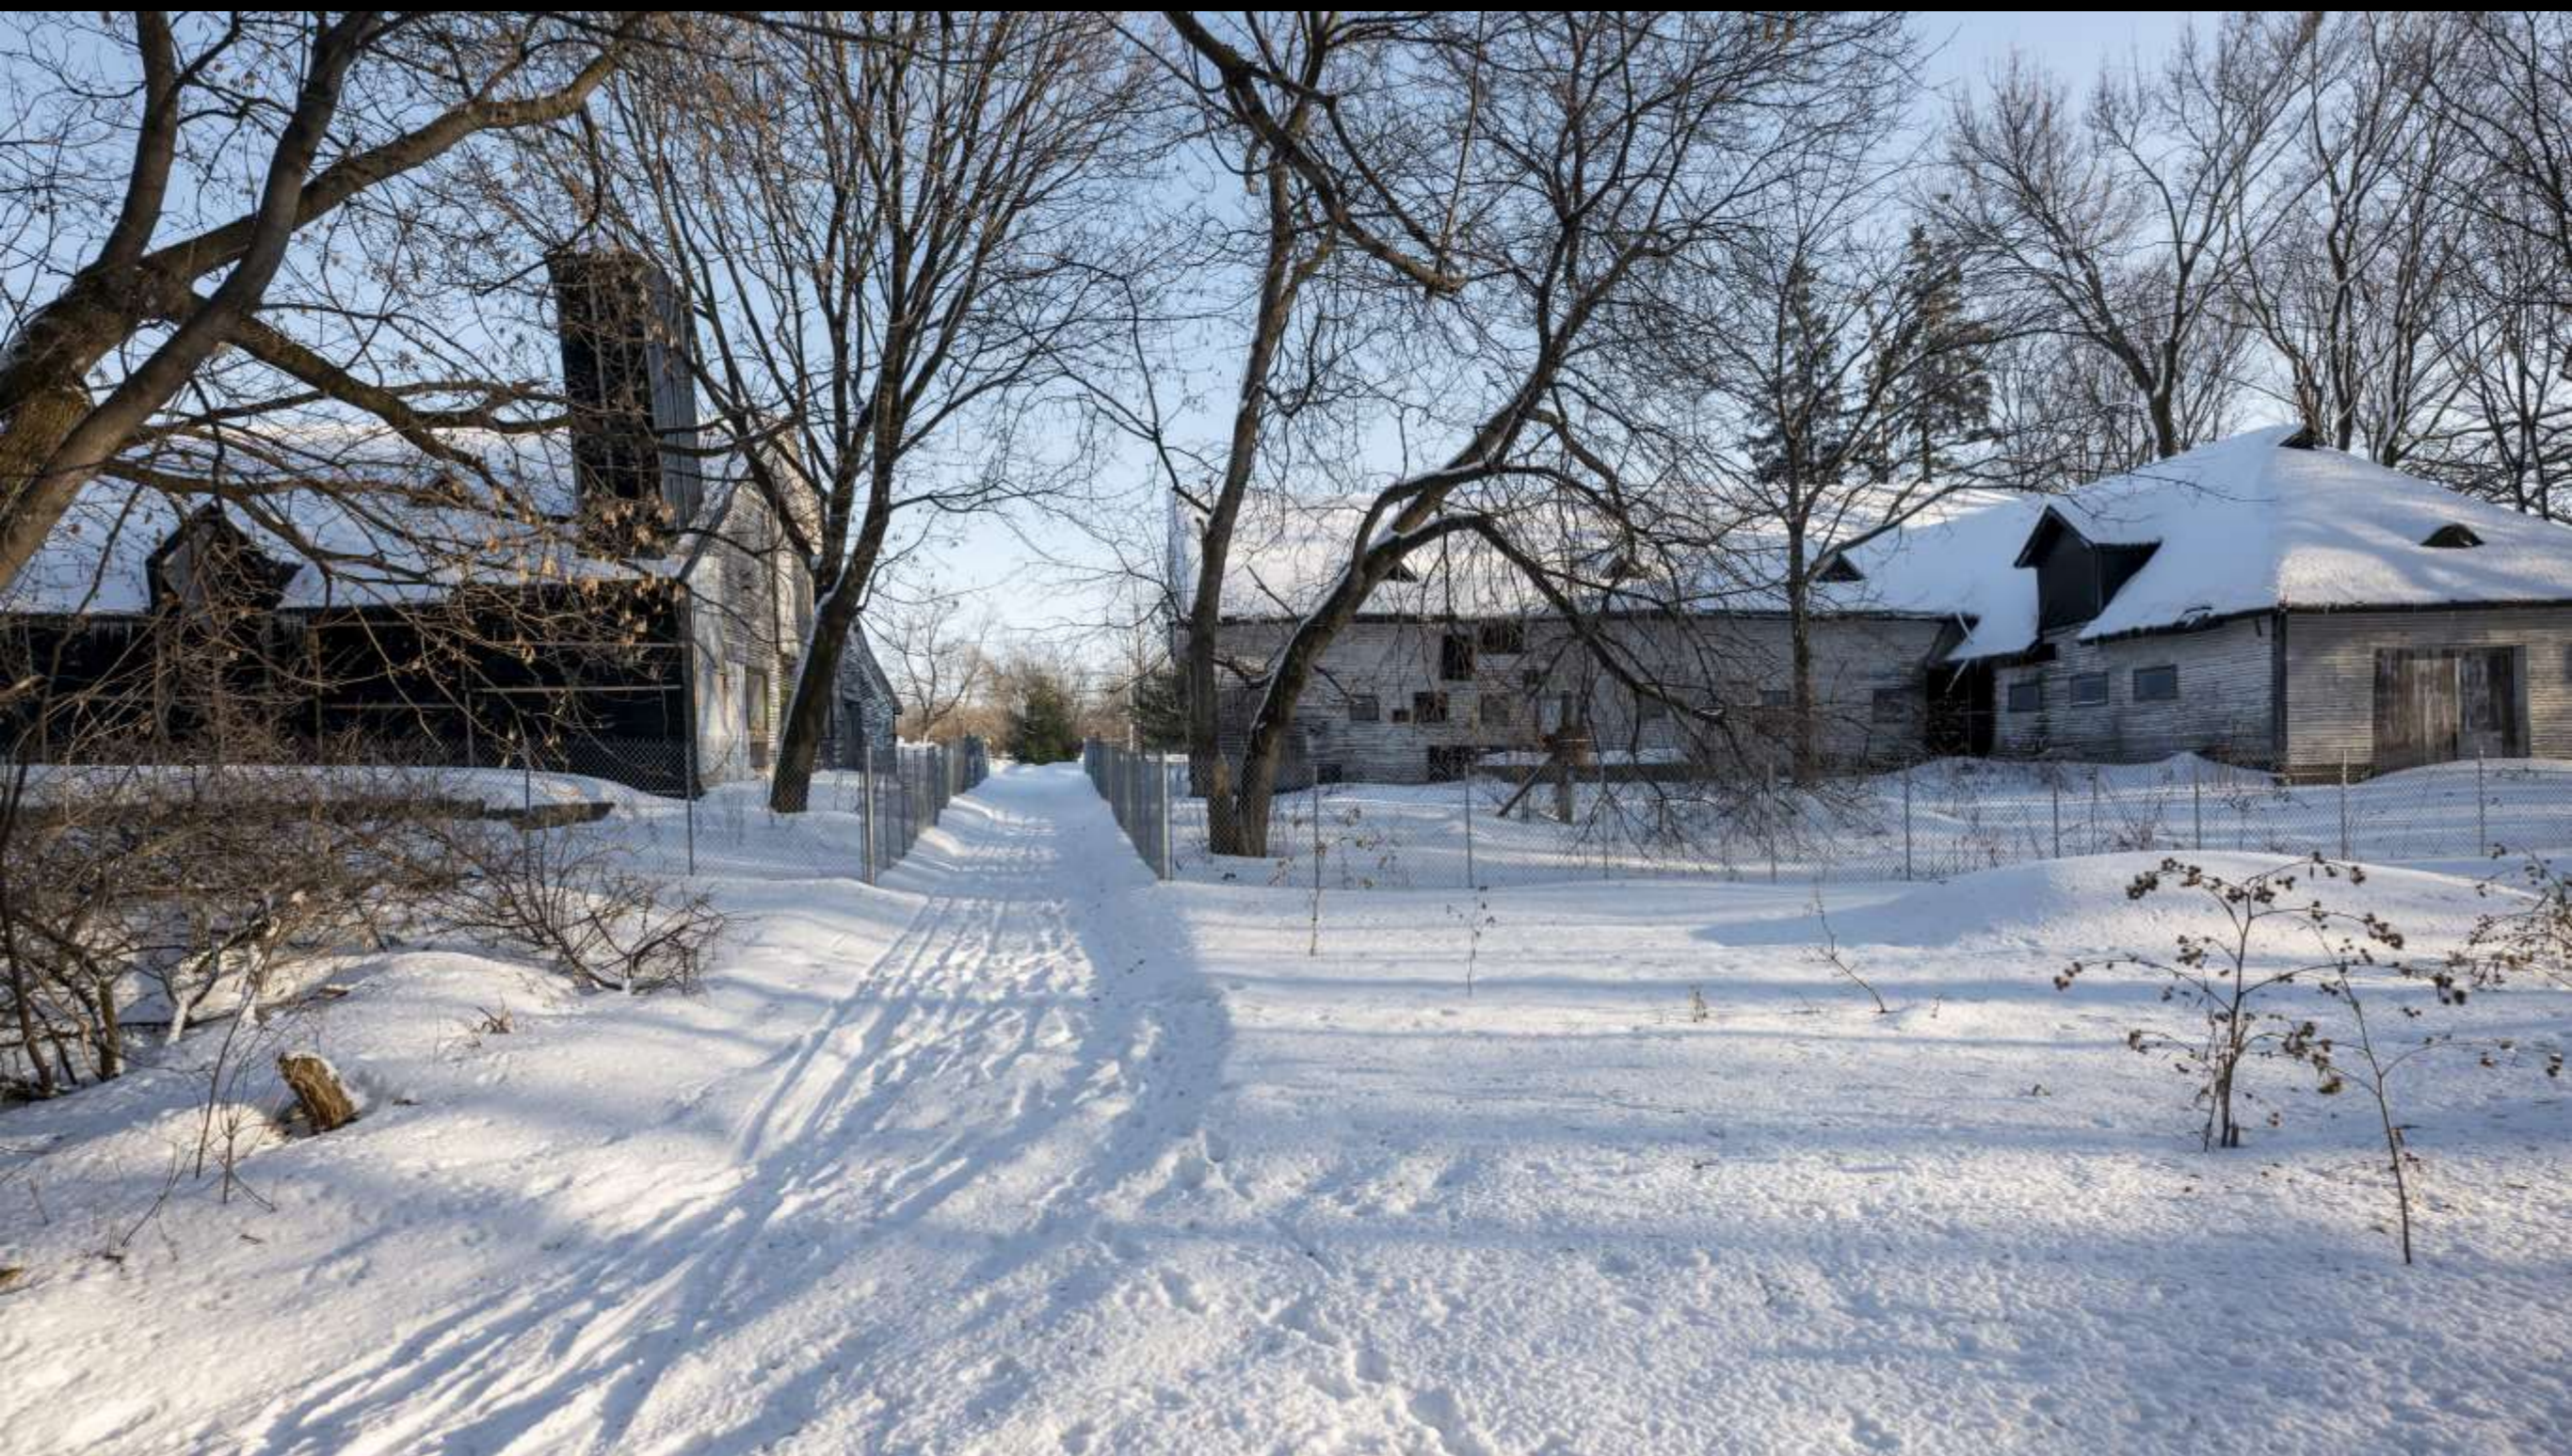
This photo from the rear shows the original horse barn on the left and the newer extensions on the right. Visually the new design blended in fairly well.

The original horse barn is less imposing than the extensions. There is a continuous window strip along the facade and has more dormers on the roof. This stable, despite being older, appears to be in relatively good condition.

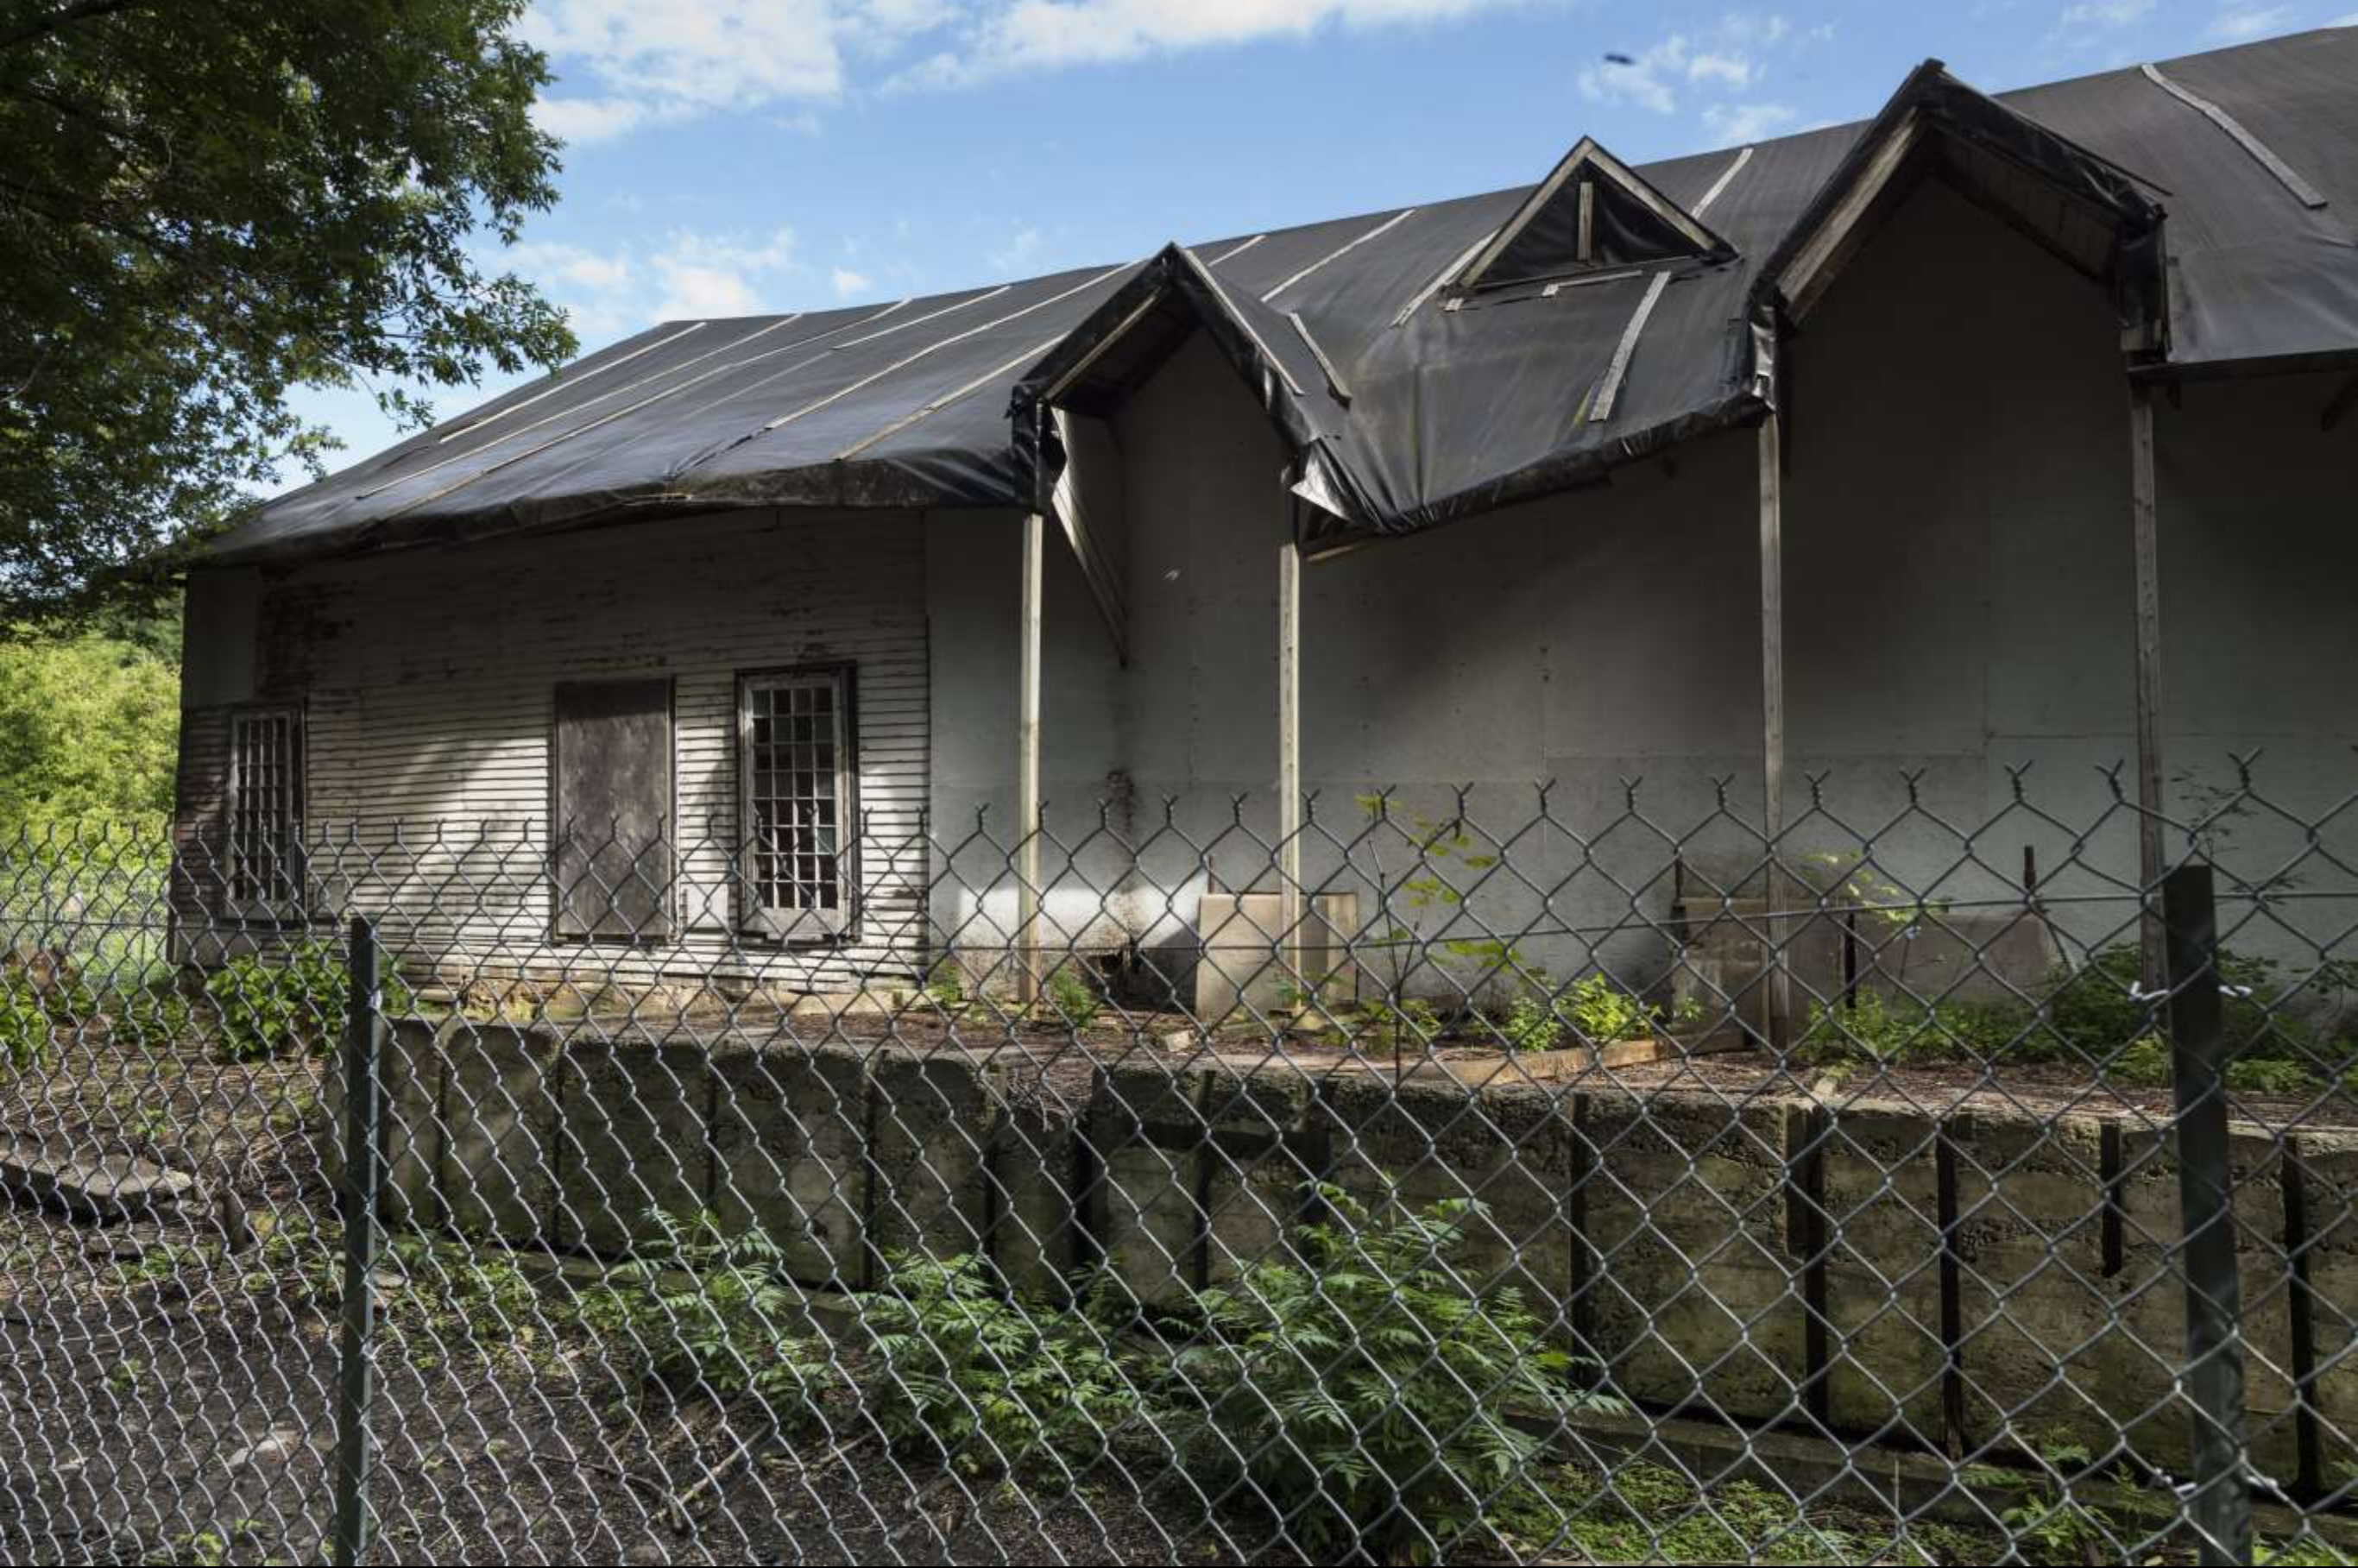
The rear facade of the original horse barn.

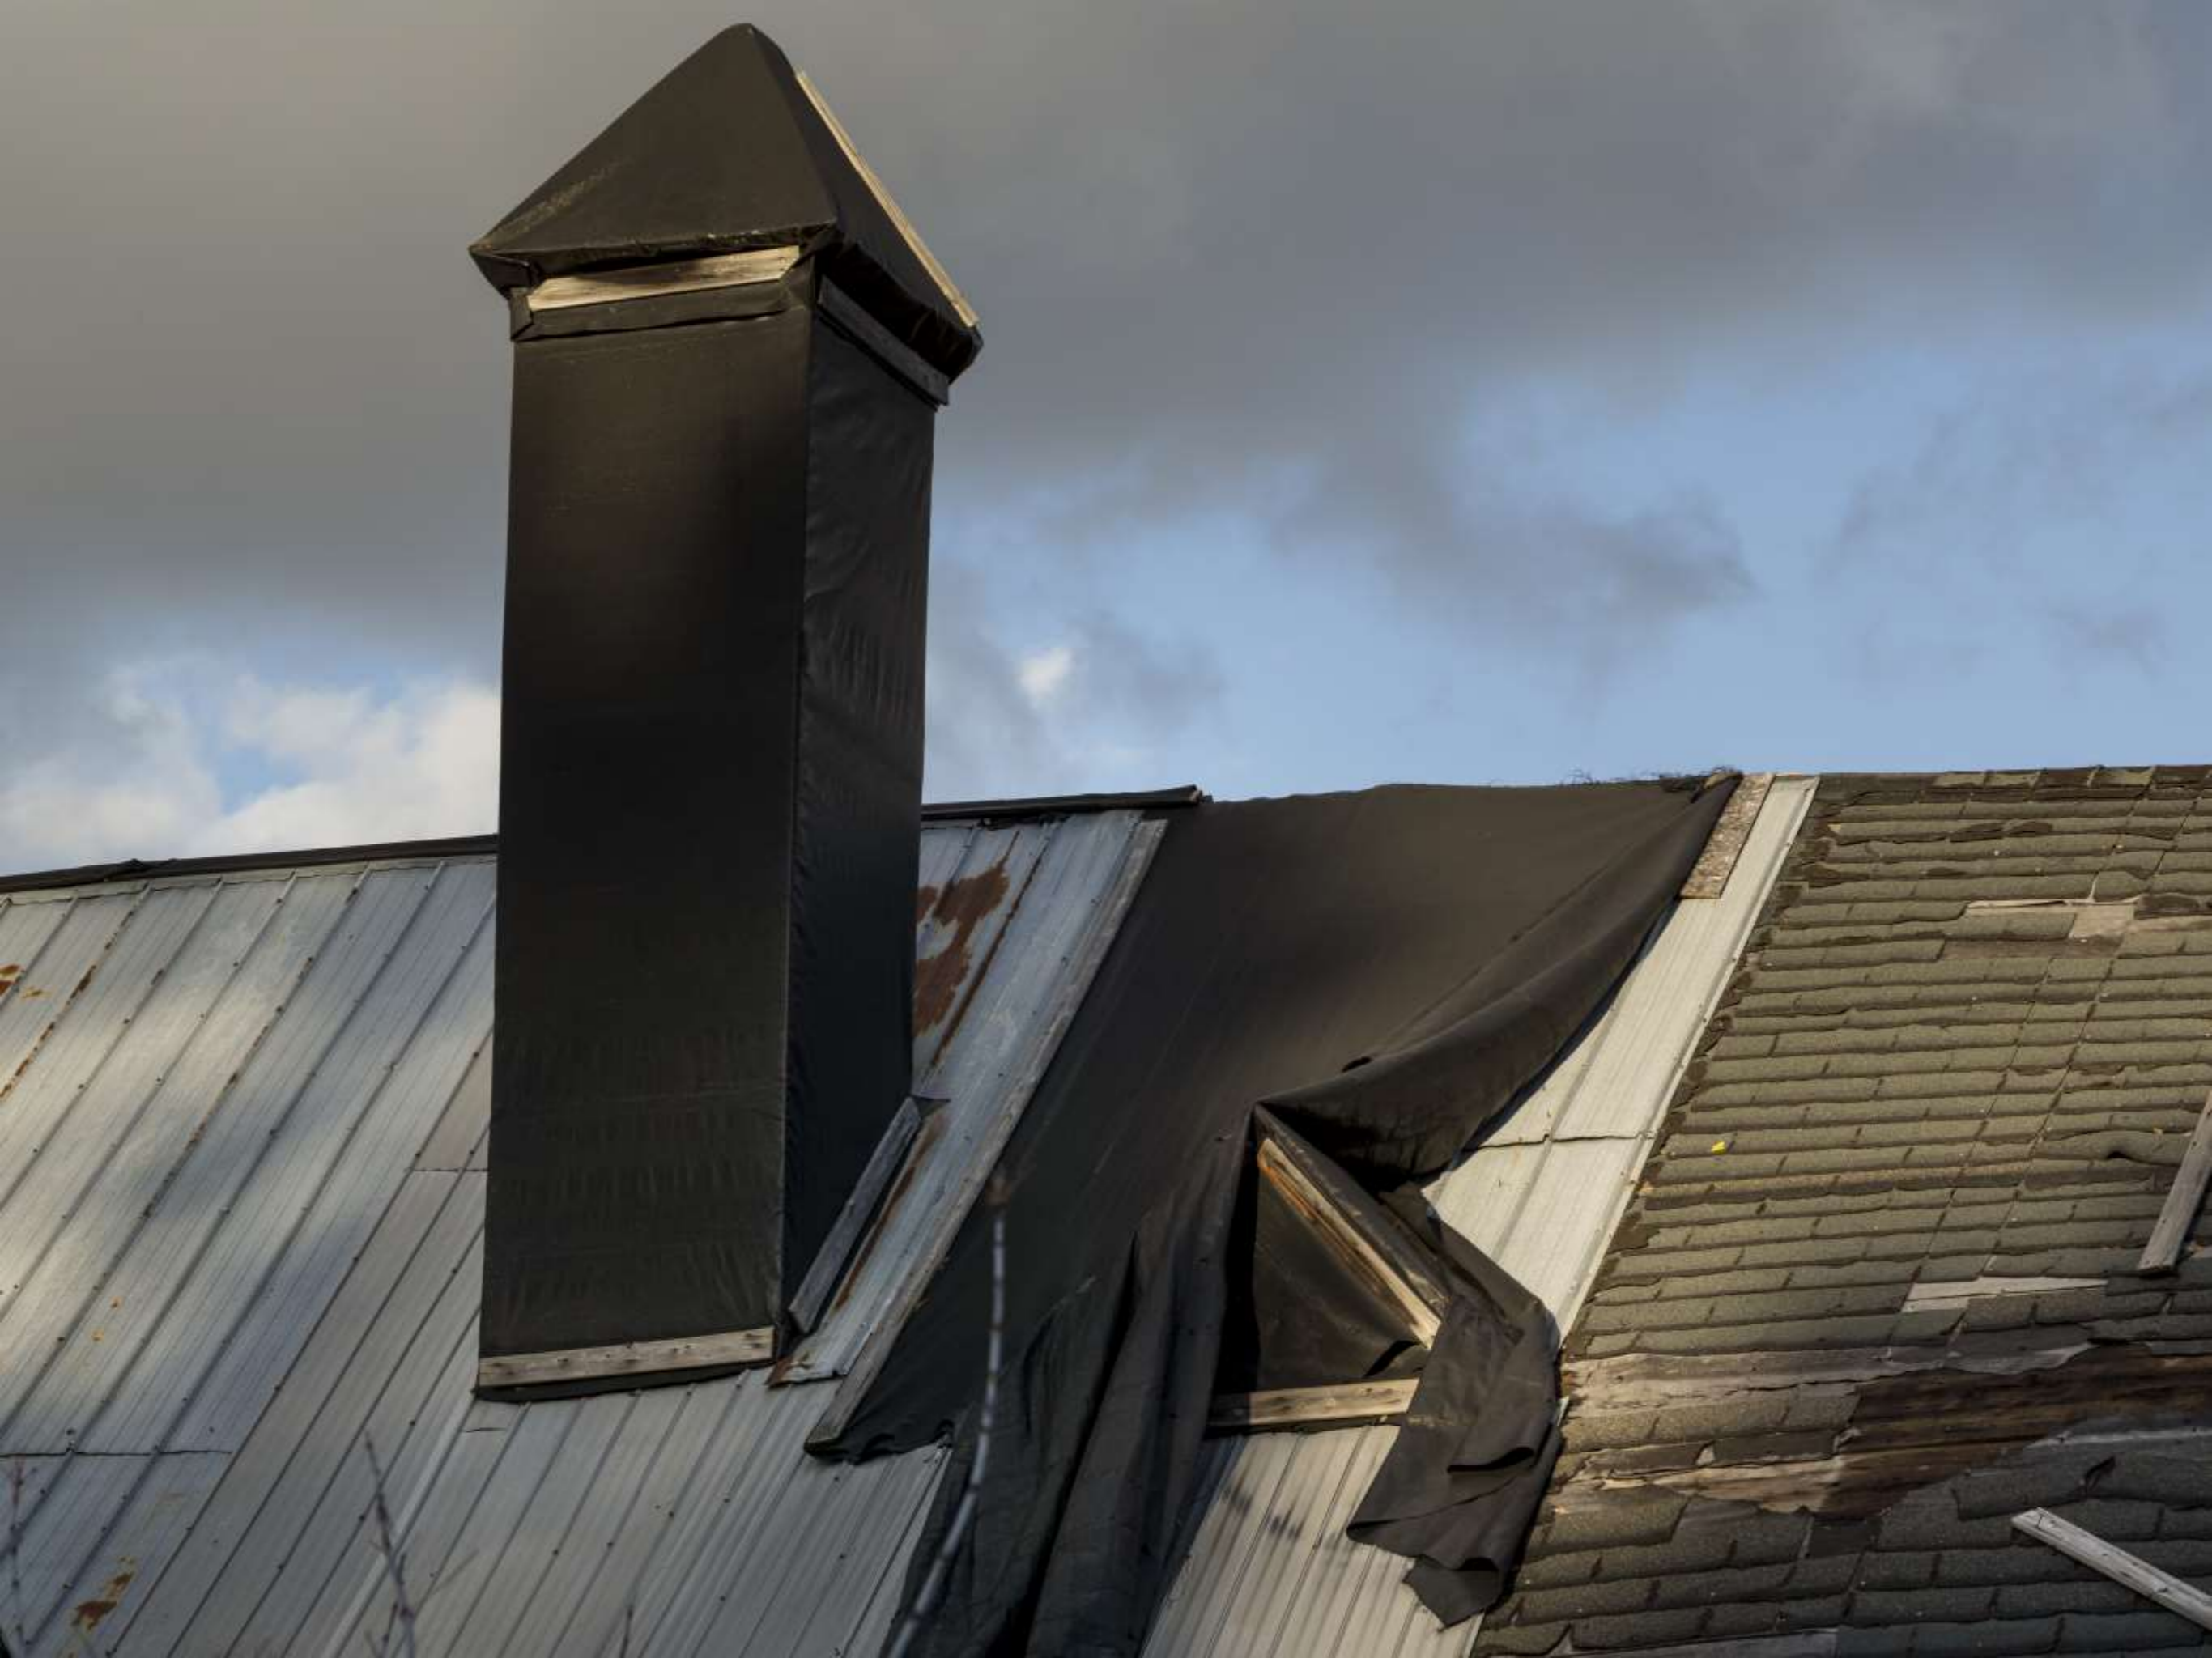
**The little triangular window
matches the projected roof outline
above it.
Such a lovely detail.**

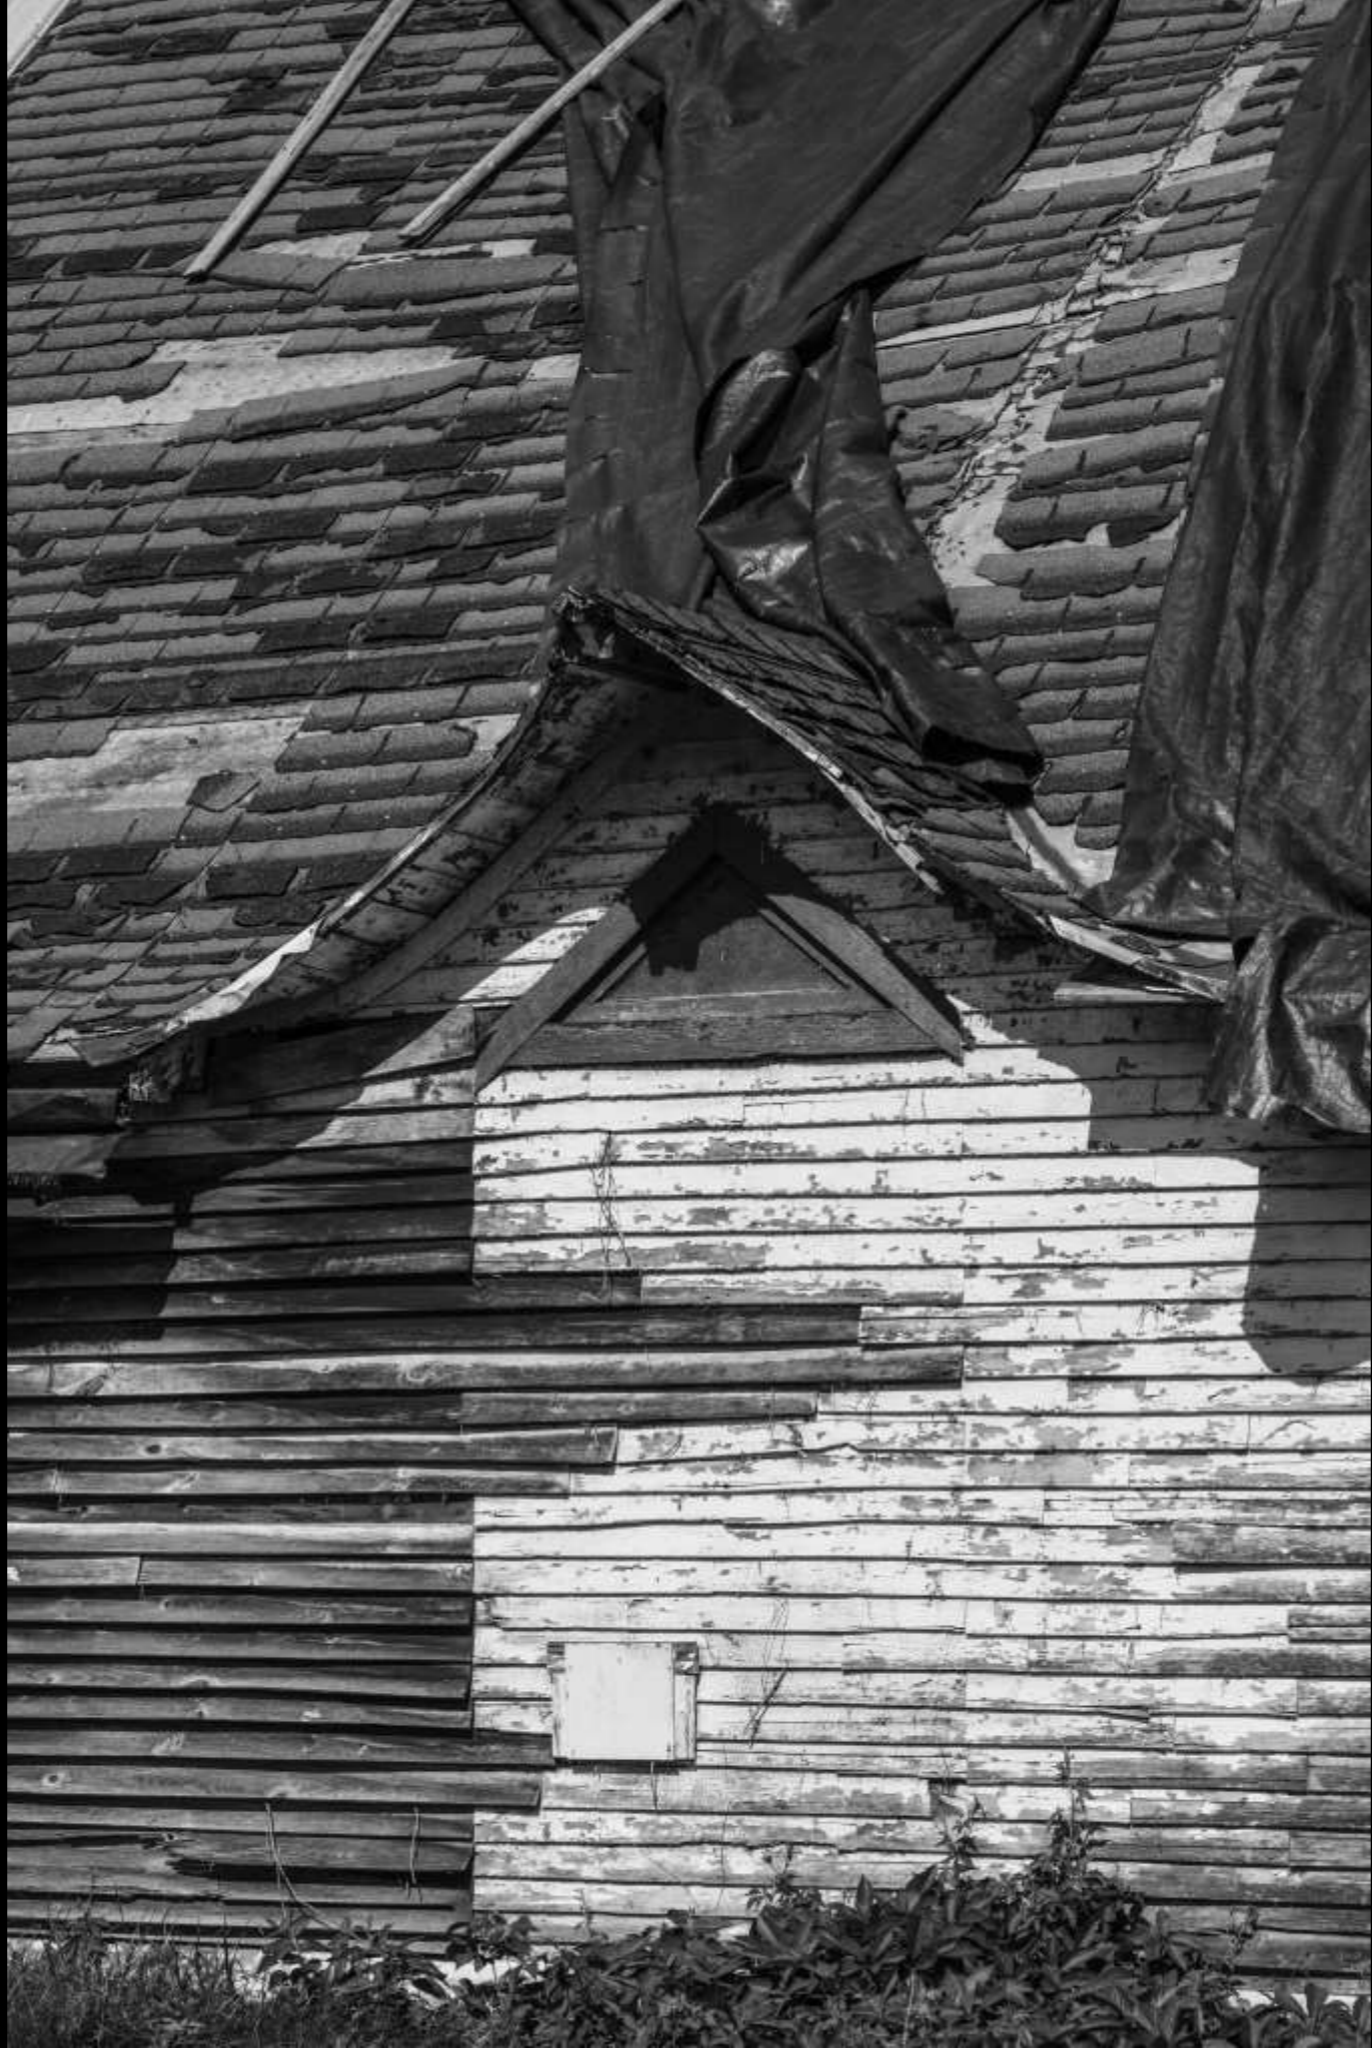
The plastic roof covering was done a number of years ago. However over time fierce winds removed much of this protection and exposed the then vulnerable roof to the elements.

Wrapping a building roof in plastic should only be seen as a temporary solution.

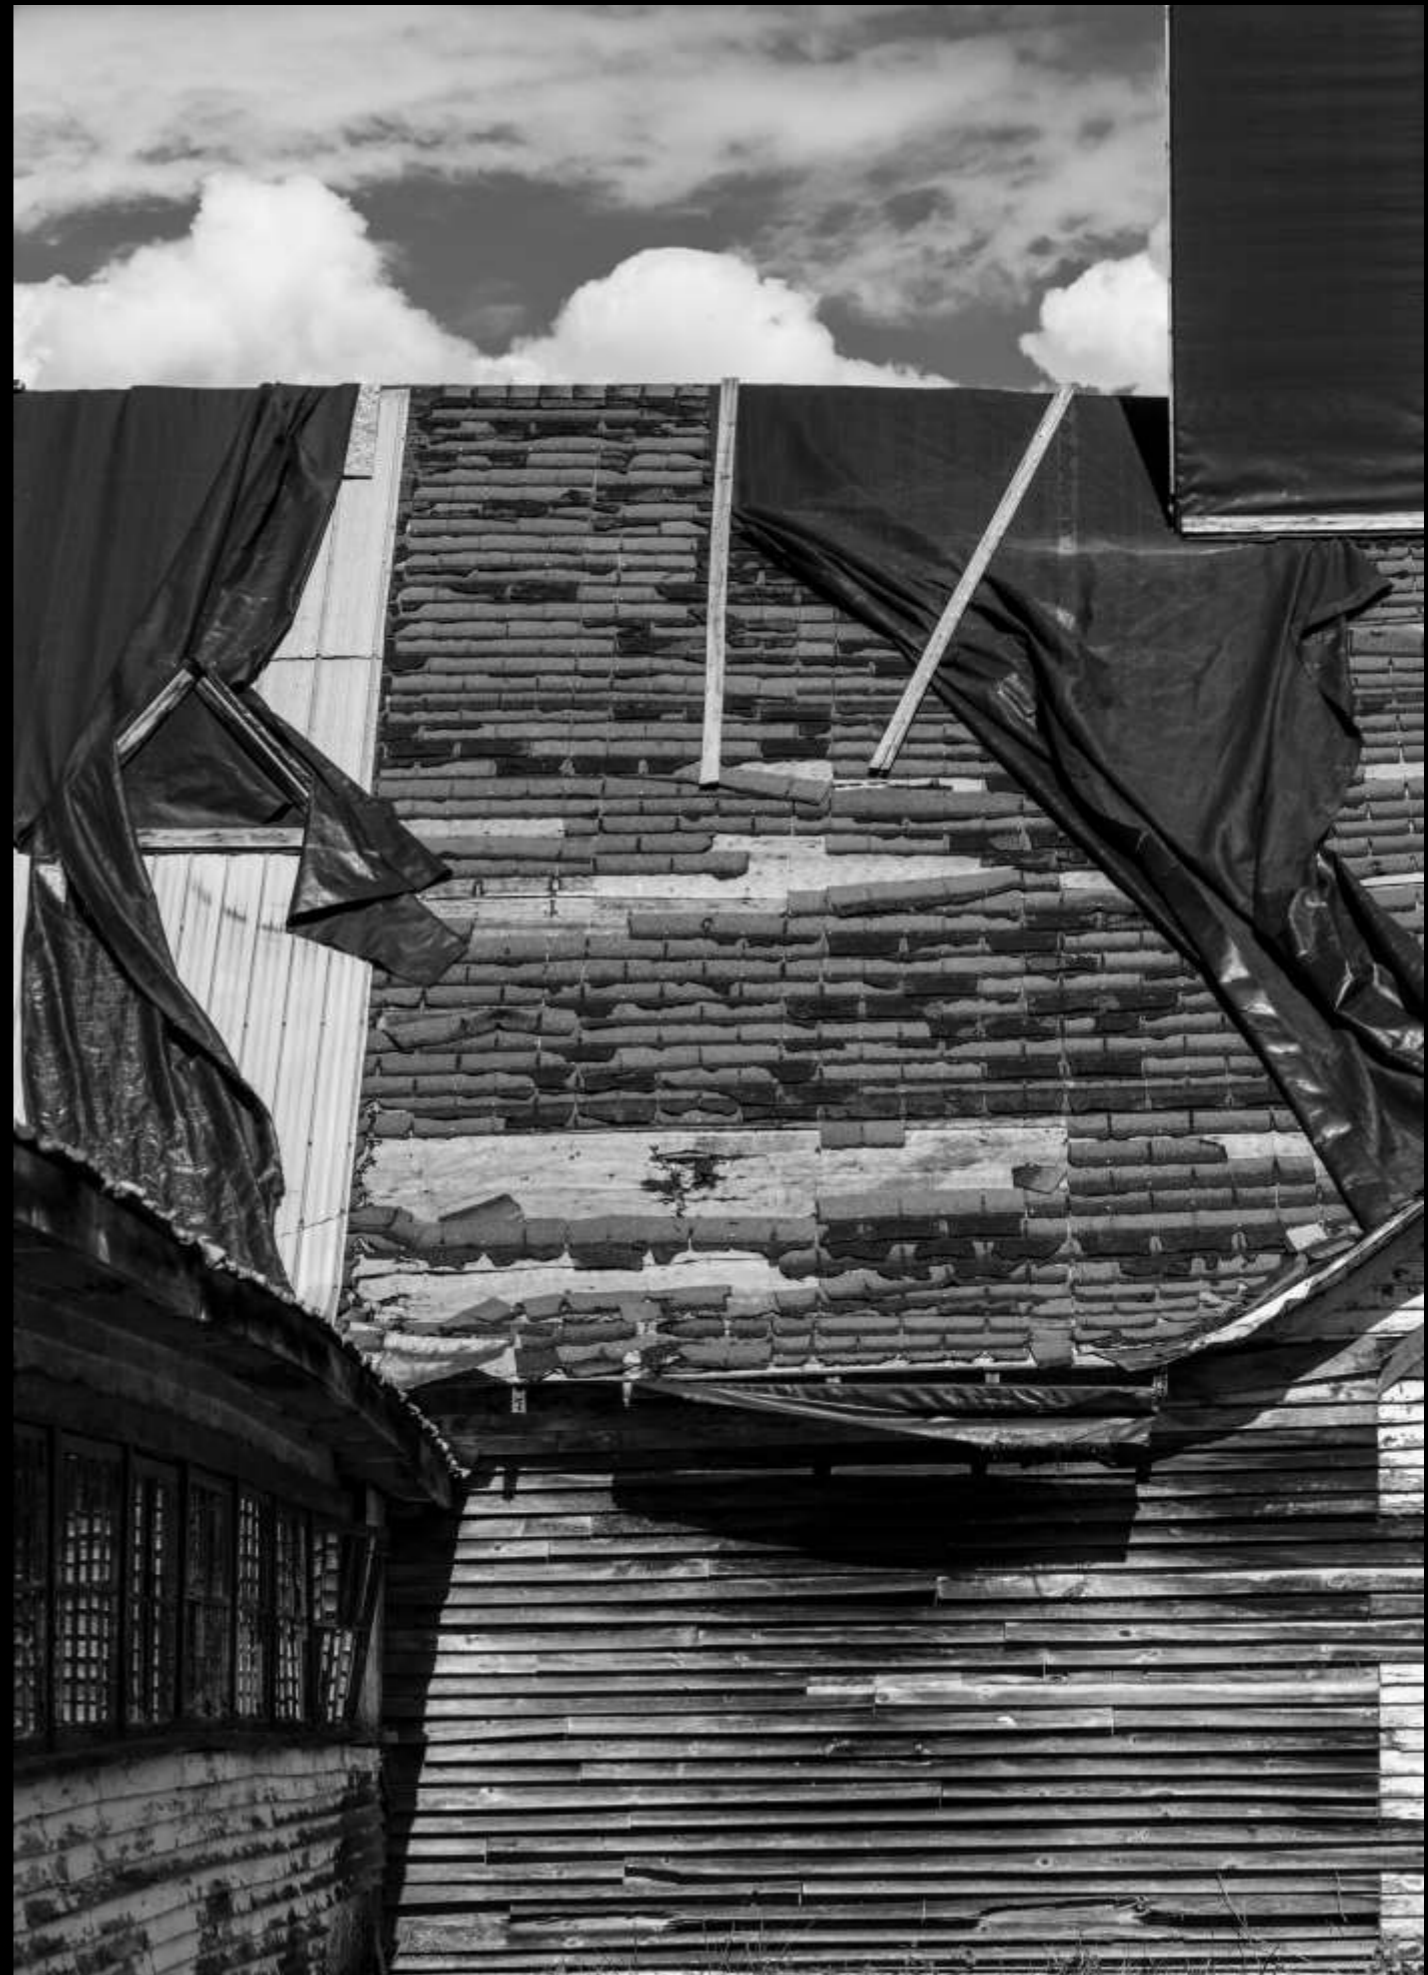
You can see here that some of the strips of wood that held down the plastic have disappeared. The plastic then becomes free to lift and can then create a new problem of moisture getting trapped under the plastic and causing further damage. In addition, the former nail holes create more wounds in the wood for moisture to collect.
