The Bois de la Roche stables at 292 Senneville Road, are on the endangered list compiled by Heritage Montreal. The wooden horse barn, built between 1880 and 1900, and enlarged in 1902, was part of the country estate of Senator Louis-Joseph Forget, whose property was acquired by the Montreal Urban Community in 1991. These stables were enlarged by architects Edward and William Maxwell.

Portions of these stables are threatened, and there has been a collapse of one section in the past few years. A temporary structure has recently been put in place to hopefully prevent further damage.

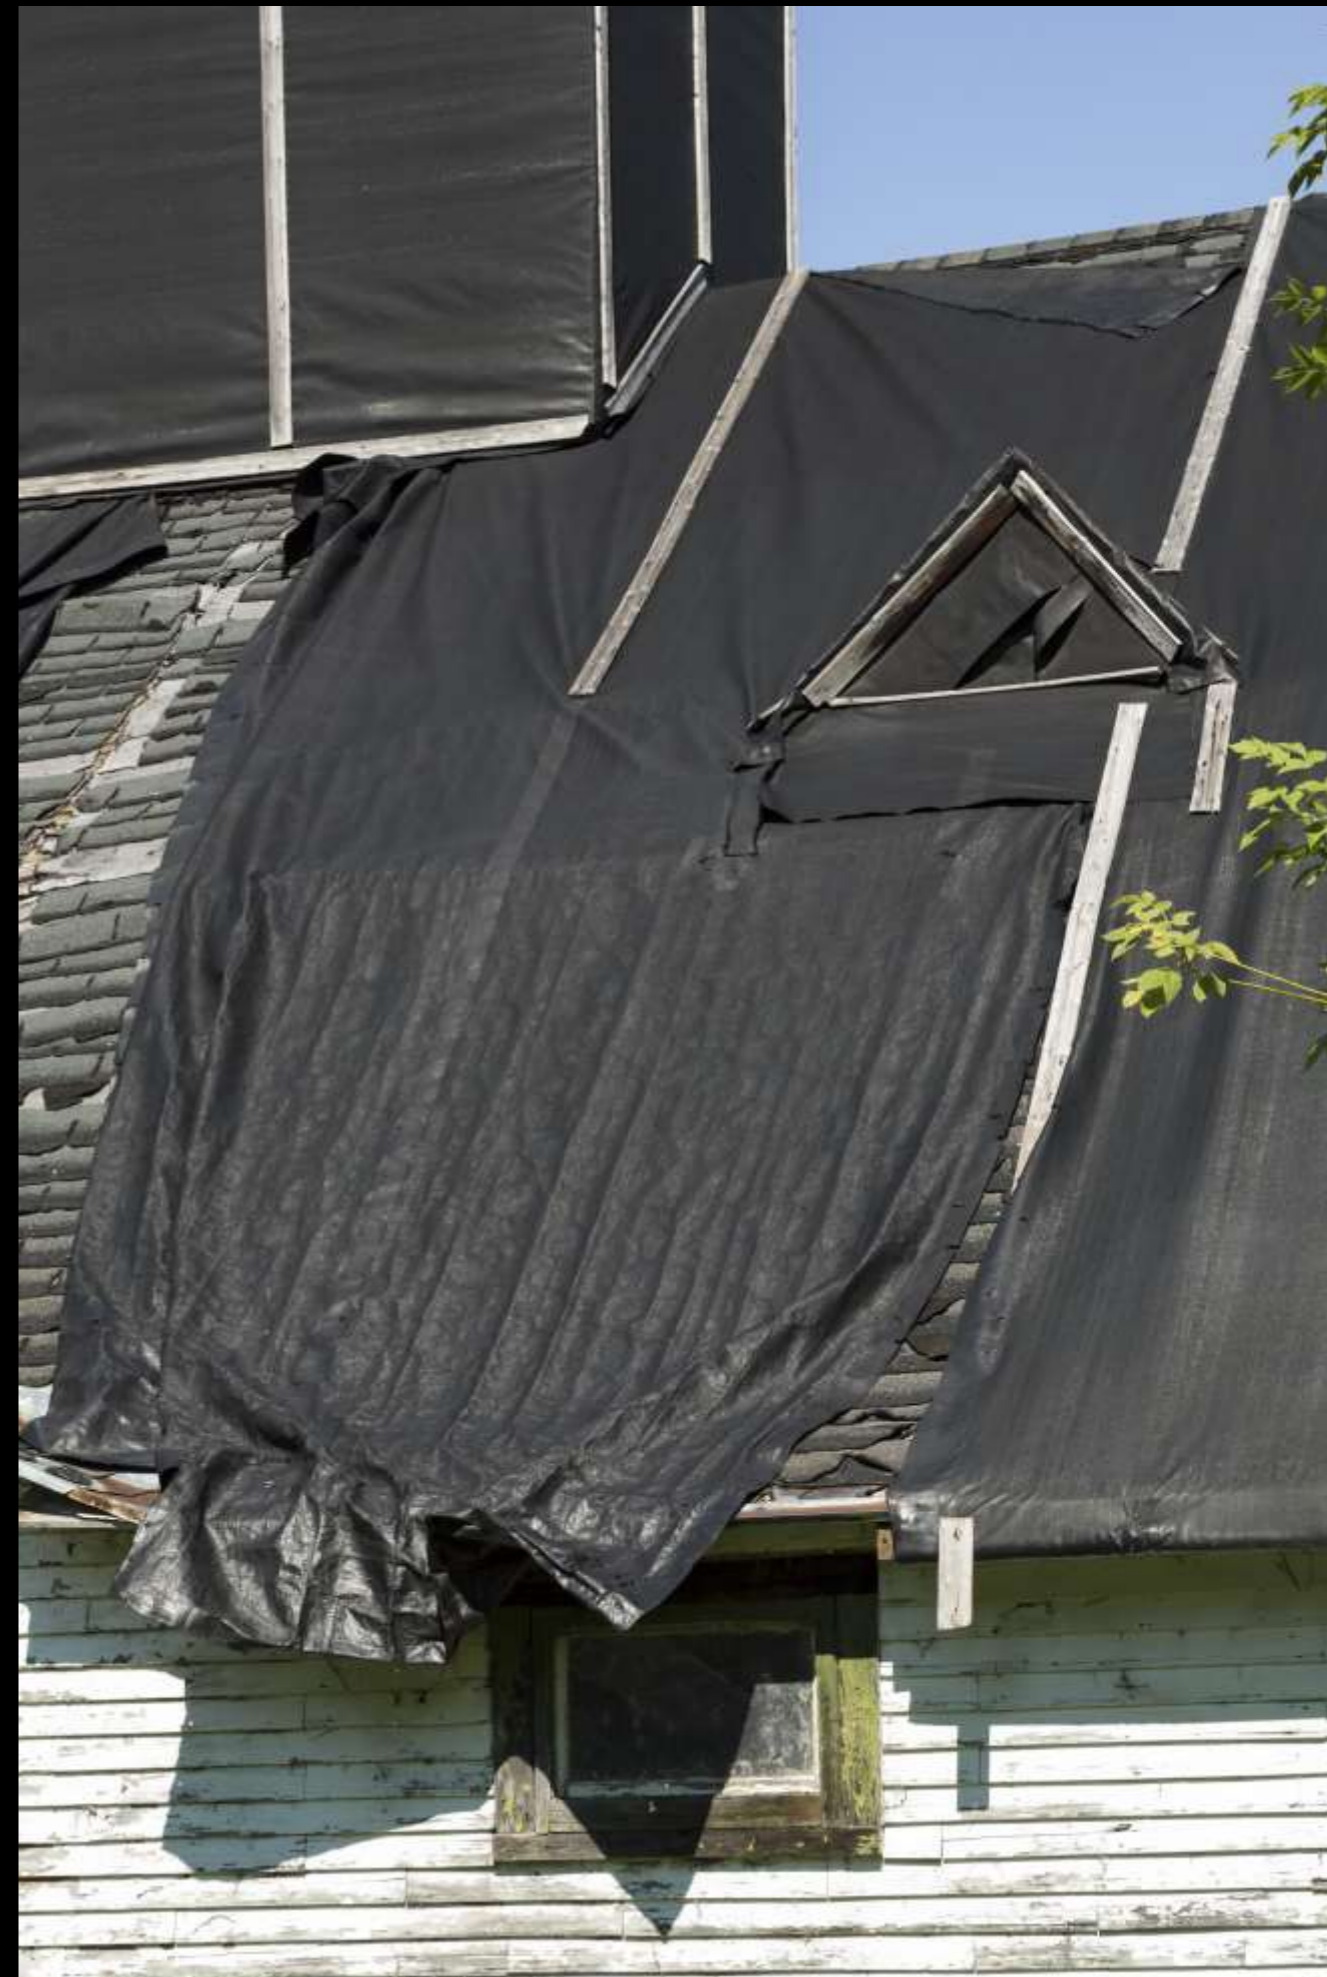
The roof vents in these Maxwell buildings were very distinctive and quite marvellous. They had been well wrapped in plastic. This photo shows three different stages of roofing material. The cheapest solution were the asphalt shingles, and they were also the least durable. Repair work was done piecemeal over the years. It was a large and expensive complex and the building suffered accordingly.

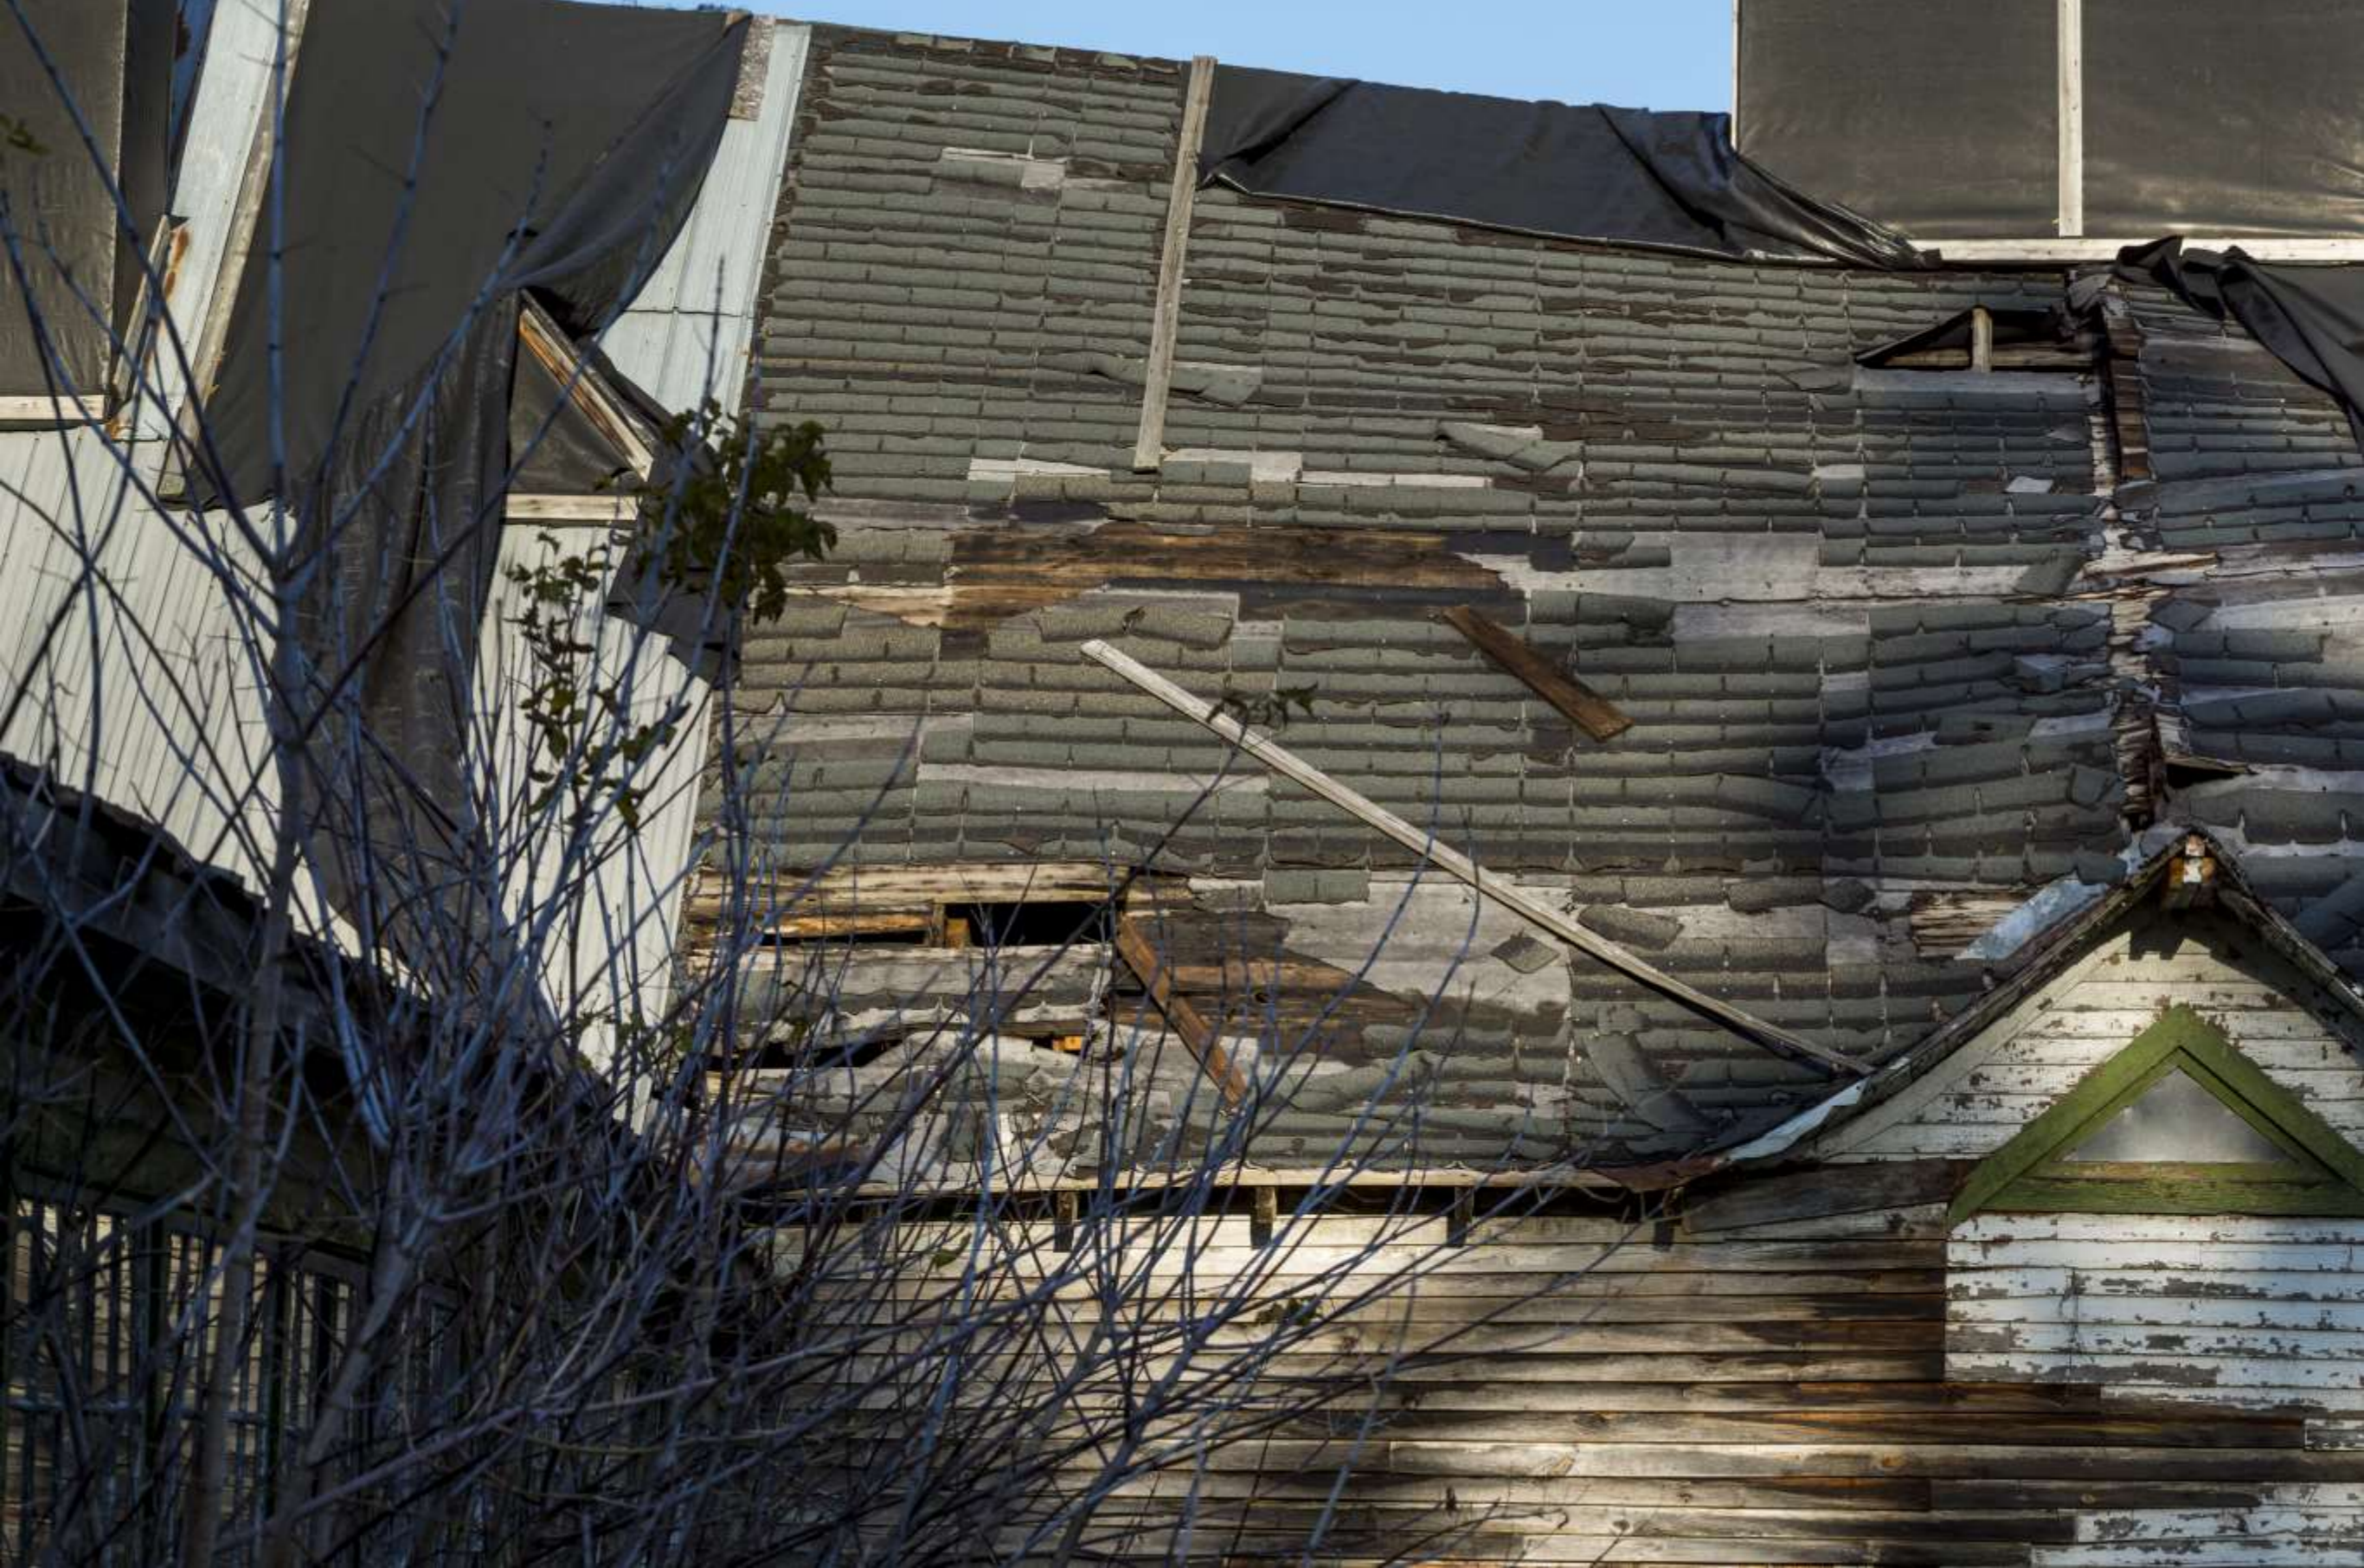
October 2017;

The roof is in a very sad state. It is now only a matter of time. I had no idea how little.

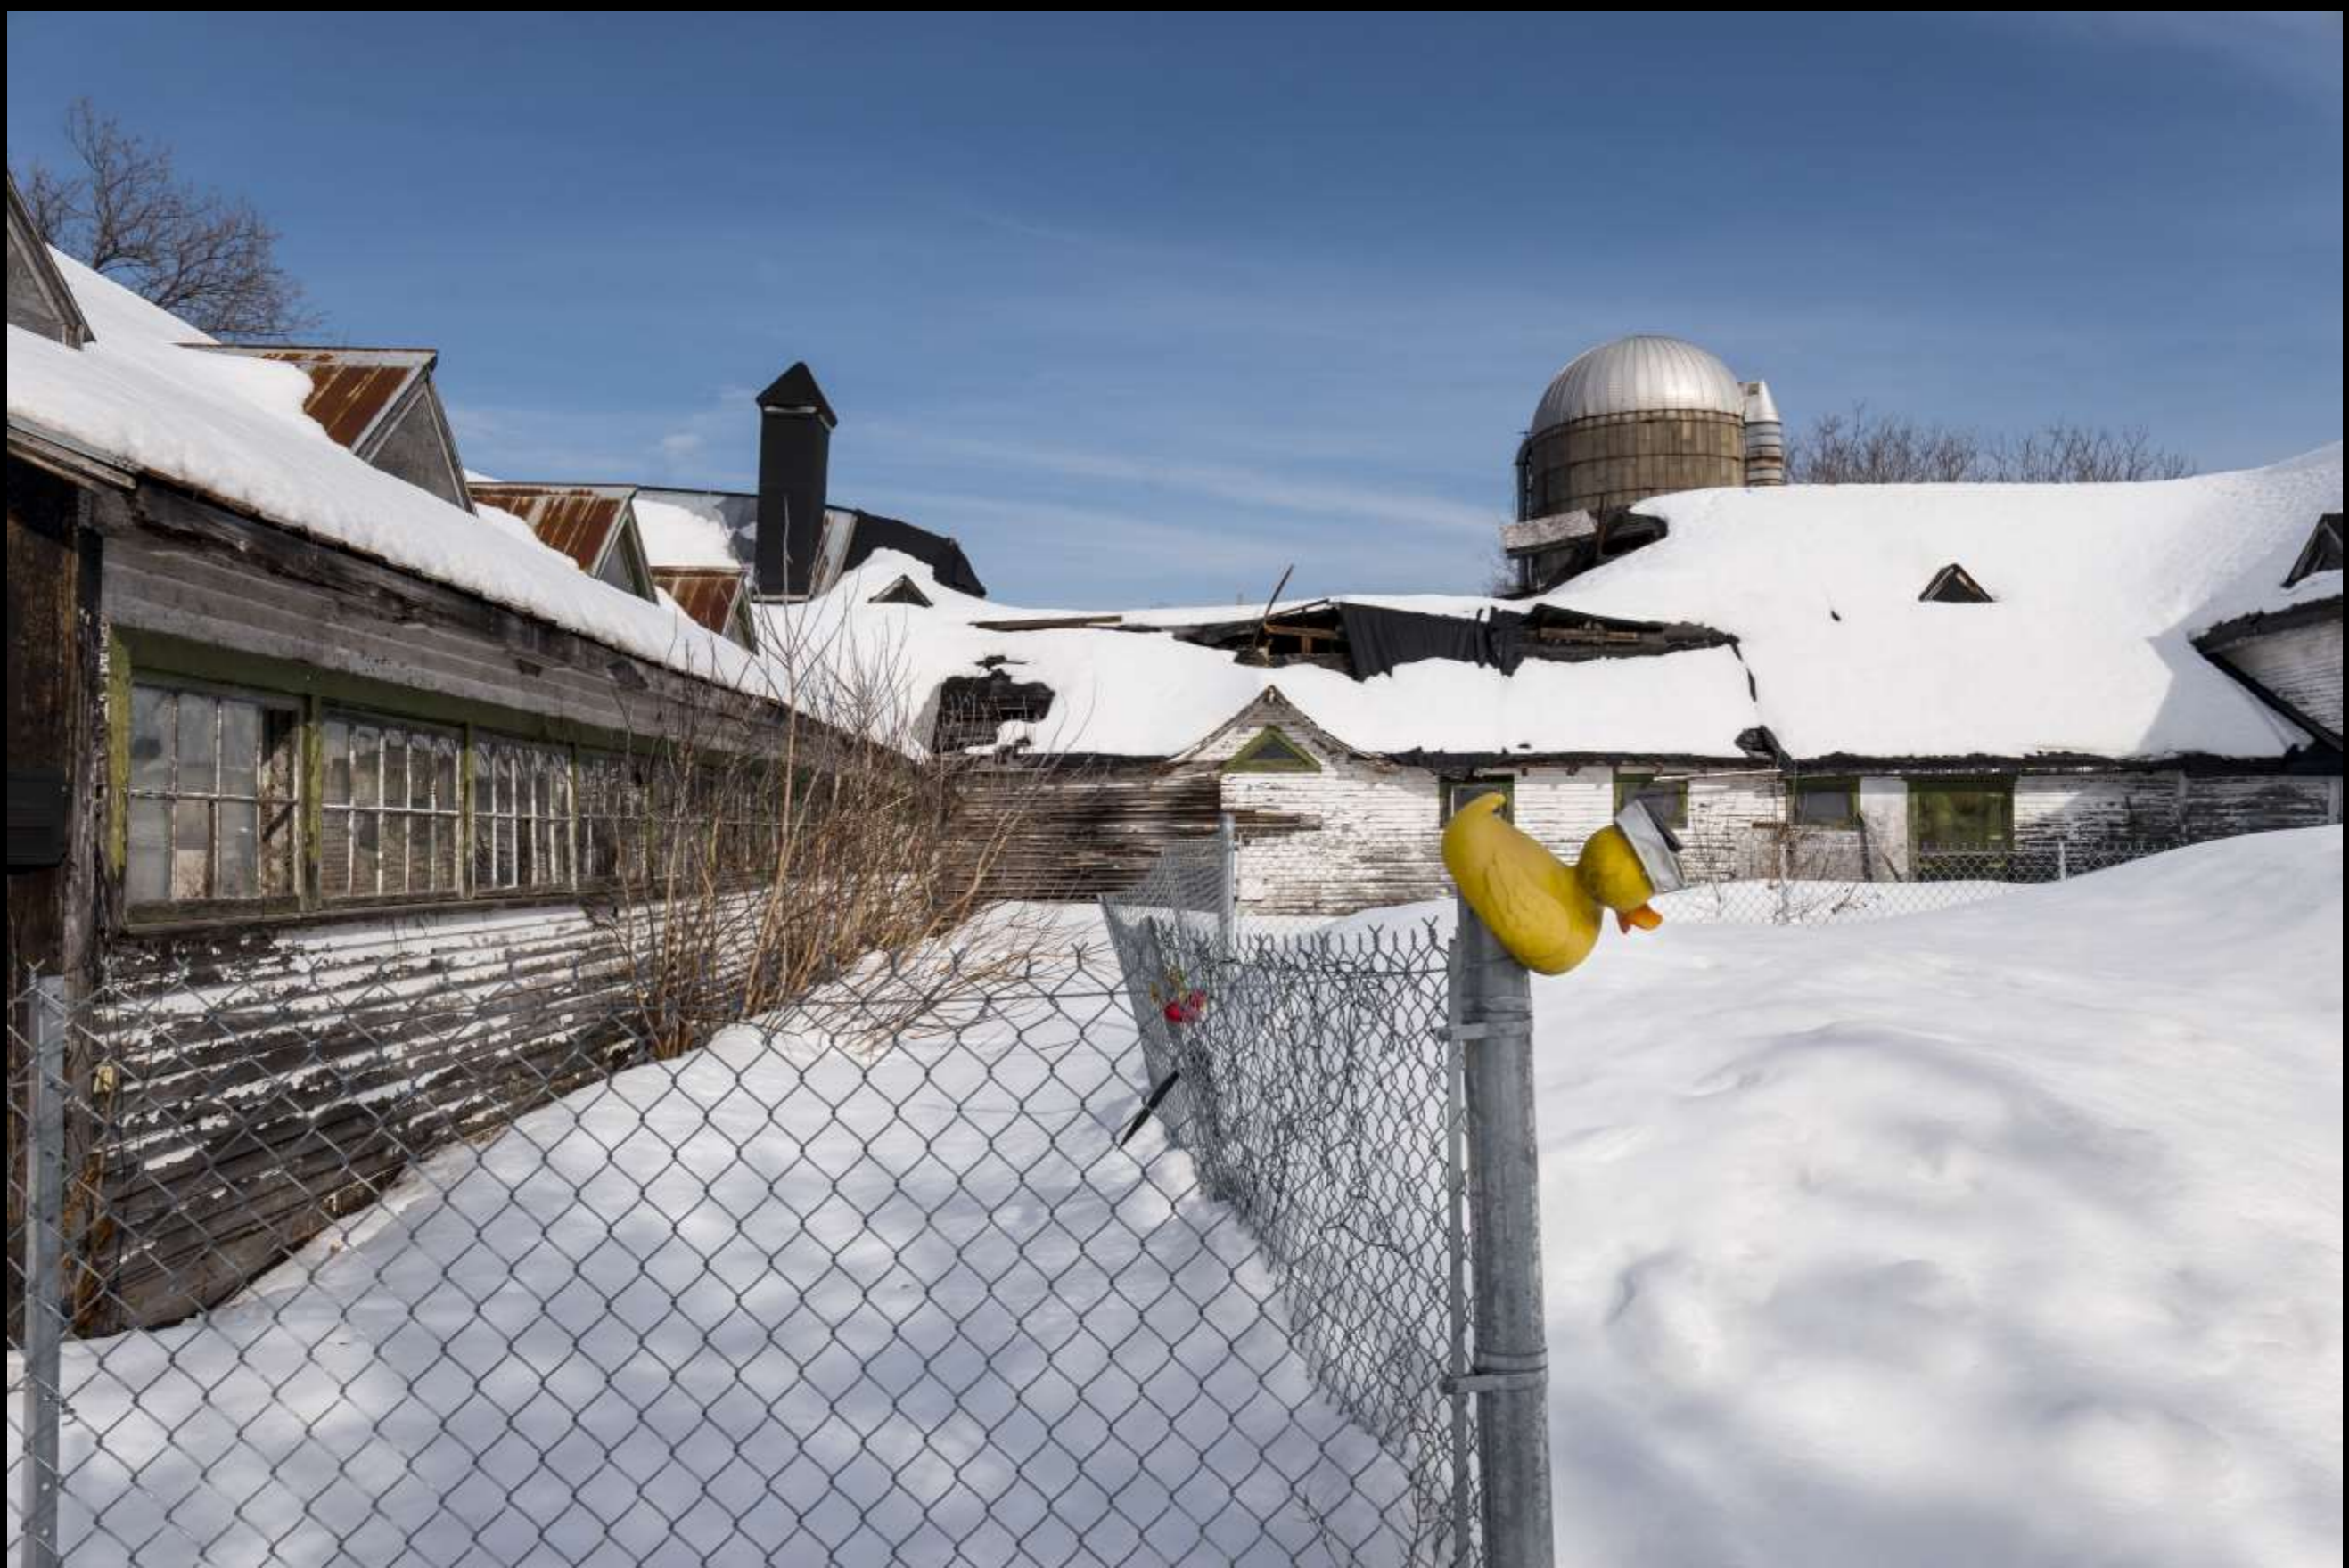
February 2018;

A large part of the roof collapses in the mid section. The sound of the crash in the middle of the

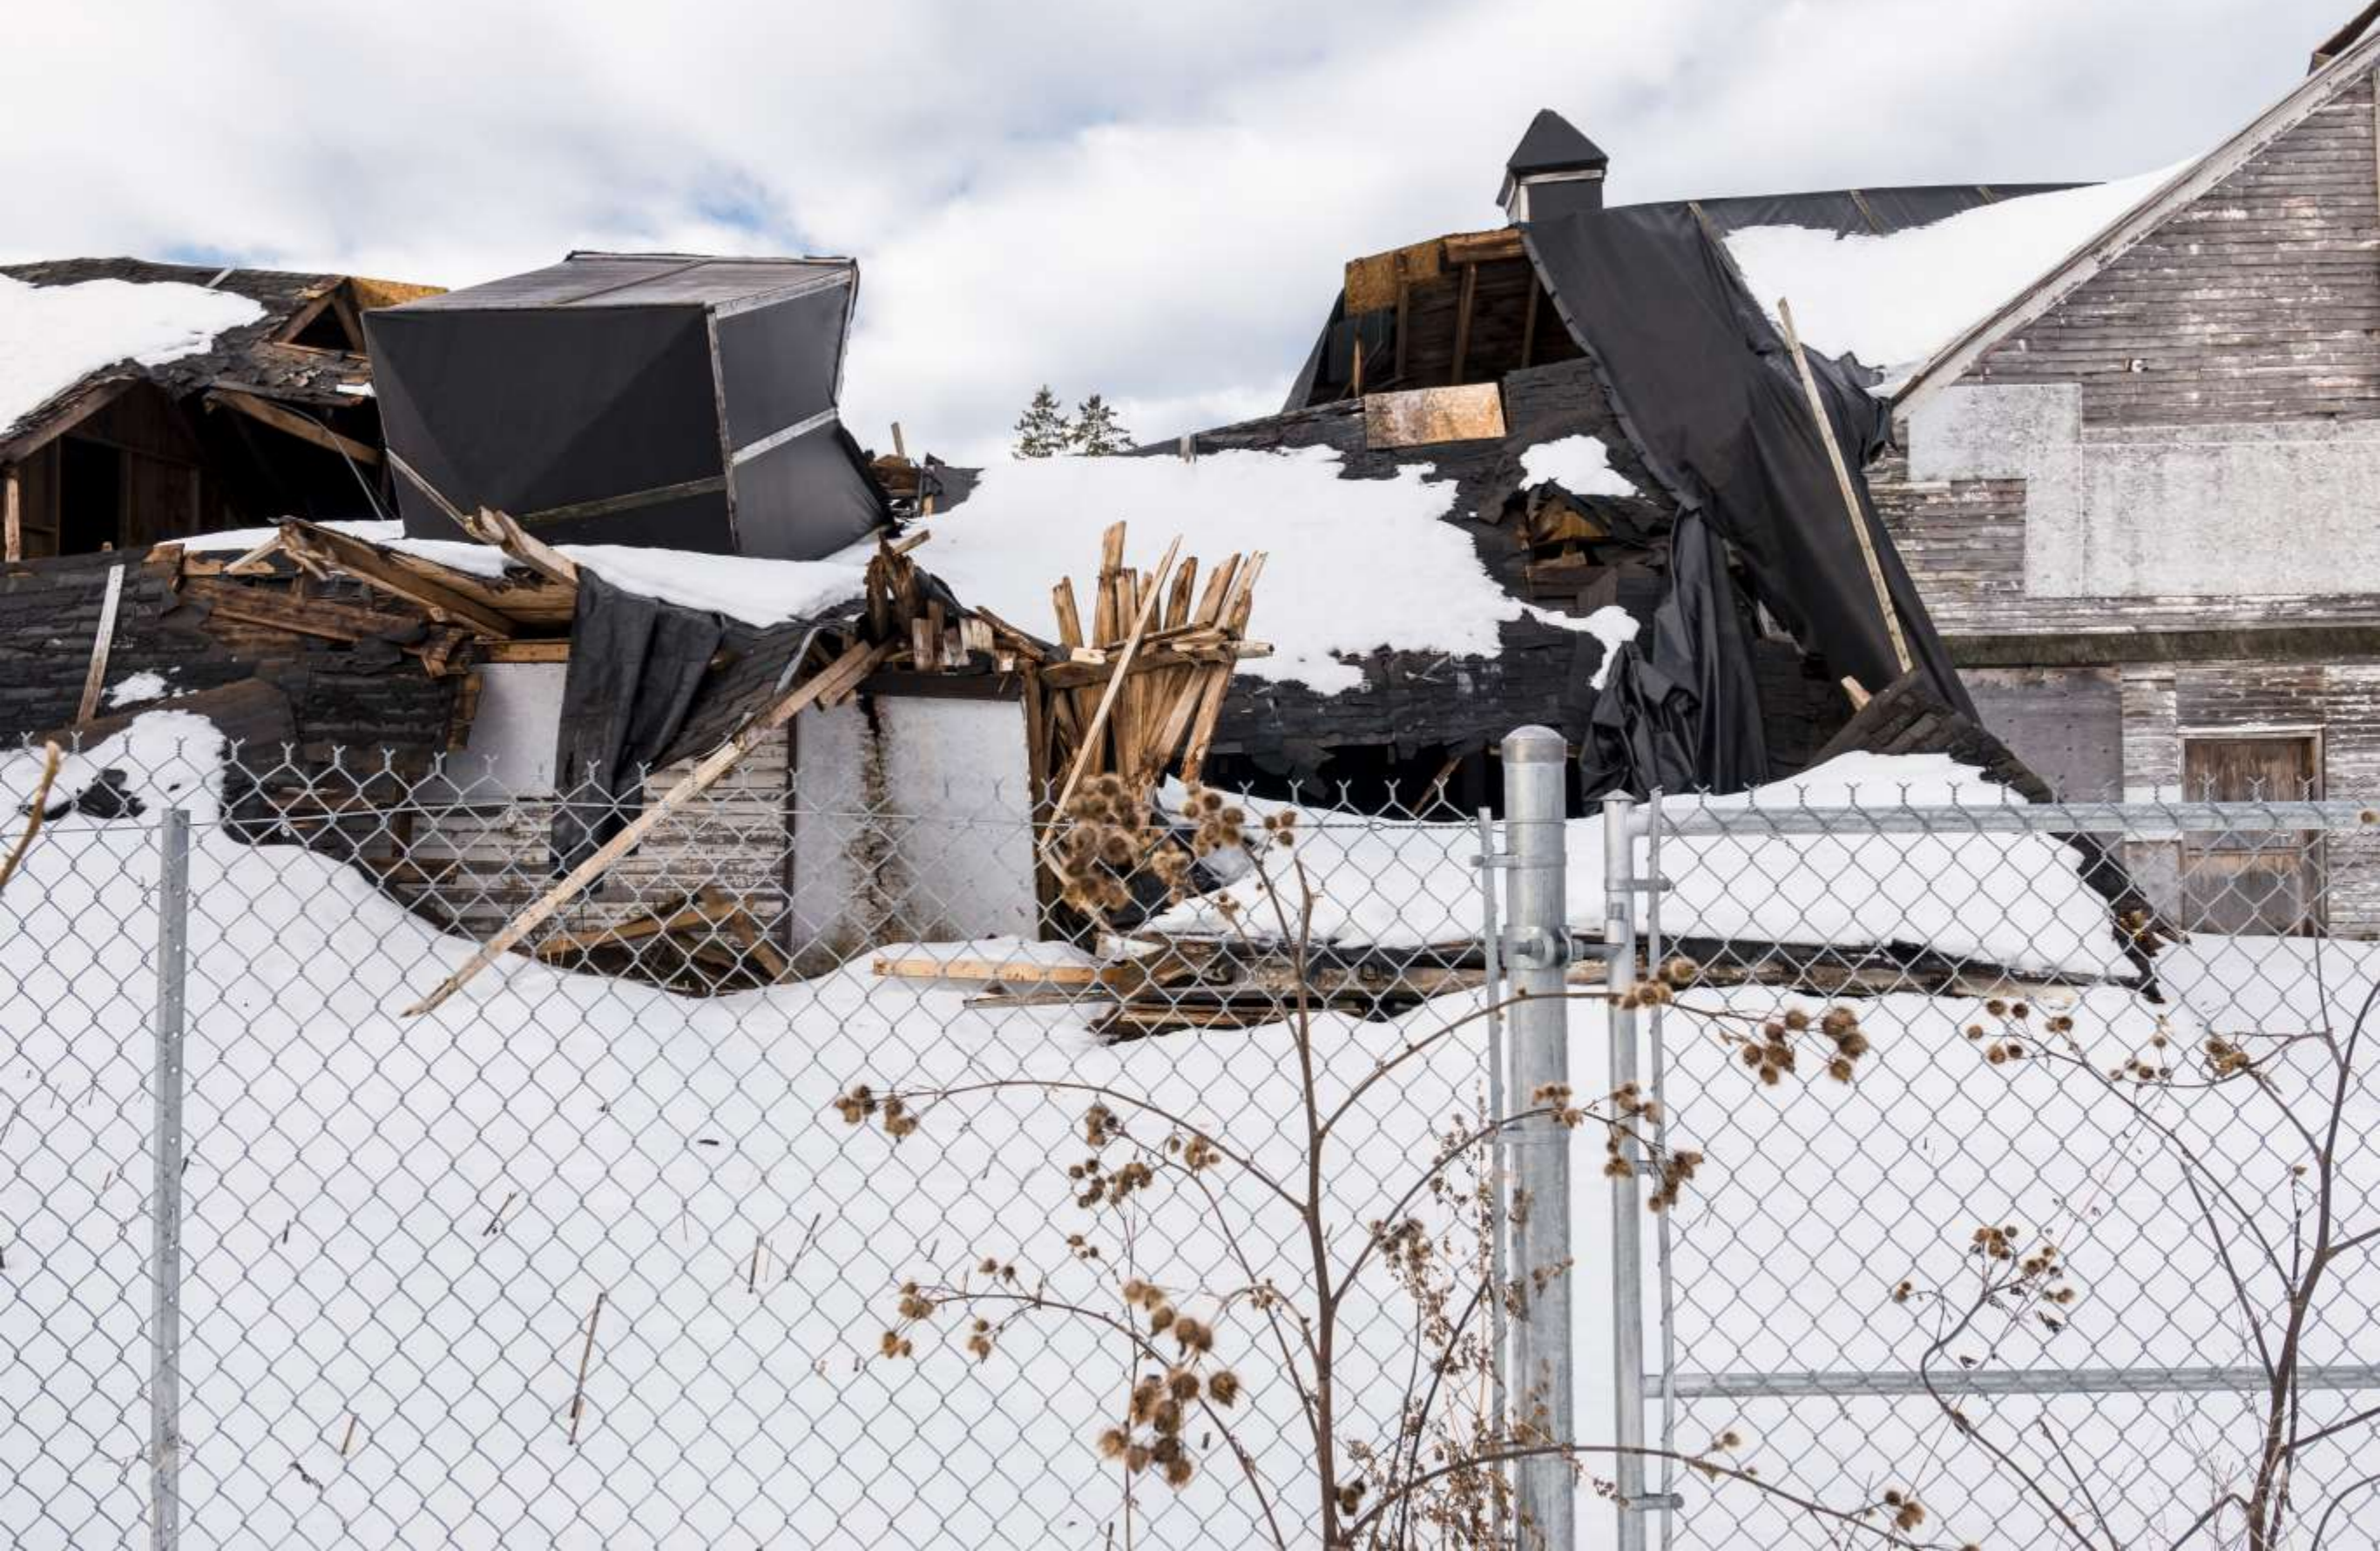
February 2018;
When I went around to the rear of the building I was shocked to see the extent of the damage. It was brutal.

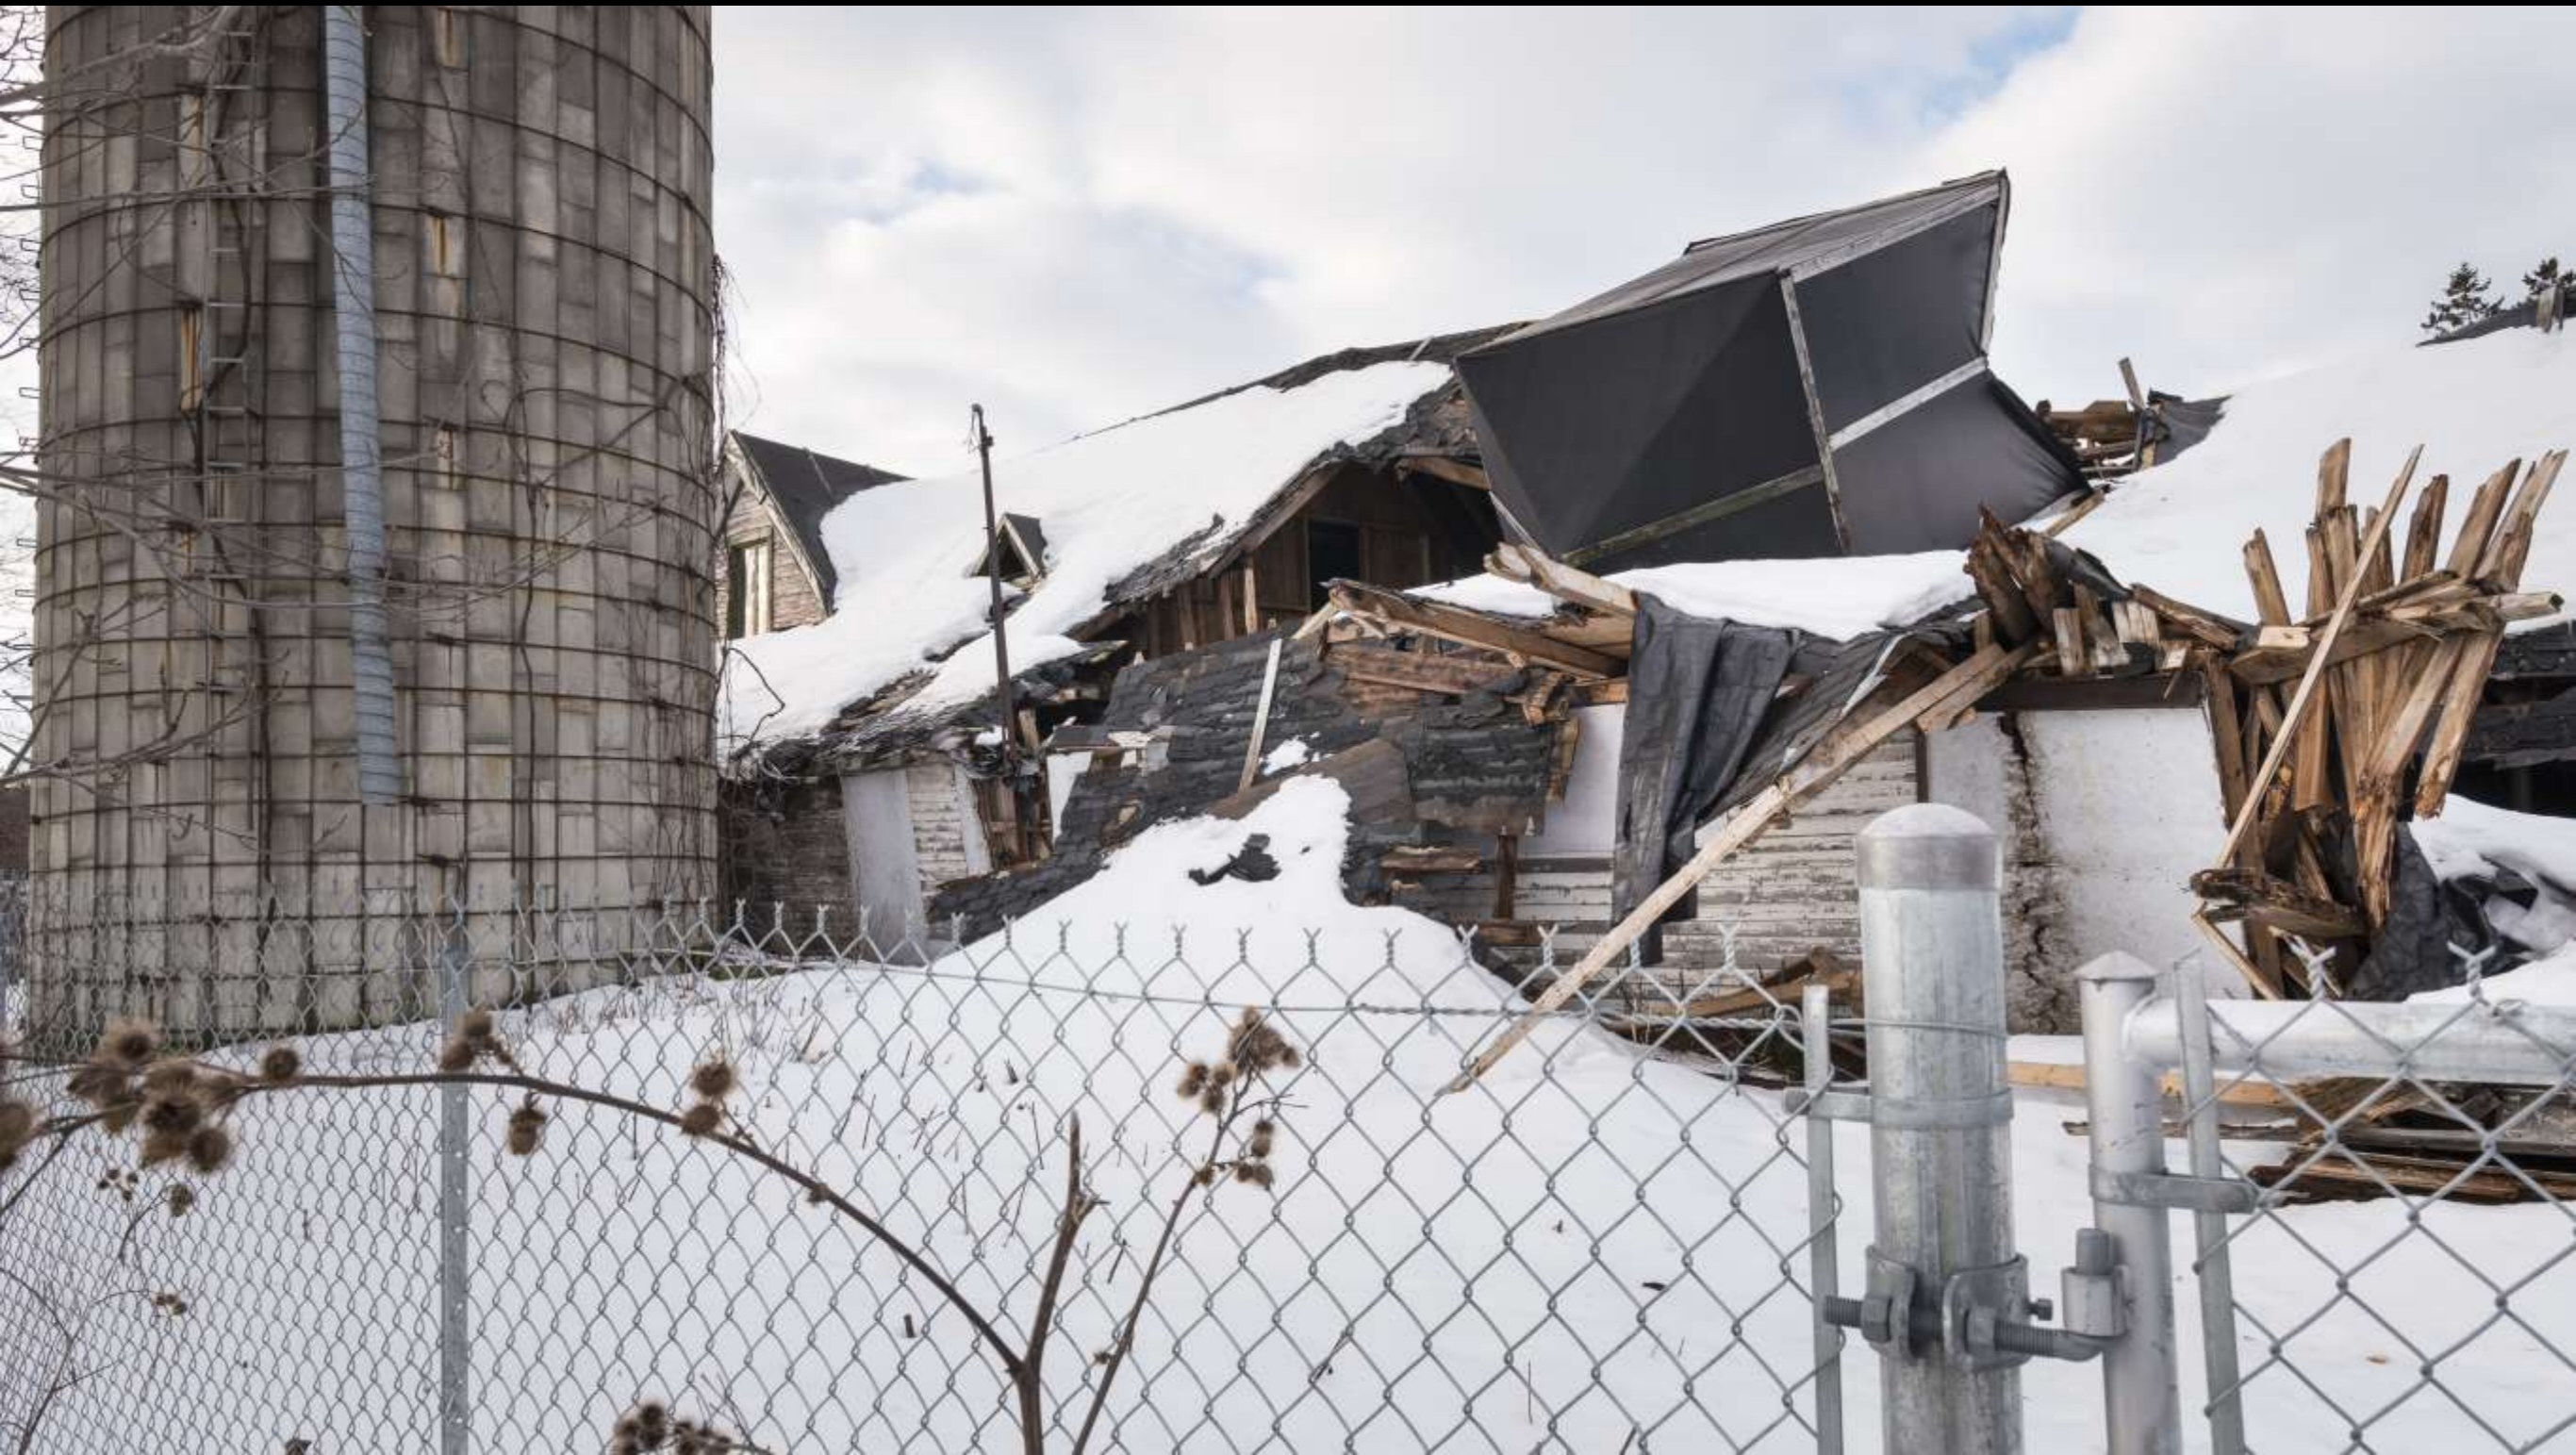
Luckily it appeared that the collapse affected only the mid section of the complex. The two end buildings appeared to be still intact.

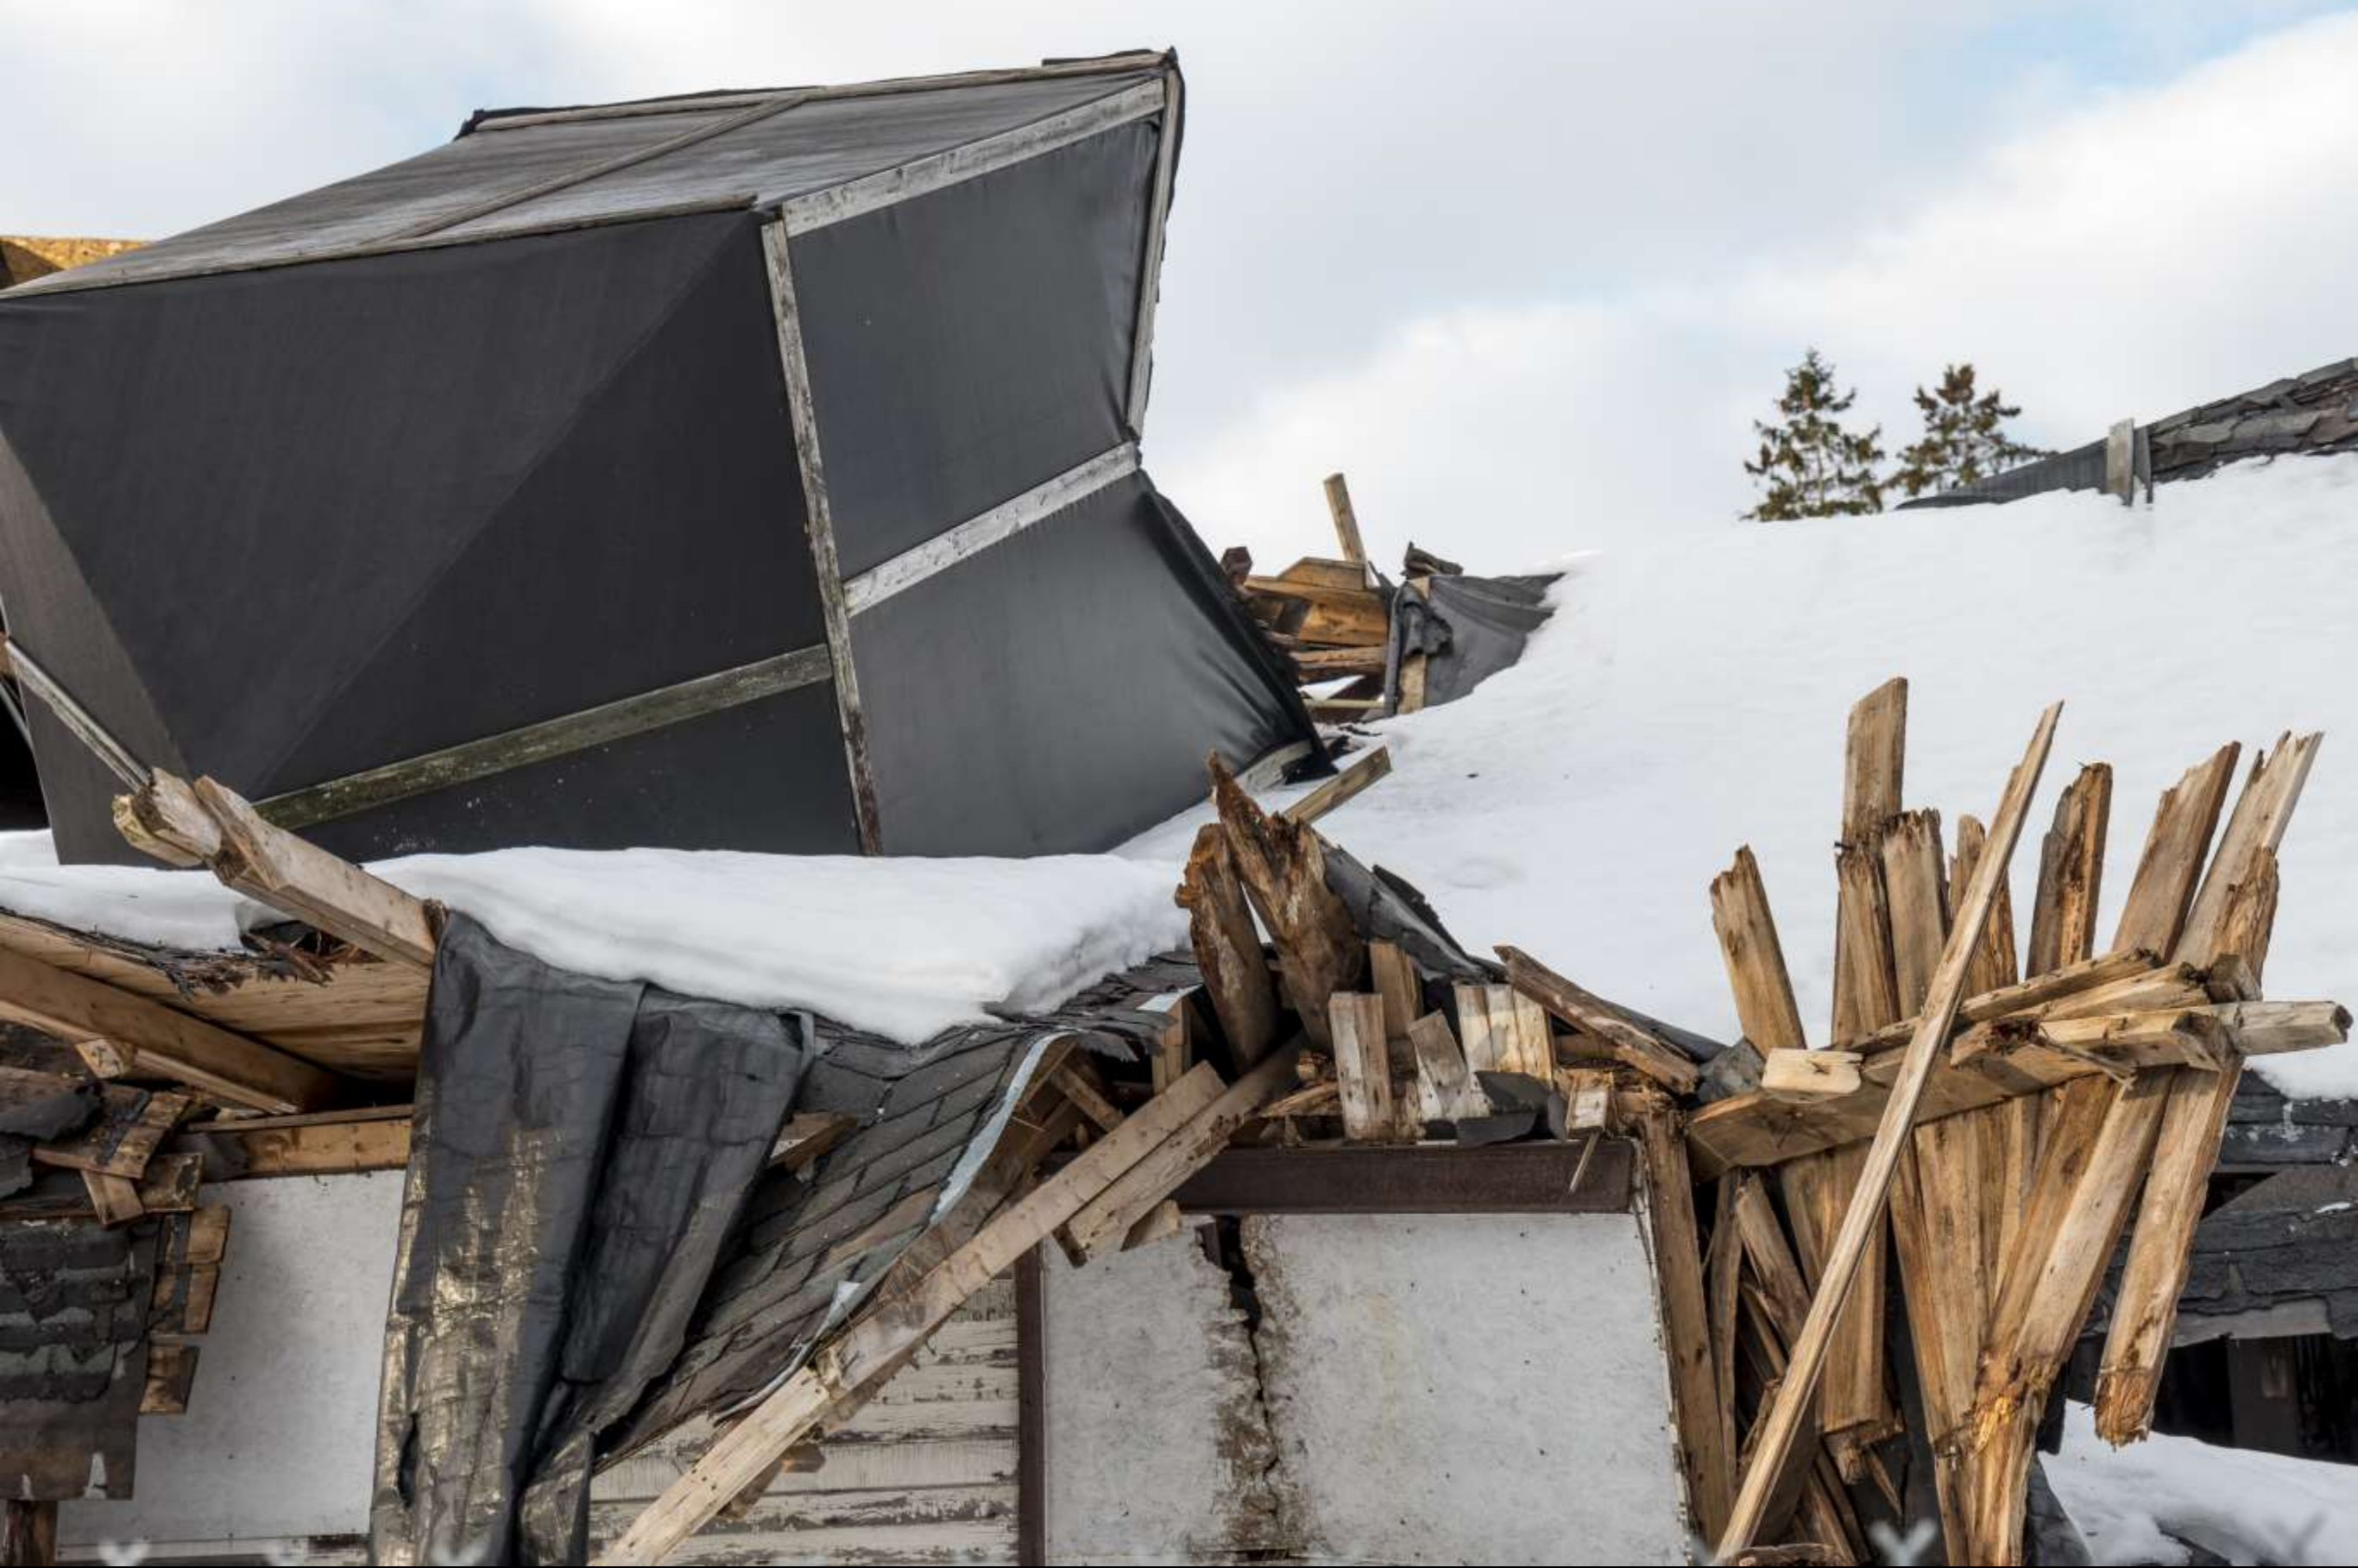
The massive roof vent has toppled over. The bits of wood look like the spine of some huge
