The Bois de la Roche stables at 292 Senneville Road, are on the endangered list compiled by Heritage Montreal. The wooden horse barn, built between 1880 and 1900, and enlarged in 1902, was part of the country estate of Senator Louis-Joseph Forget, whose property was acquired by the Montreal Urban Community in 1991. These stables were enlarged by architects Edward and William Maxwell.

Portions of these stables are threatened, and there has been a collapse of one section in the past few years. A temporary structure has recently been put in place to hopefully prevent further damage.

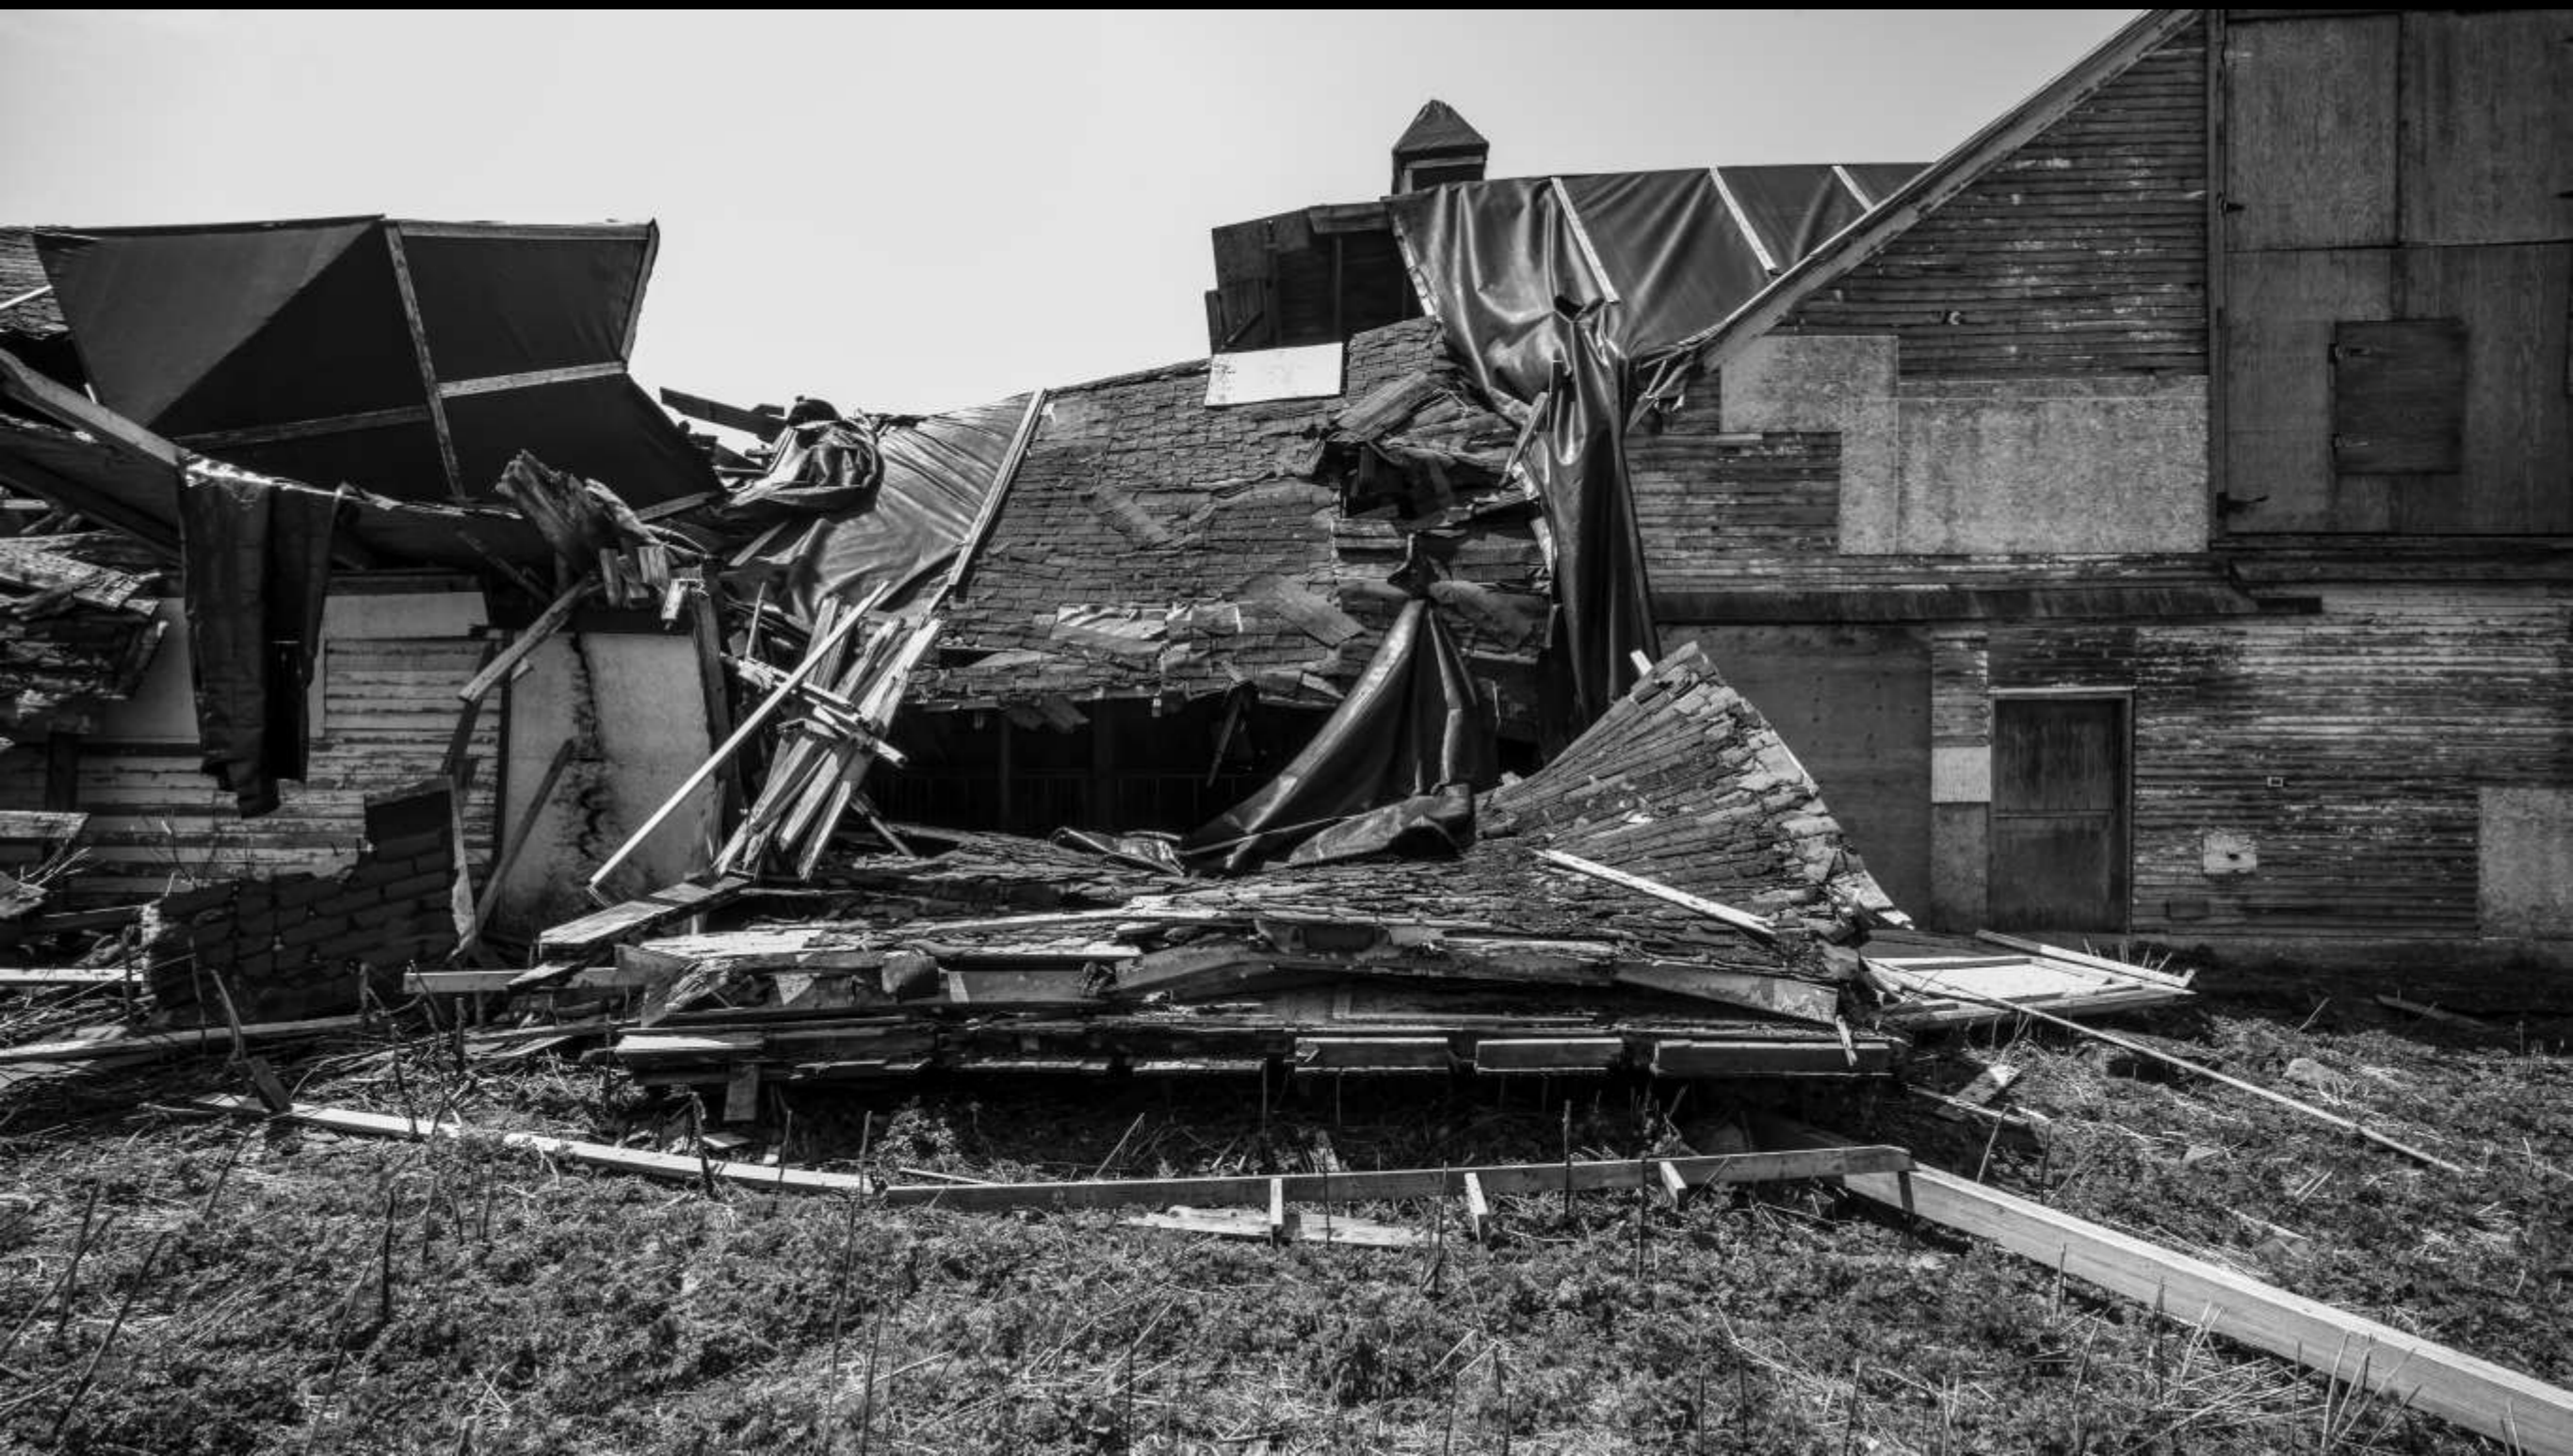
May 2018

A few months later a second collapse occurs.

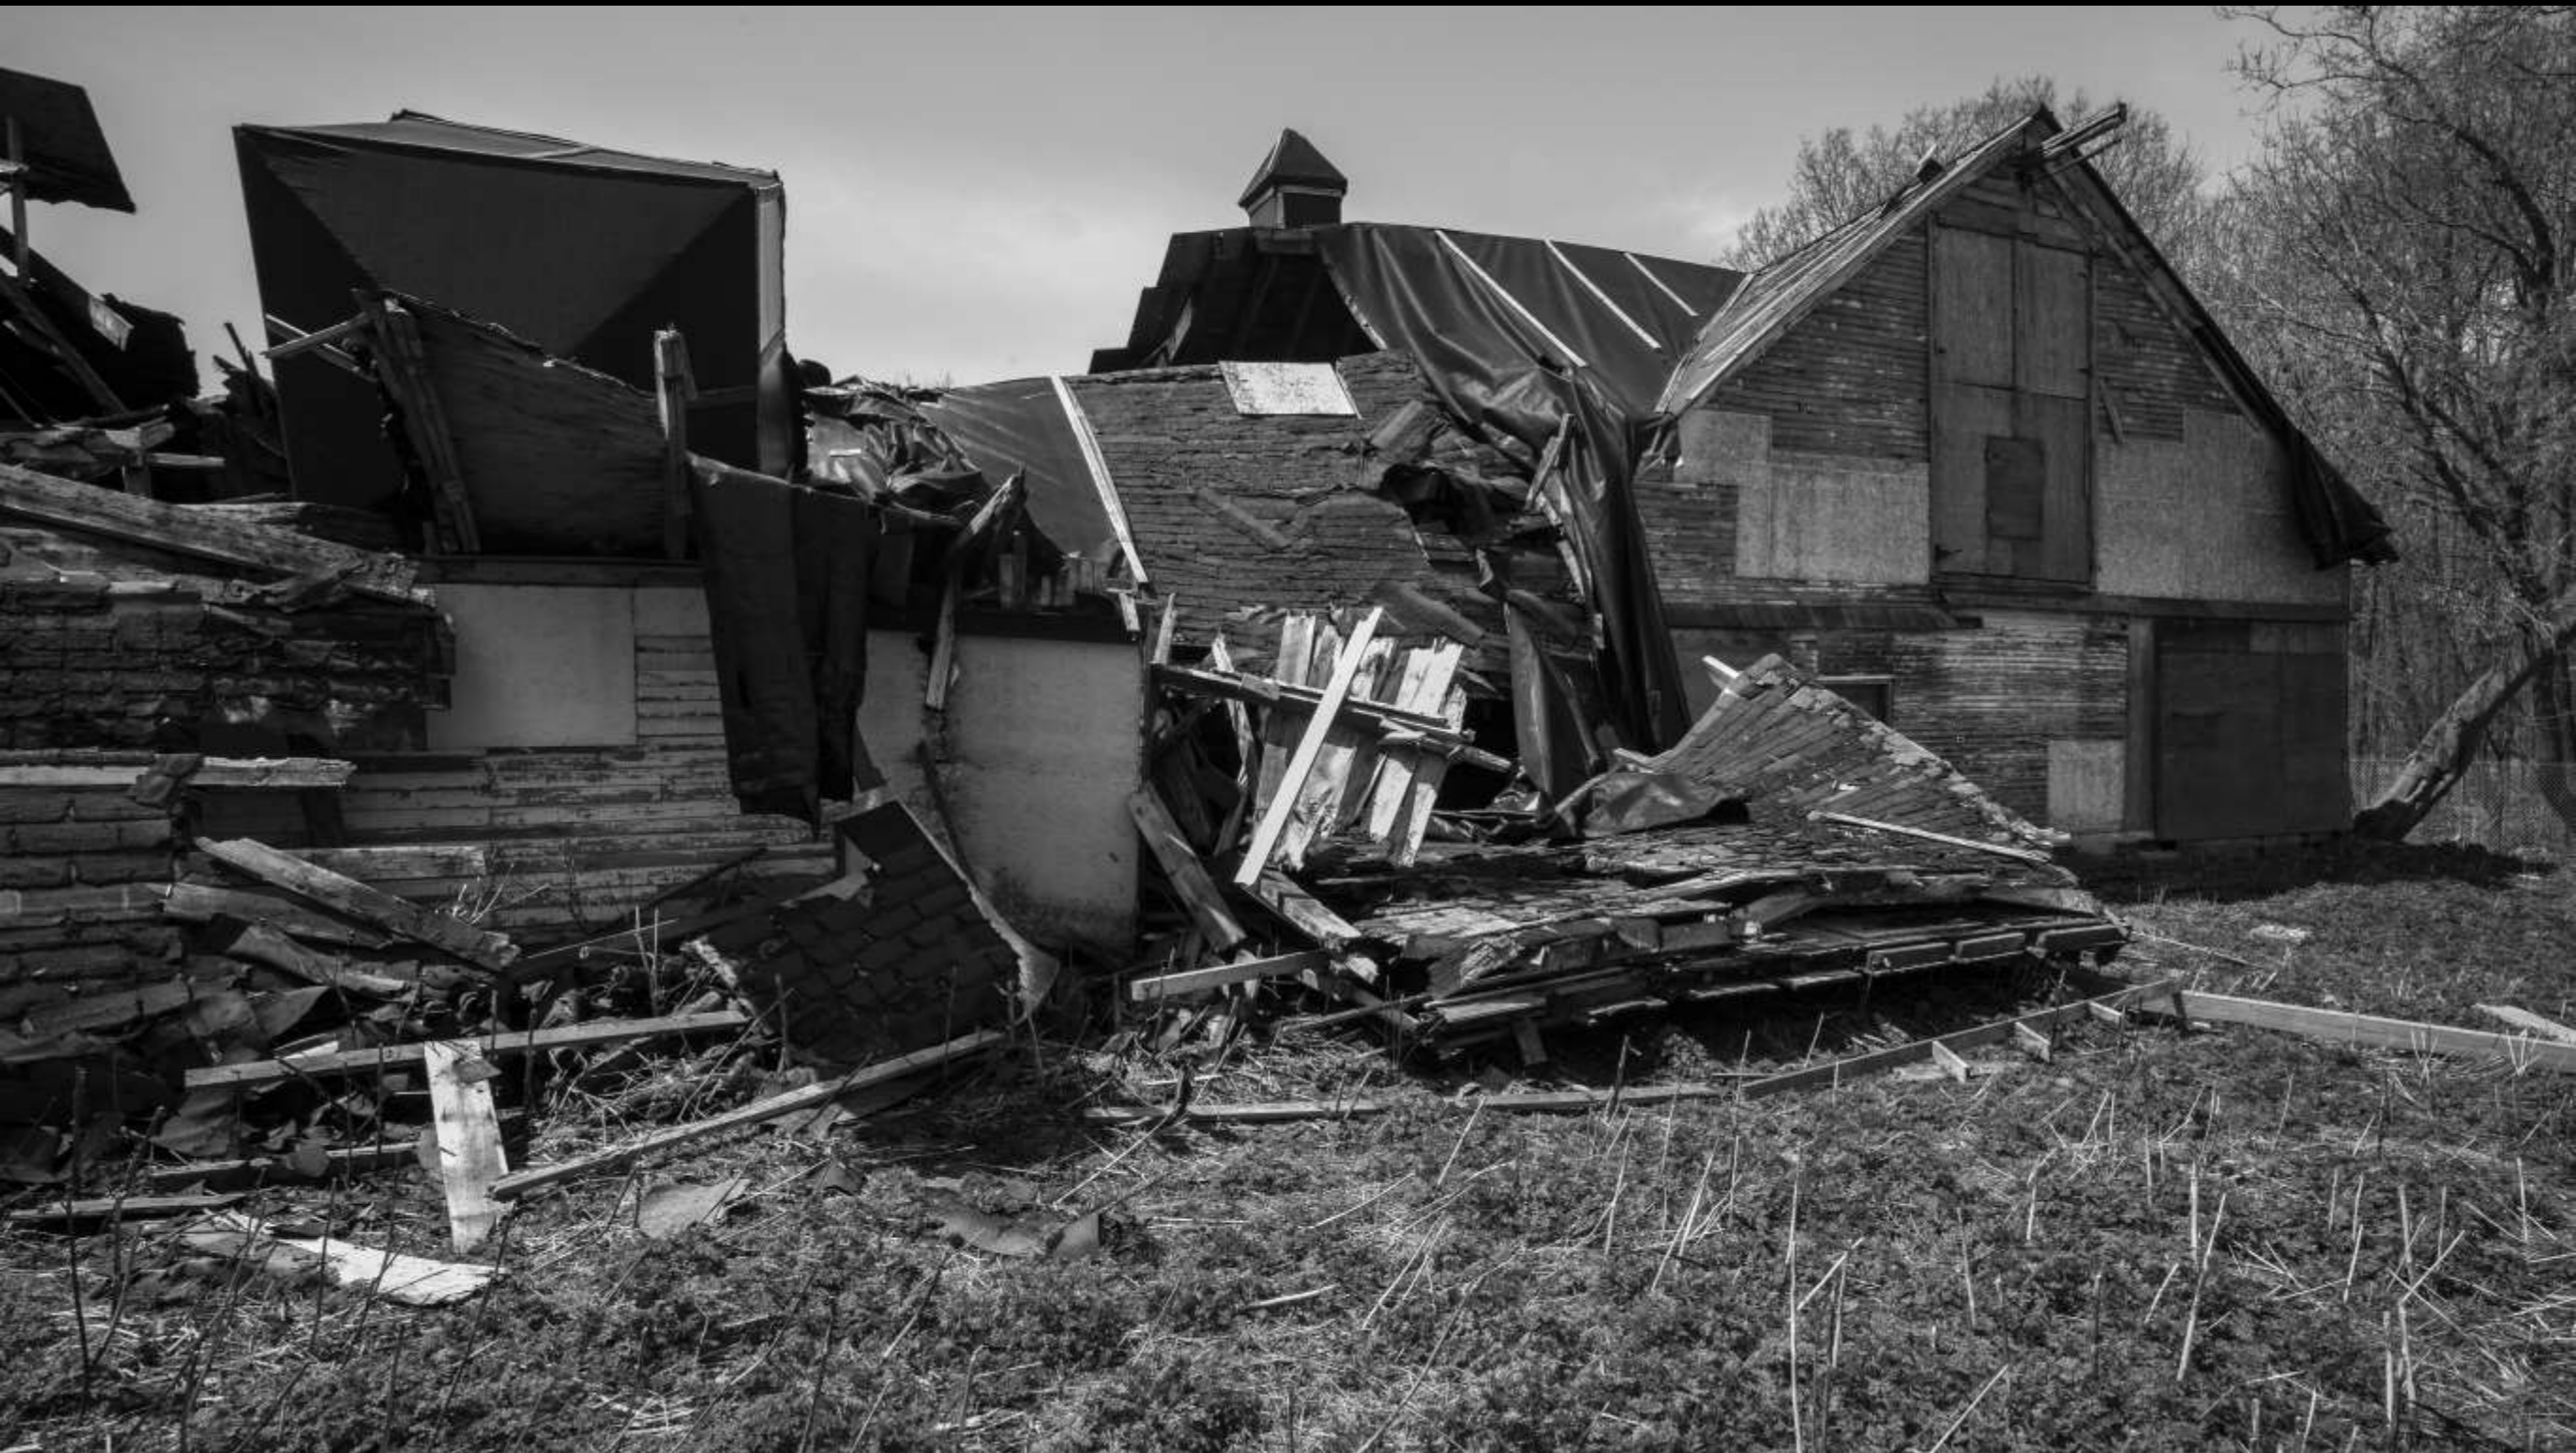
The end building still appears to be intact. The big question is ‘what will the city of Montreal do now with these structures? Will they tear this mid section down and leave the ends as they are? If so, how will they protect the exposed parts of the good buildings? Or will they attempt to rebuild it as it was built?’

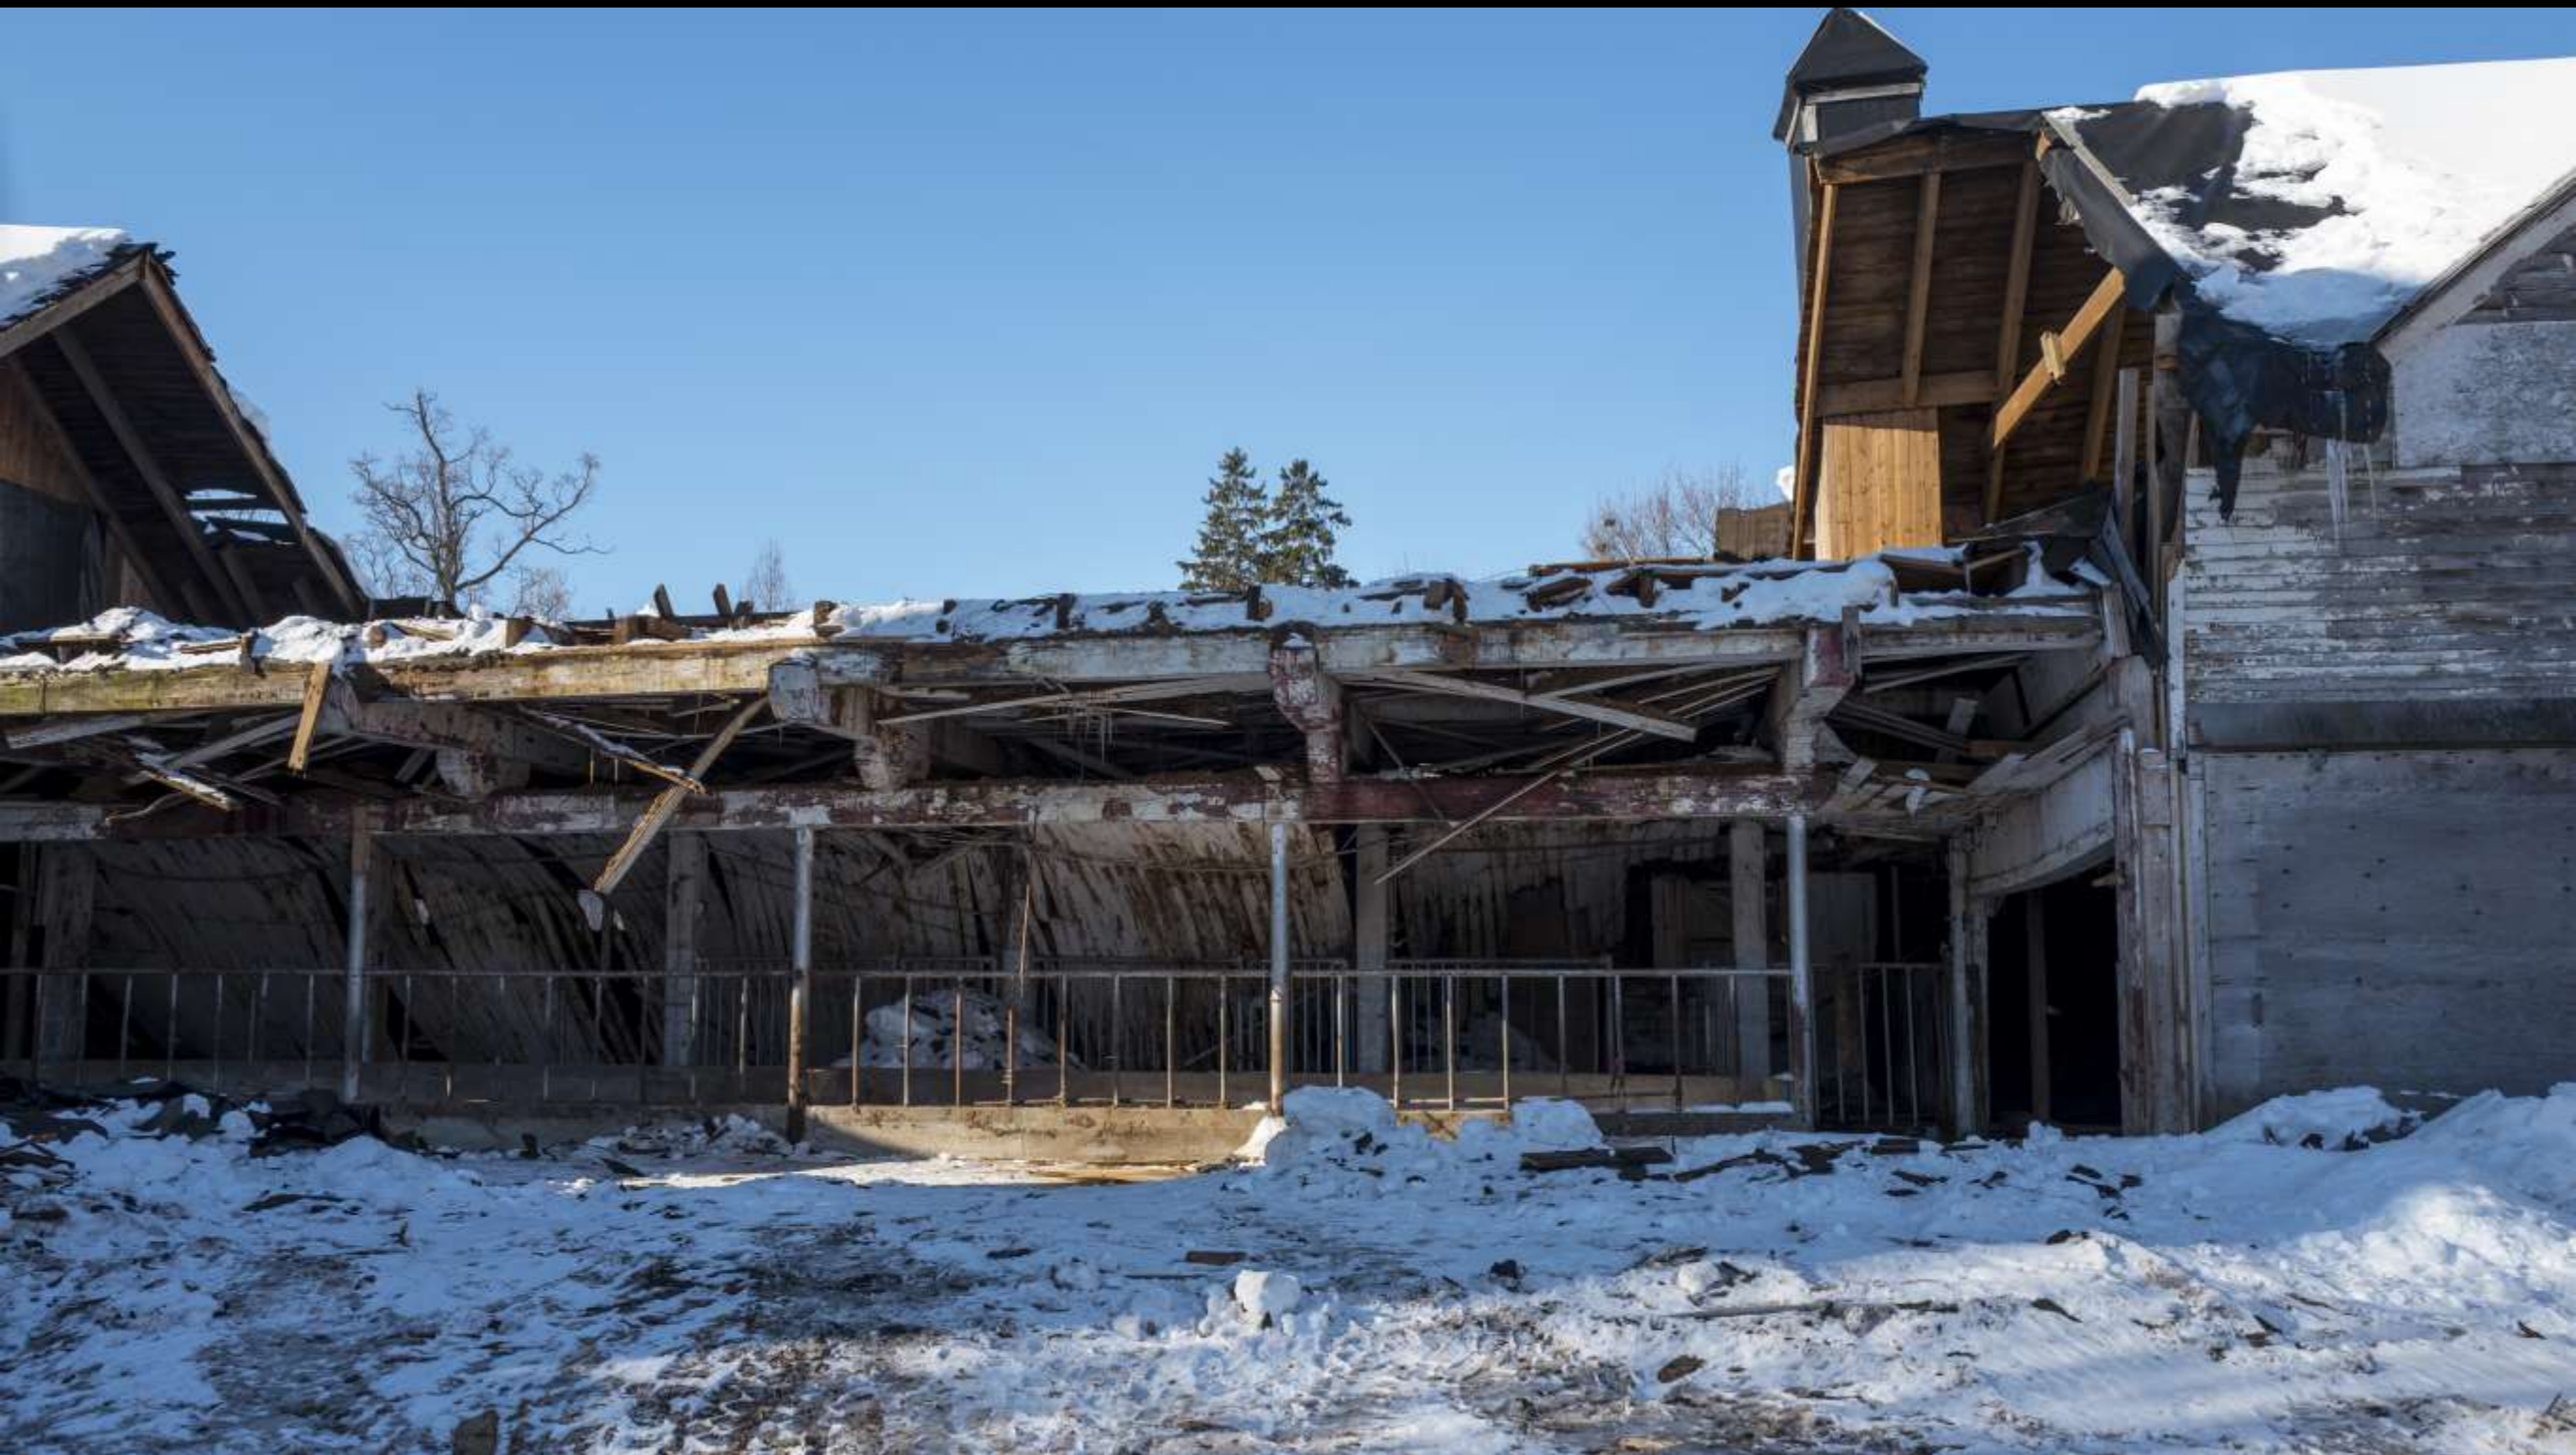
March 2019

**I was relieved to see that they had decided to clean up the damage carefully without bringing in the 'wrecking ball'.
Where they would go from here was not yet clear.**

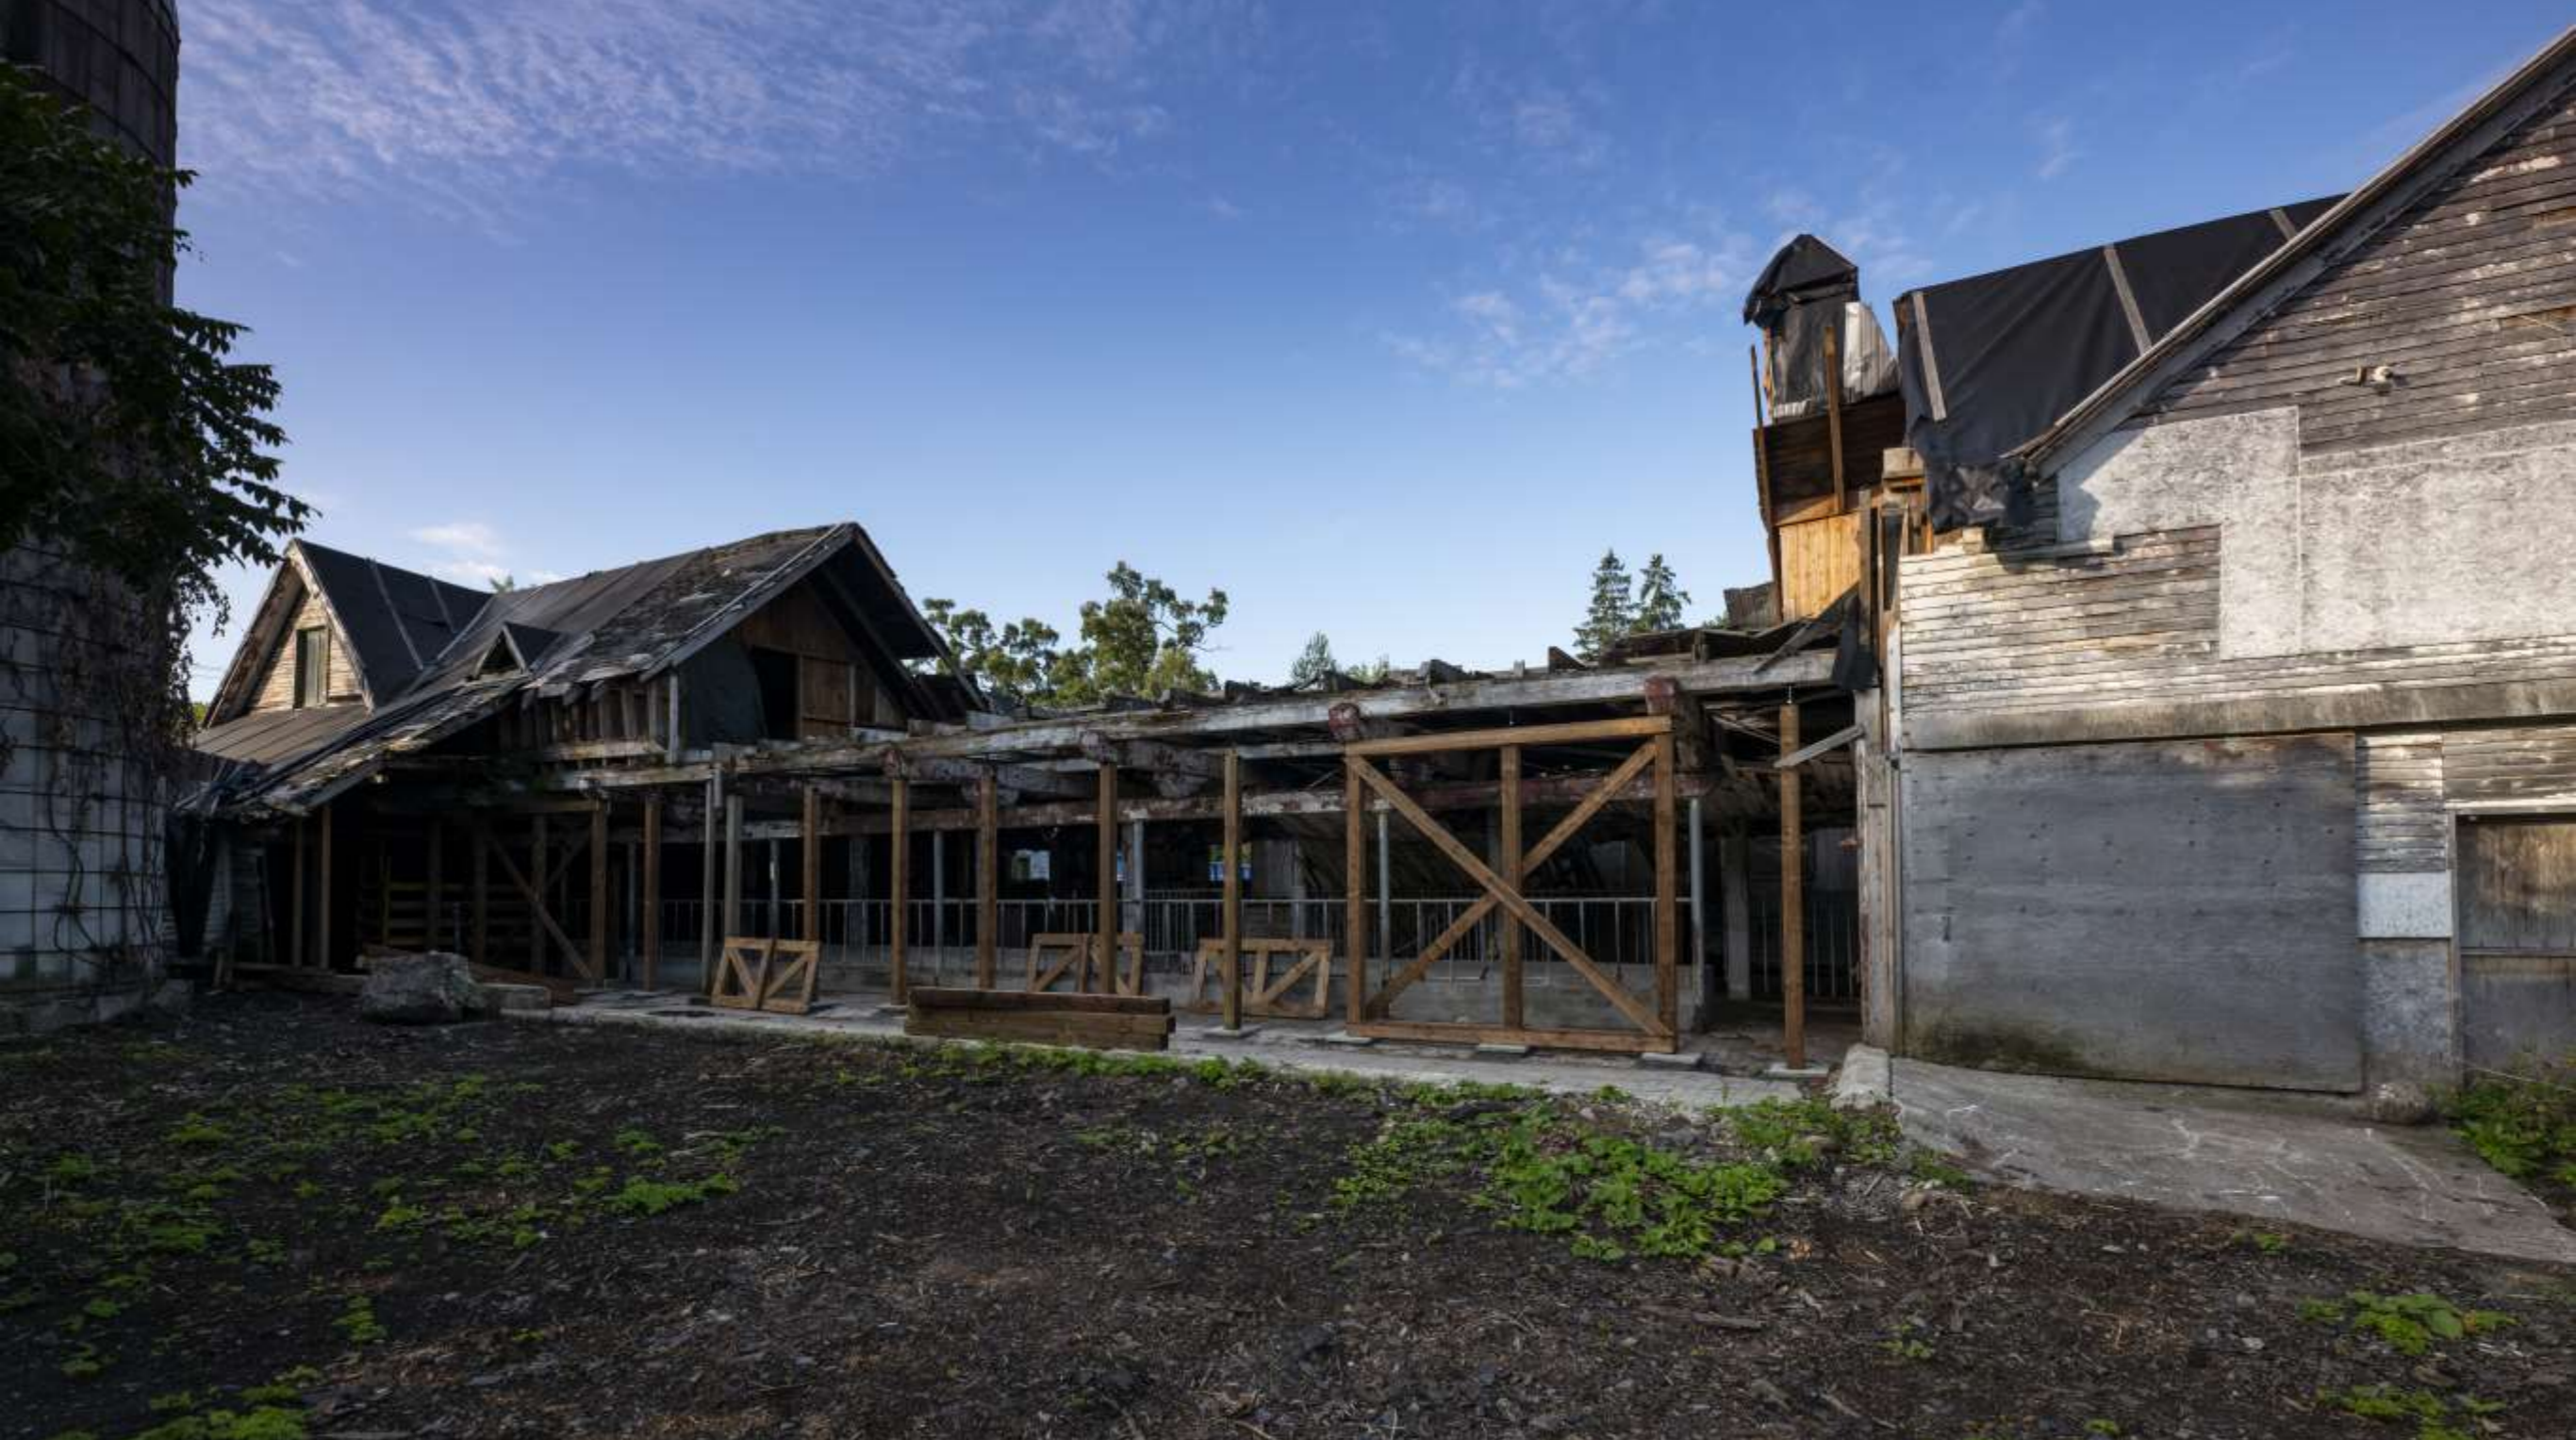
September 2019

With great relief I saw them bringing in new timber to help shore up the existing structure, which seemed to be relatively good. Originally, they had used a massive steel beam that ran the entire length of the building, and this was still intact. Where would the city go at this point. Would it be a complete restoration, or partial?

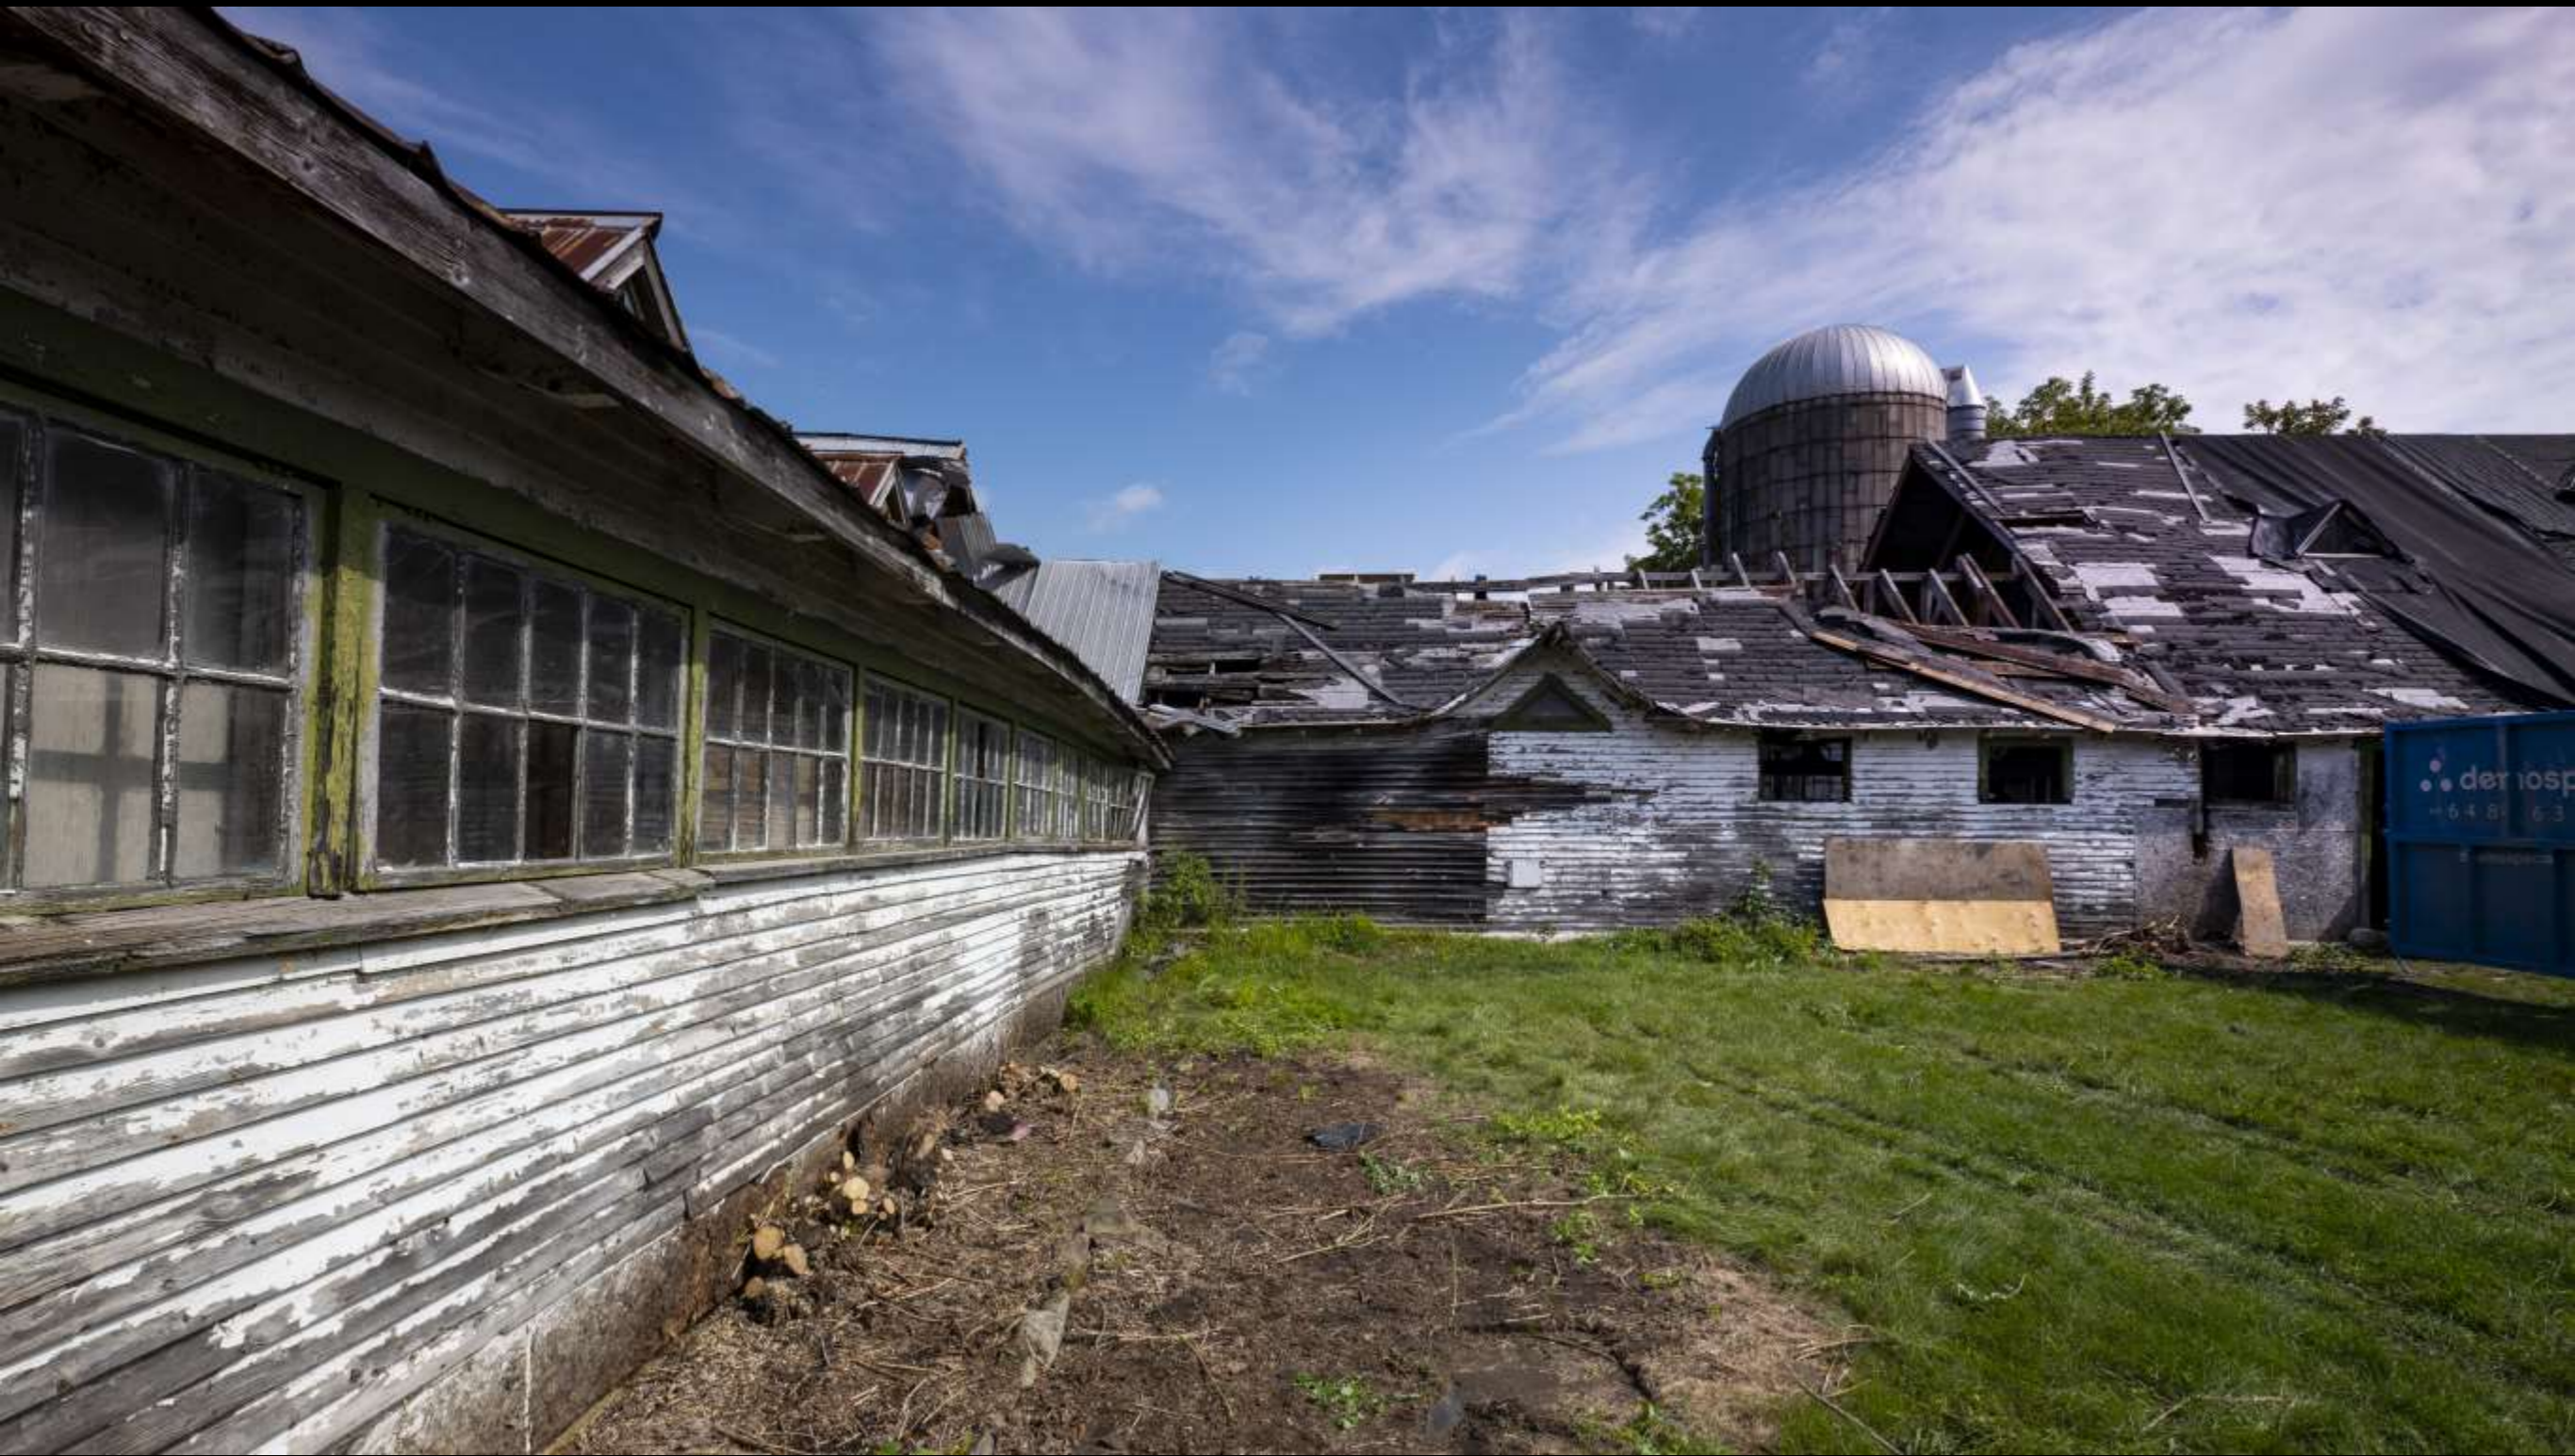
After the clean up the front facade is seen as having suffered not that much damage.

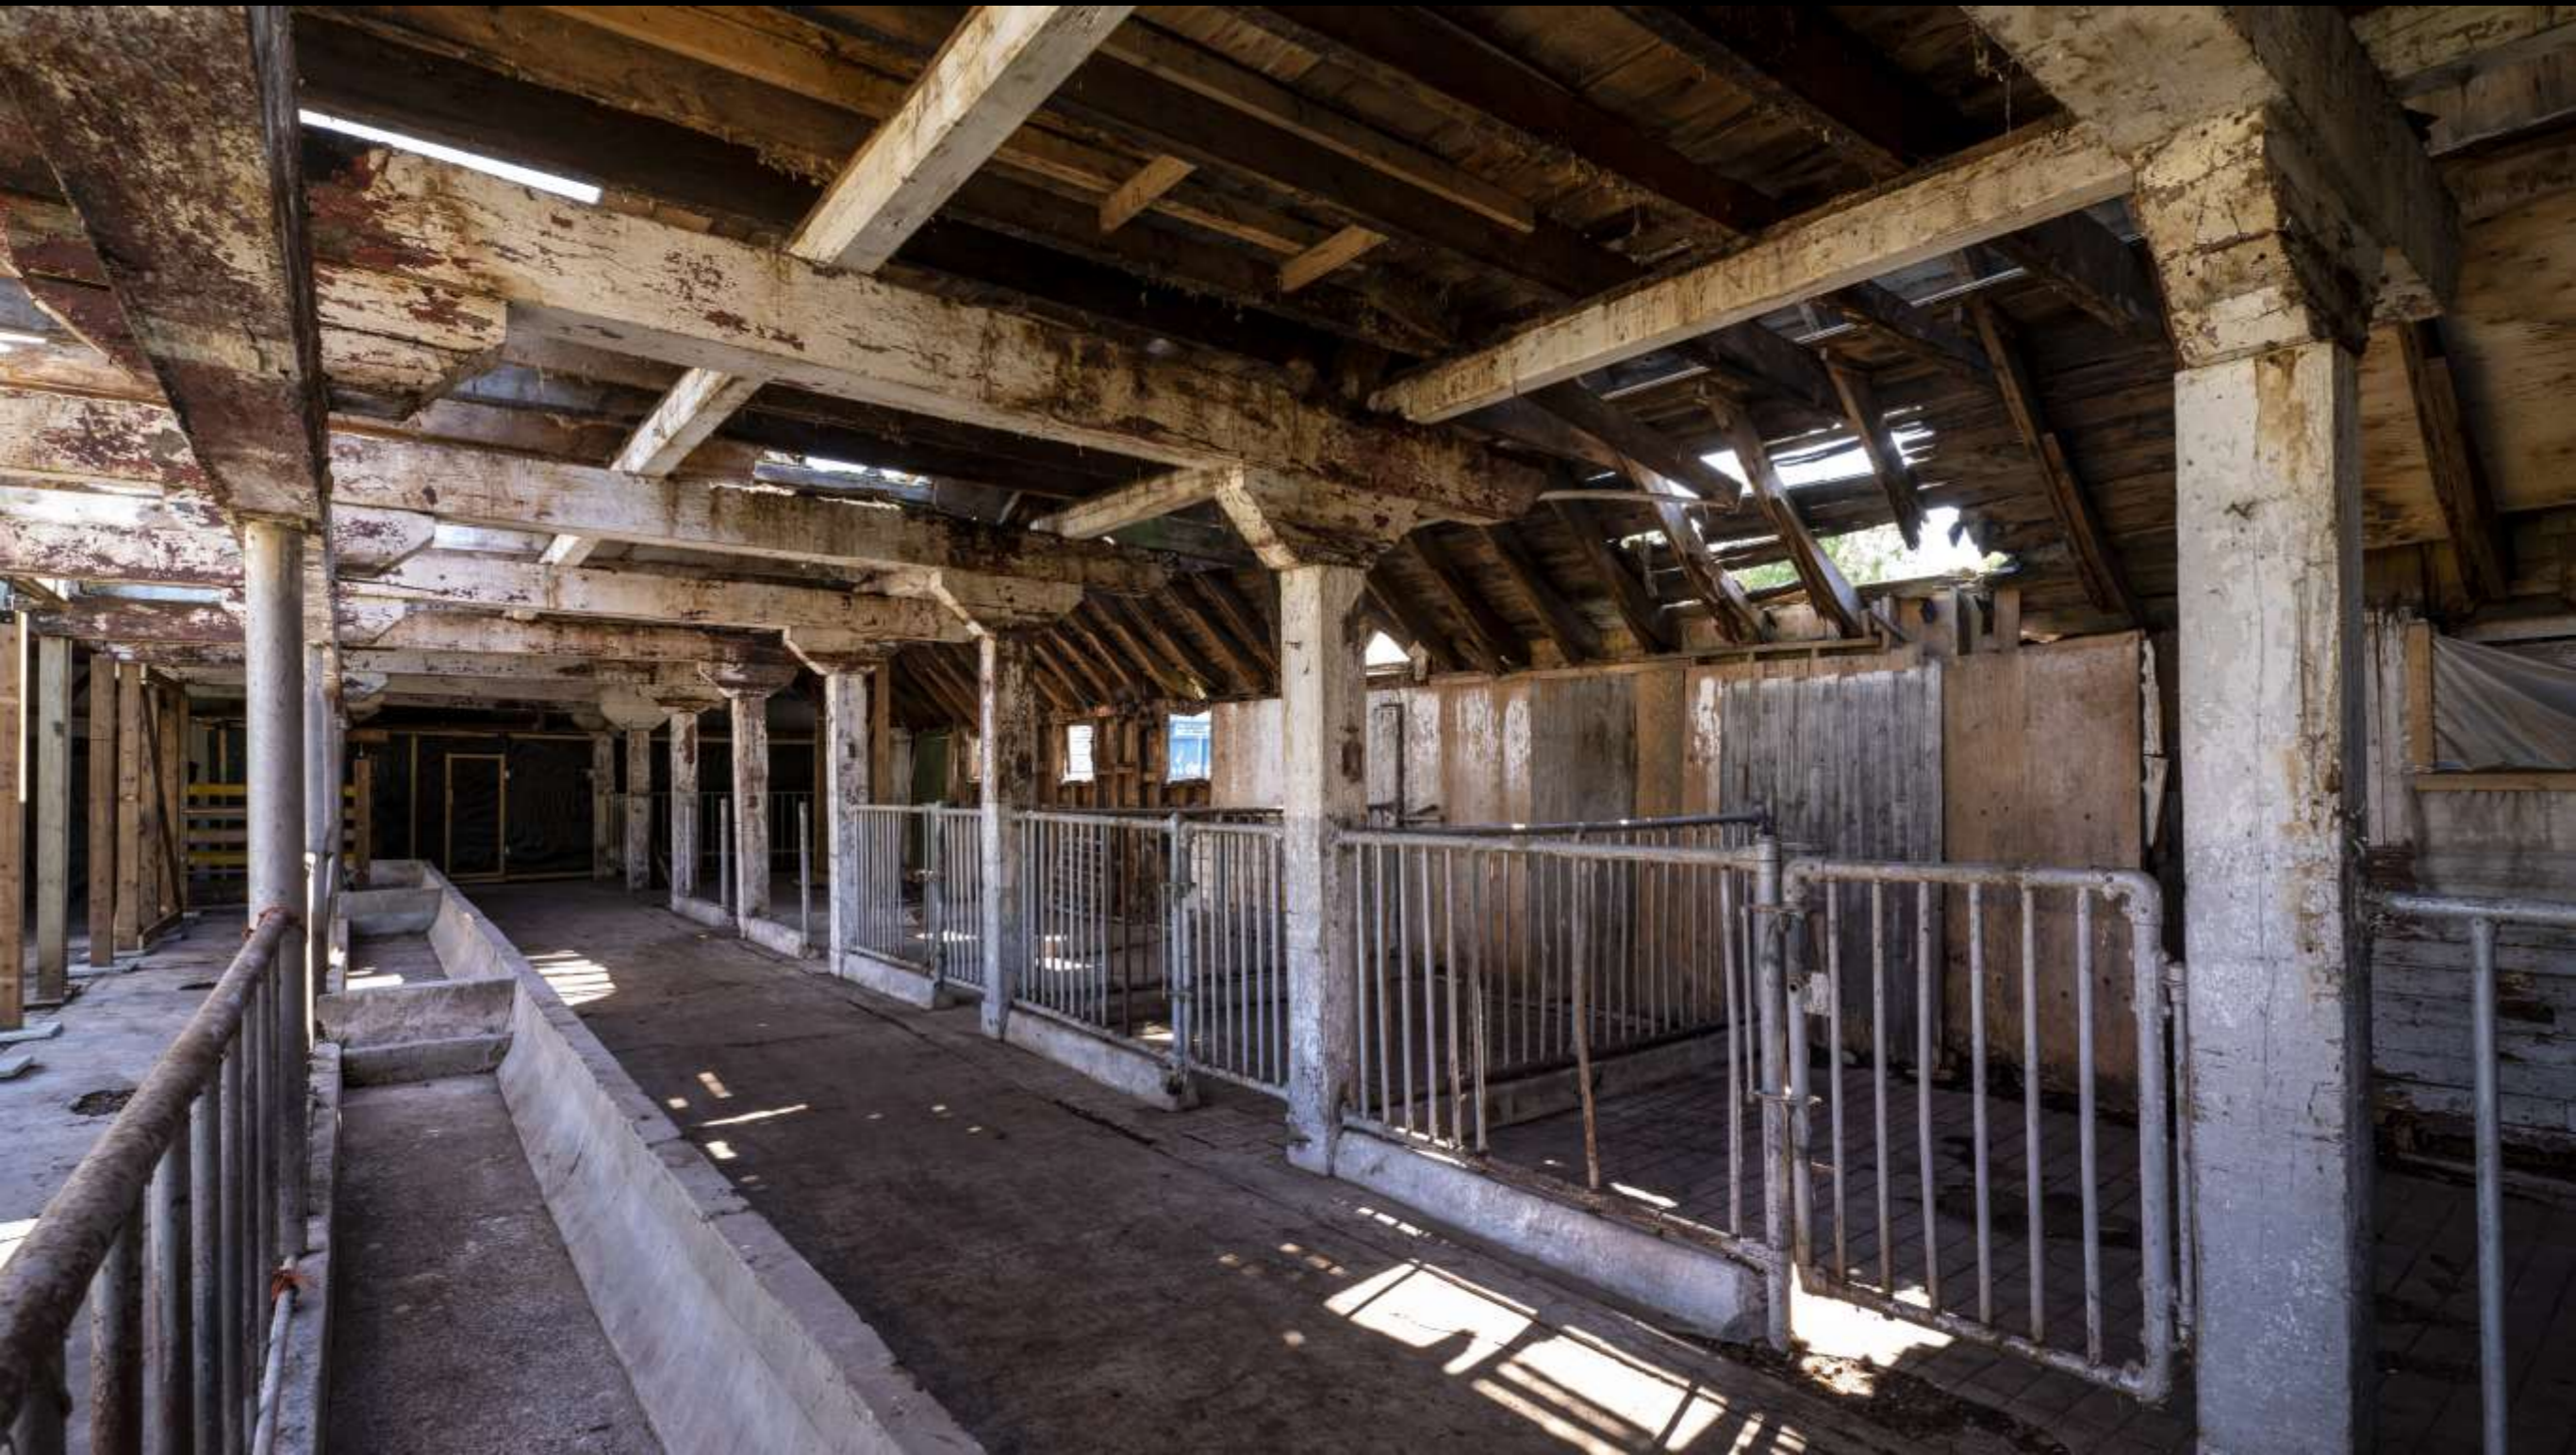
To the casual observer, the main structure appears to be sound. Everything here appears to be remarkably straight and as it should be. It is only the outer shell that suffered damage.
