The Bois de la Roche stables at 292 Senneville Road, are on the endangered list compiled by Heritage Montreal. The wooden horse barn, built between 1880 and 1900, and enlarged in 1902, was part of the country estate of Senator Louis-Joseph Forget, whose property was acquired by the Montreal Urban Community in 1991. These stables were enlarged by architects Edward and William Maxwell.

Portions of these stables are threatened, and there has been a collapse of one section in the past few years. A temporary structure has recently been put in place to hopefully prevent further damage.

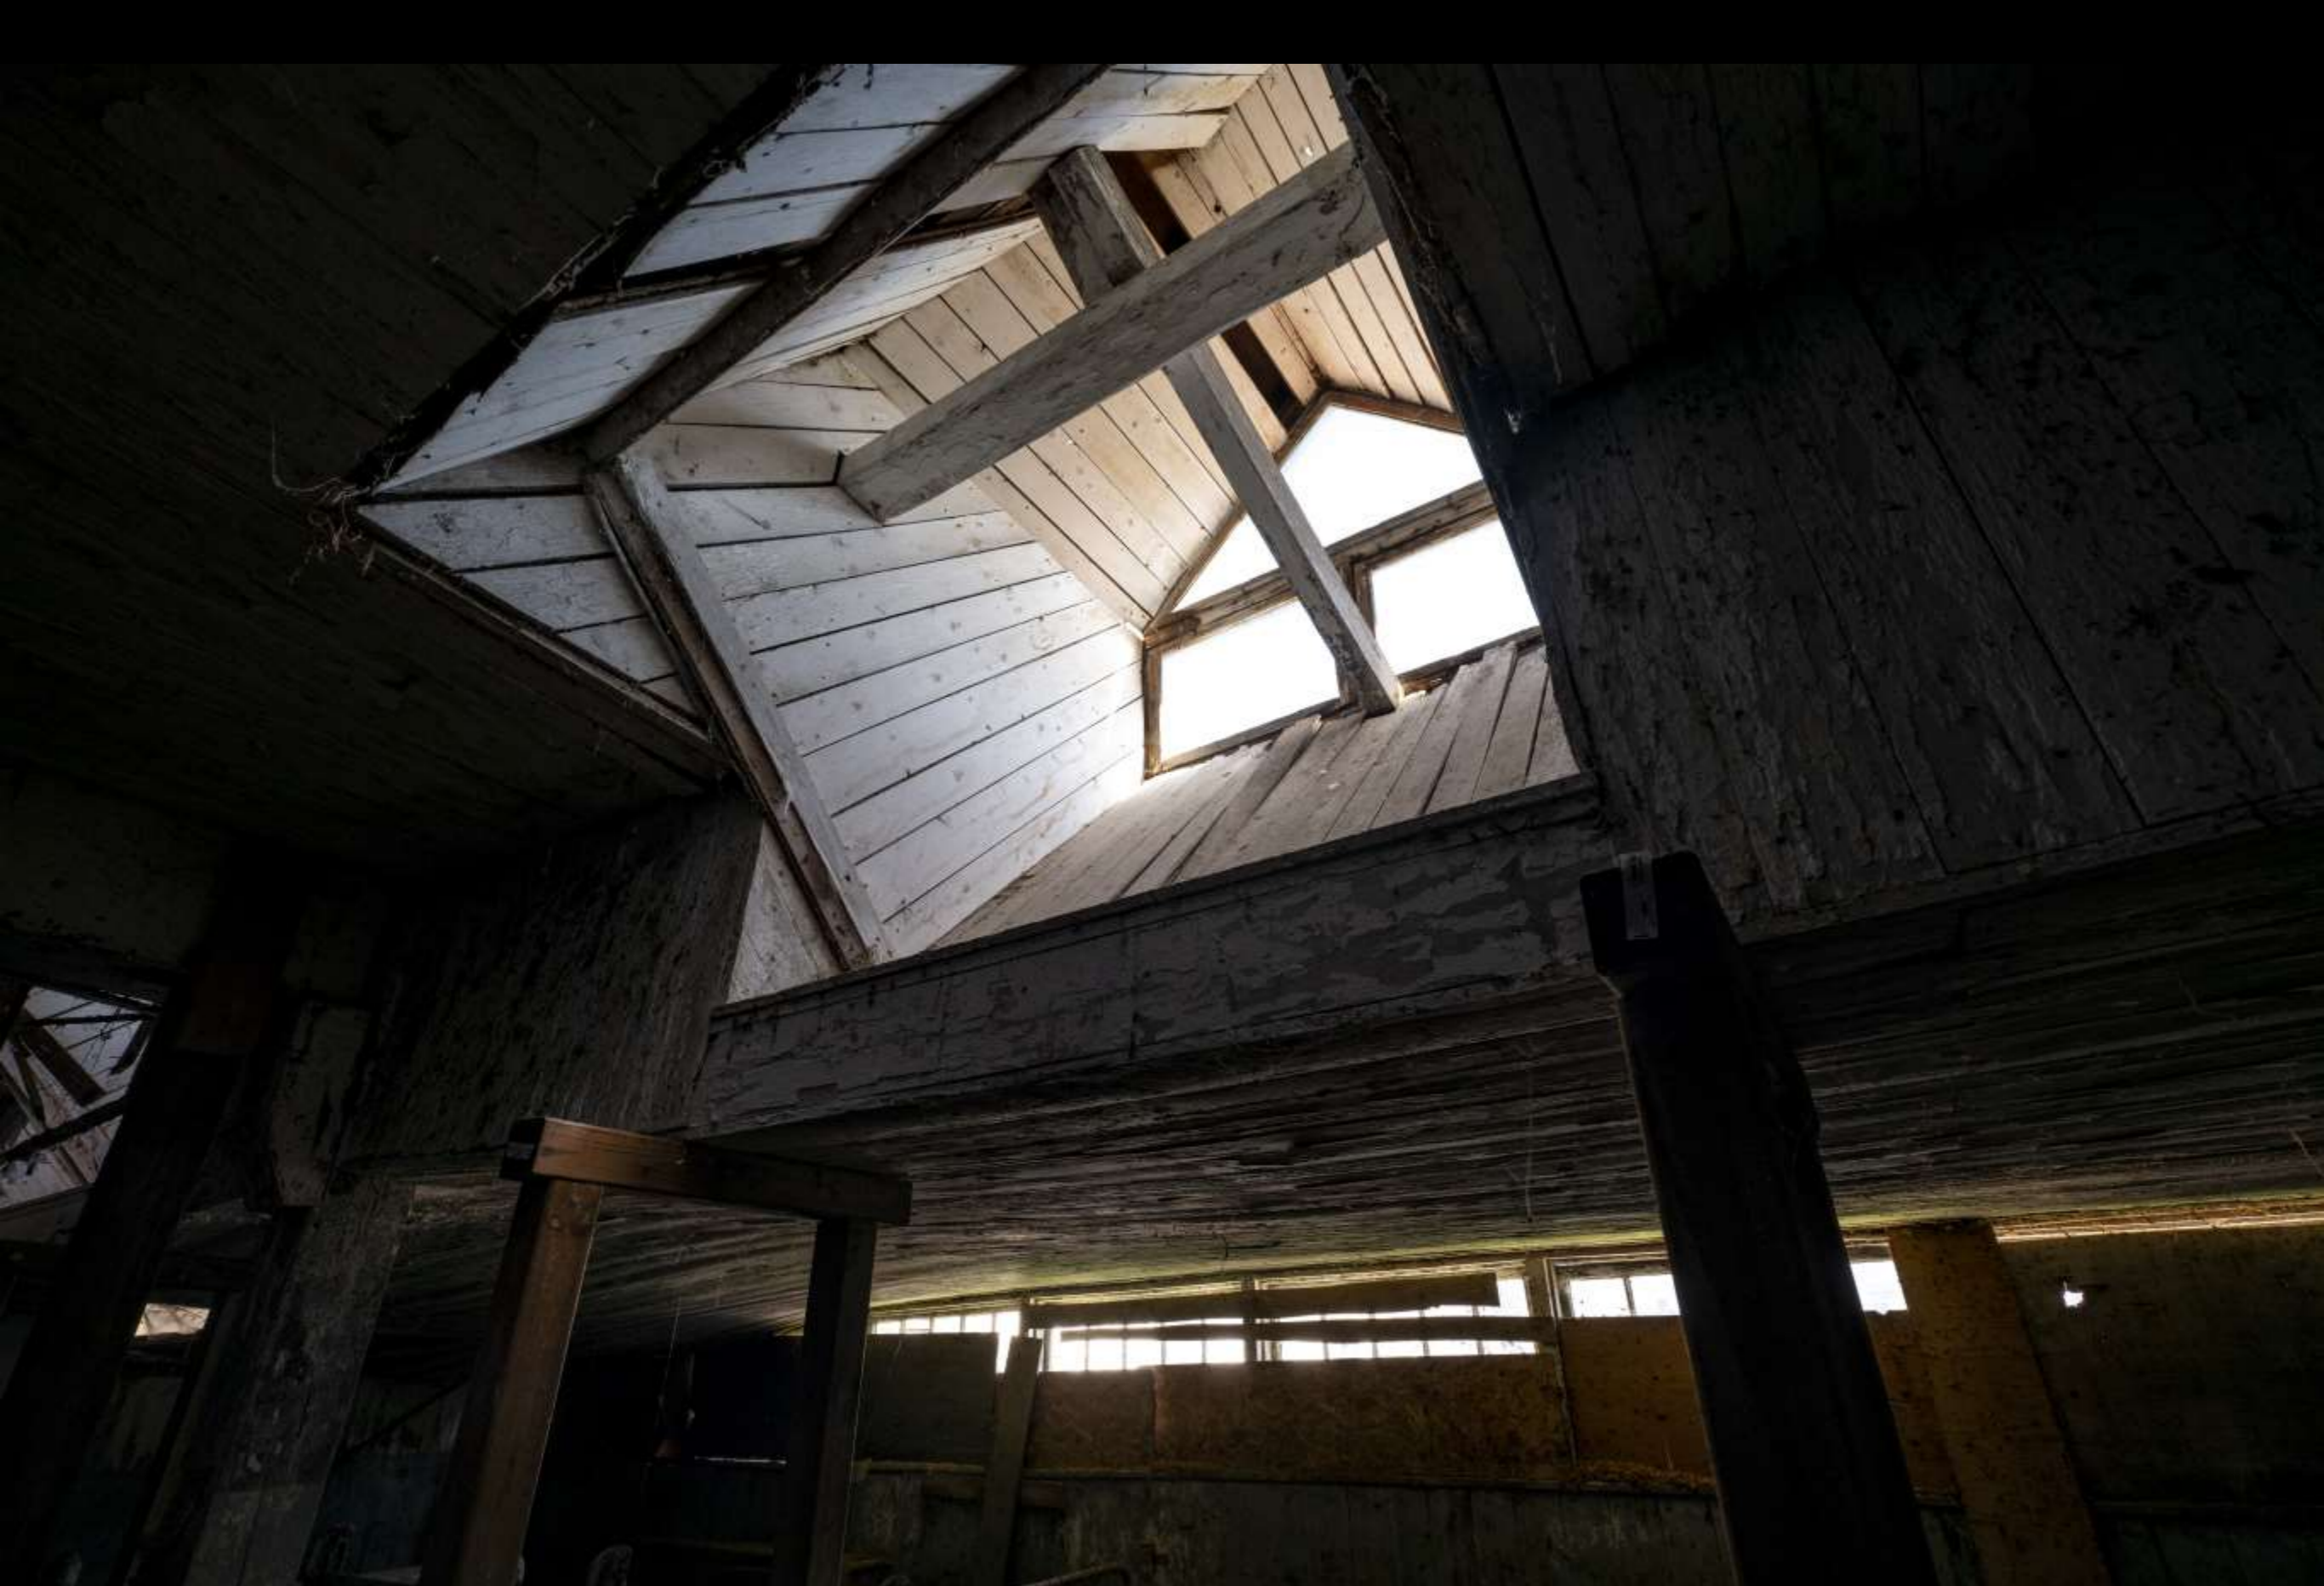
An interesting window detail from the original horse barn that was designed to reflect light downwards into the stable.

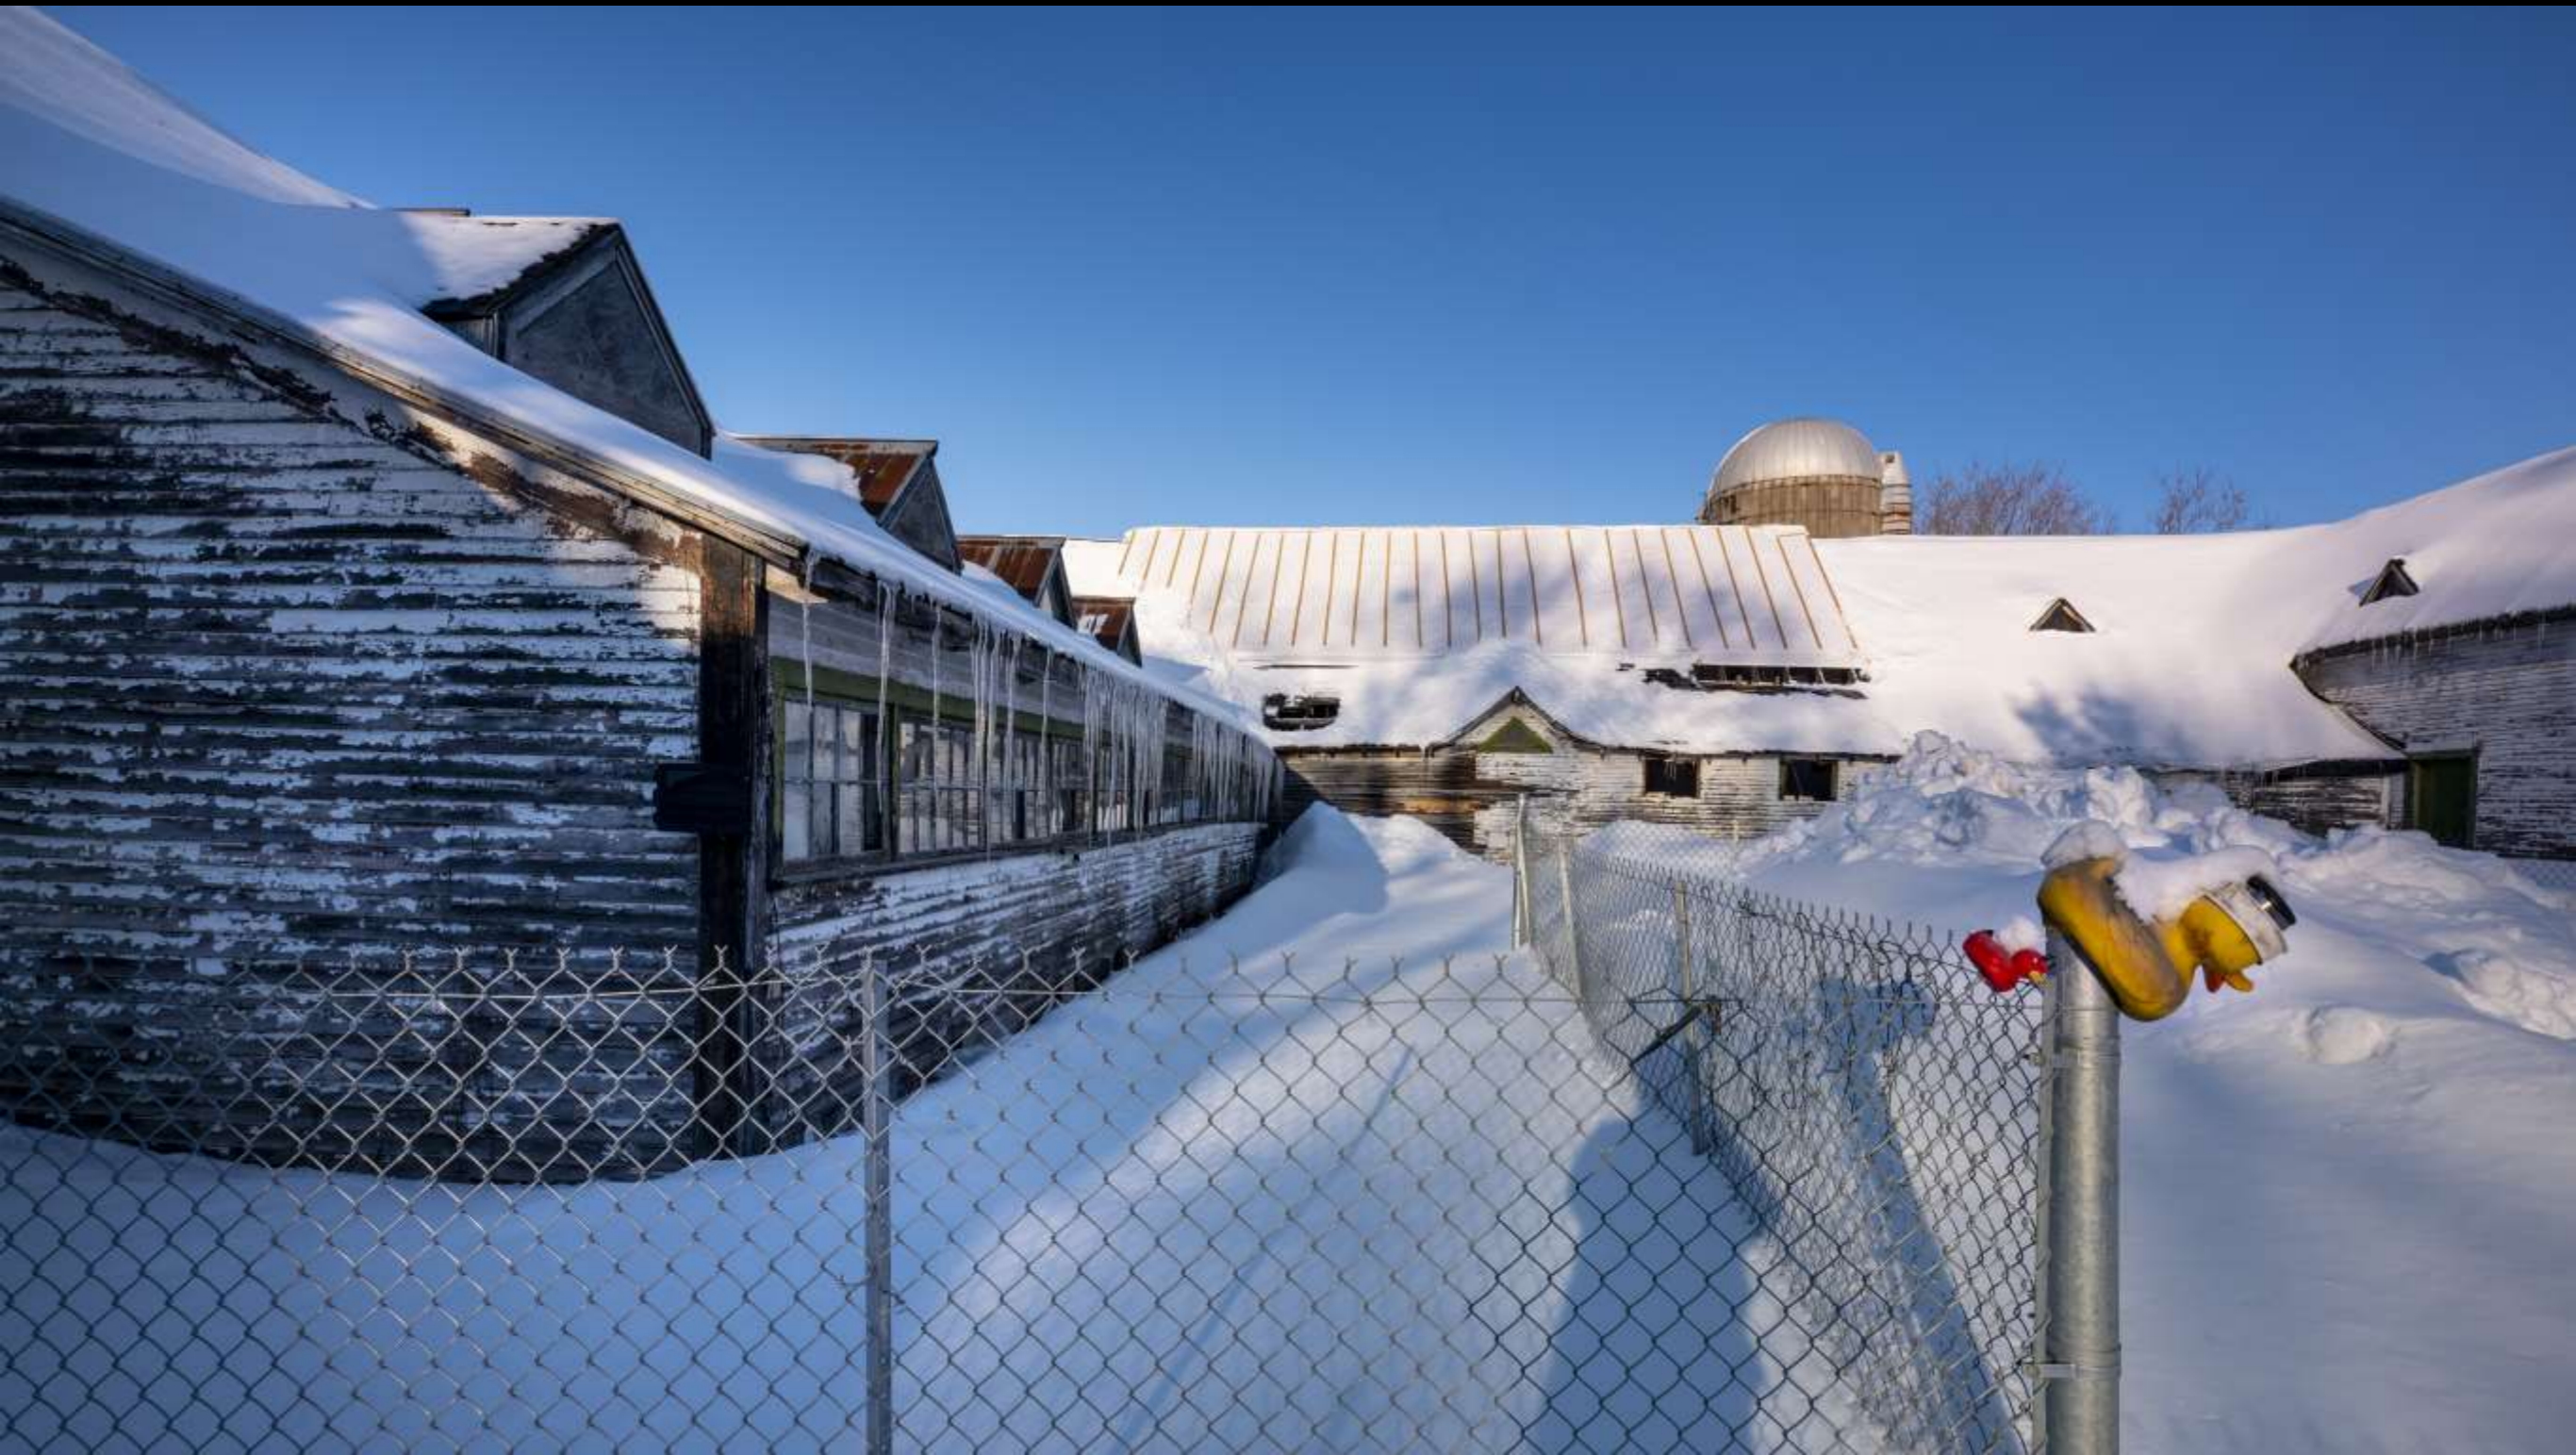
March 2020

The work was completed last fall to build a protective structure over the open area to the rear, and a good portion of the roof.

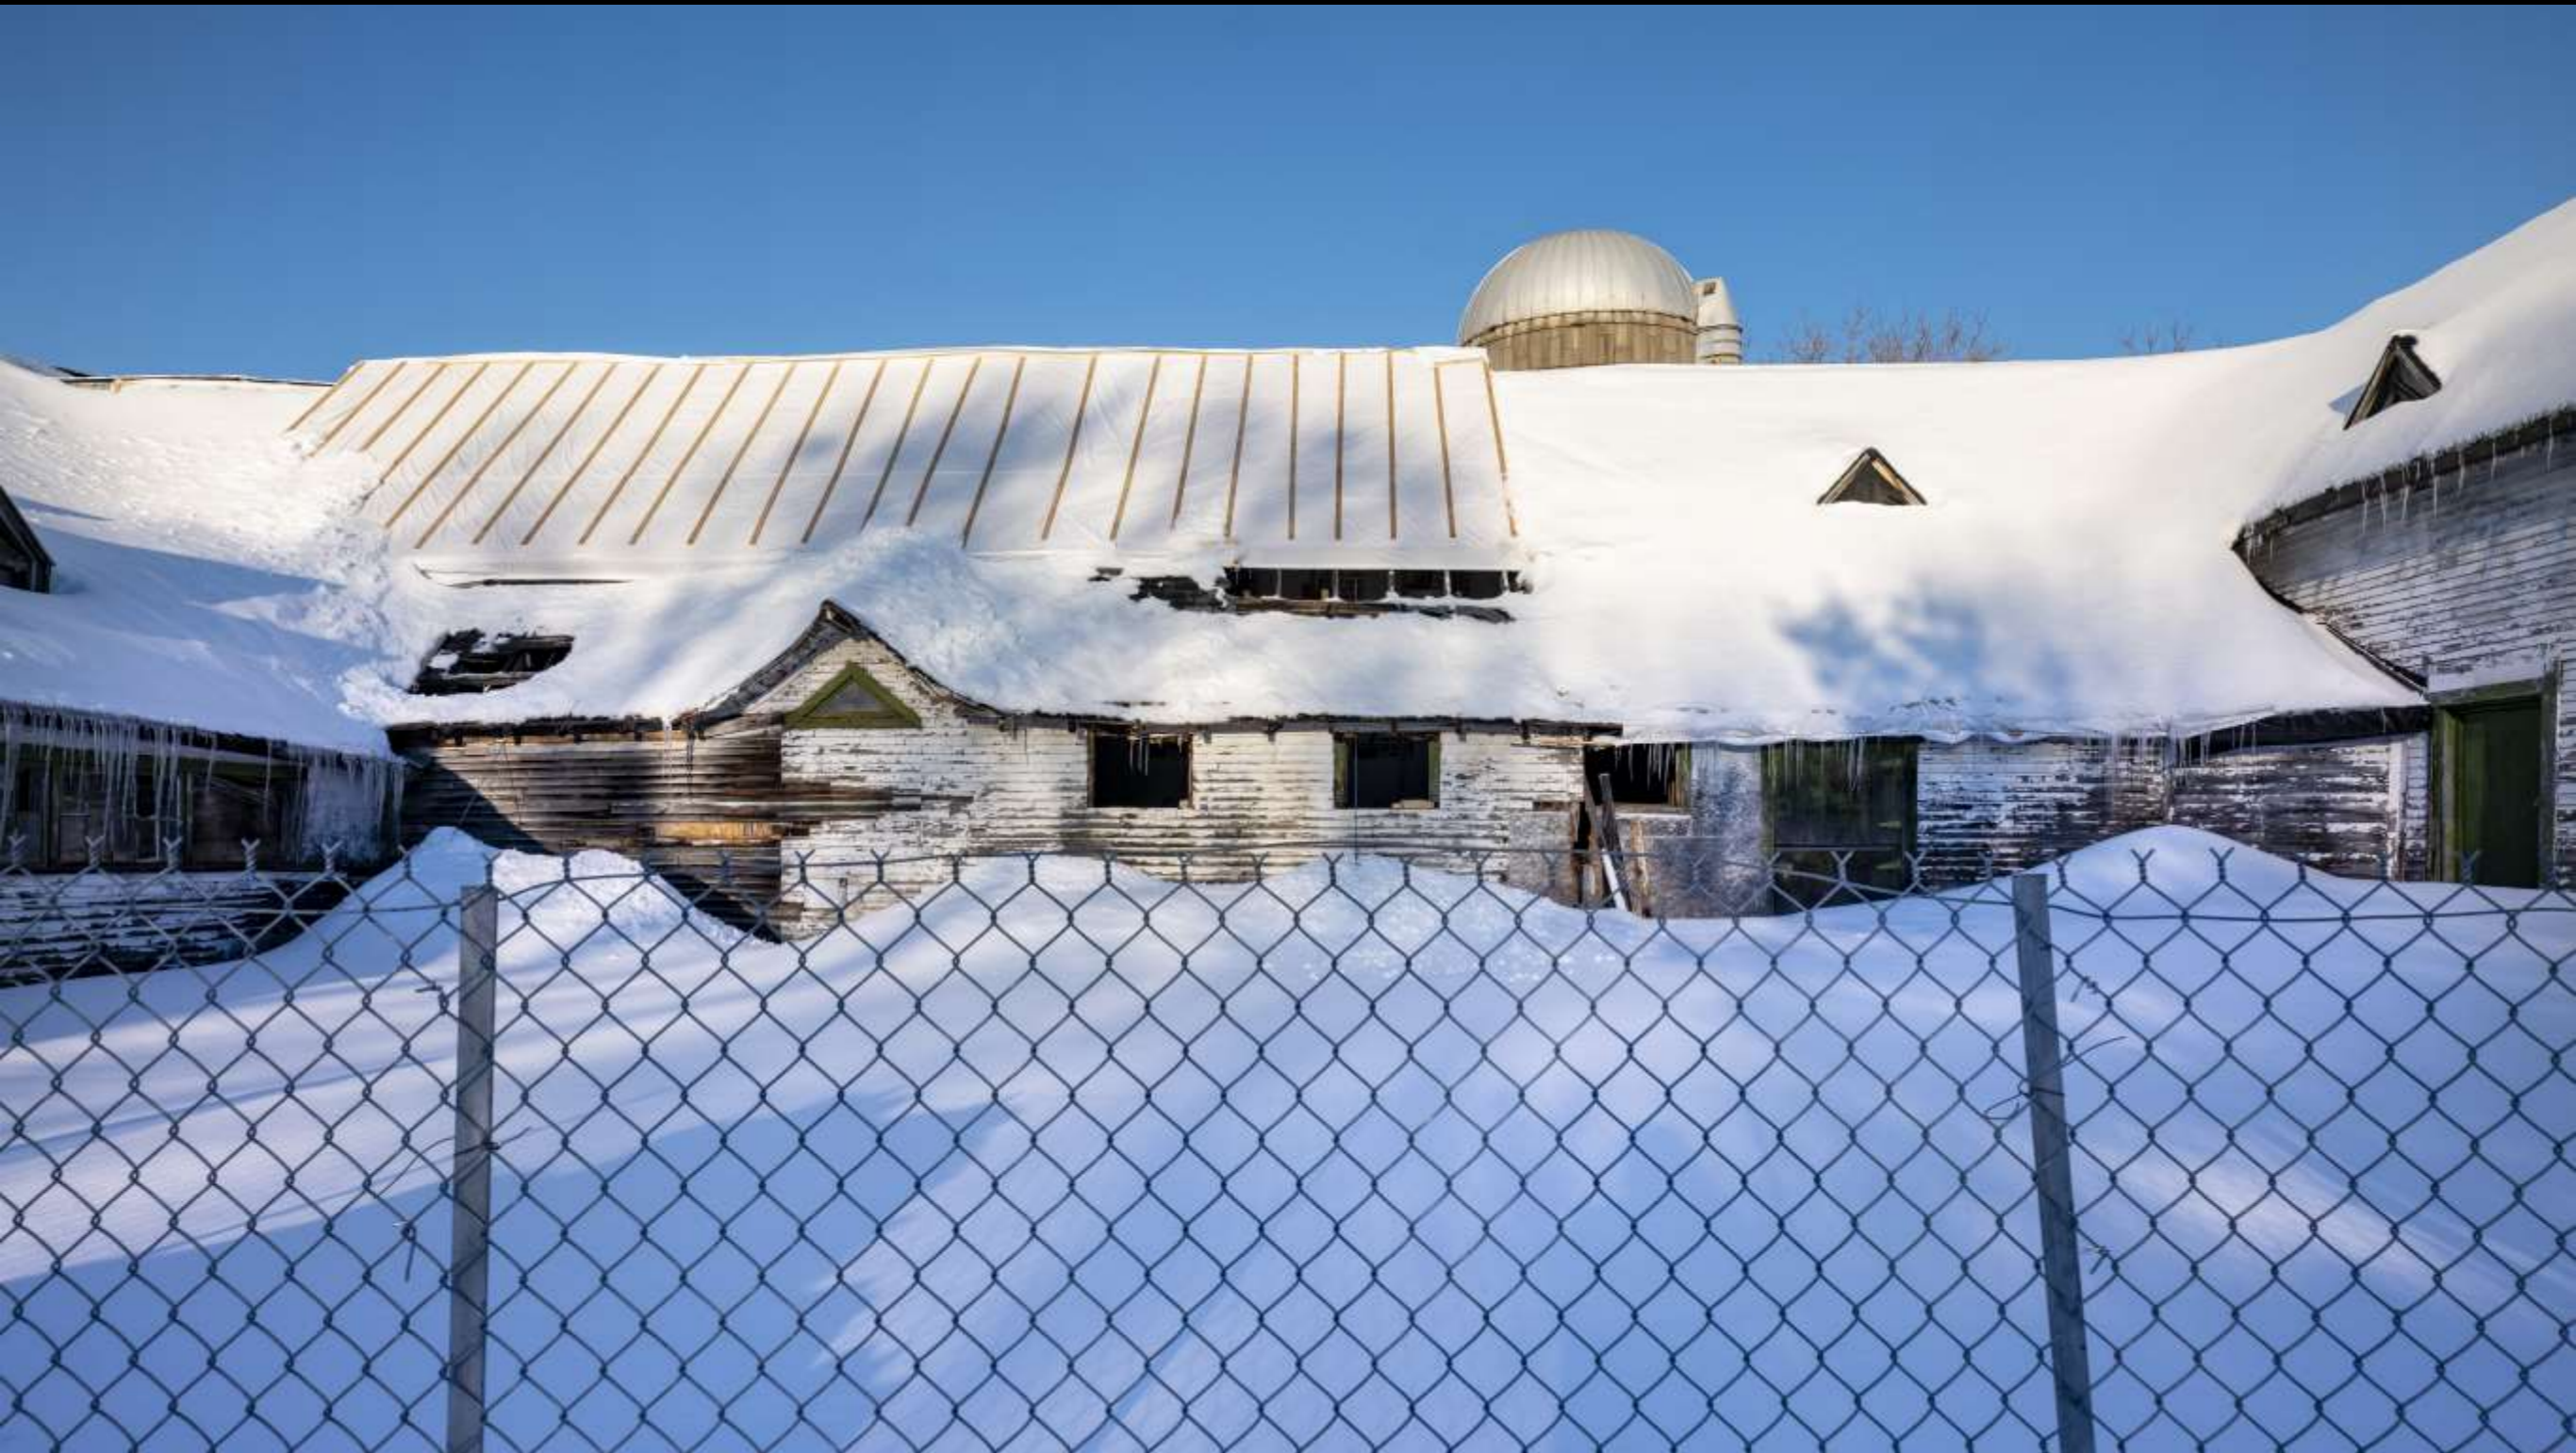
The new protection did not extend downwards far enough to cover open wounds in the roof. Will more be done next year? We should be thankful that this much was done.

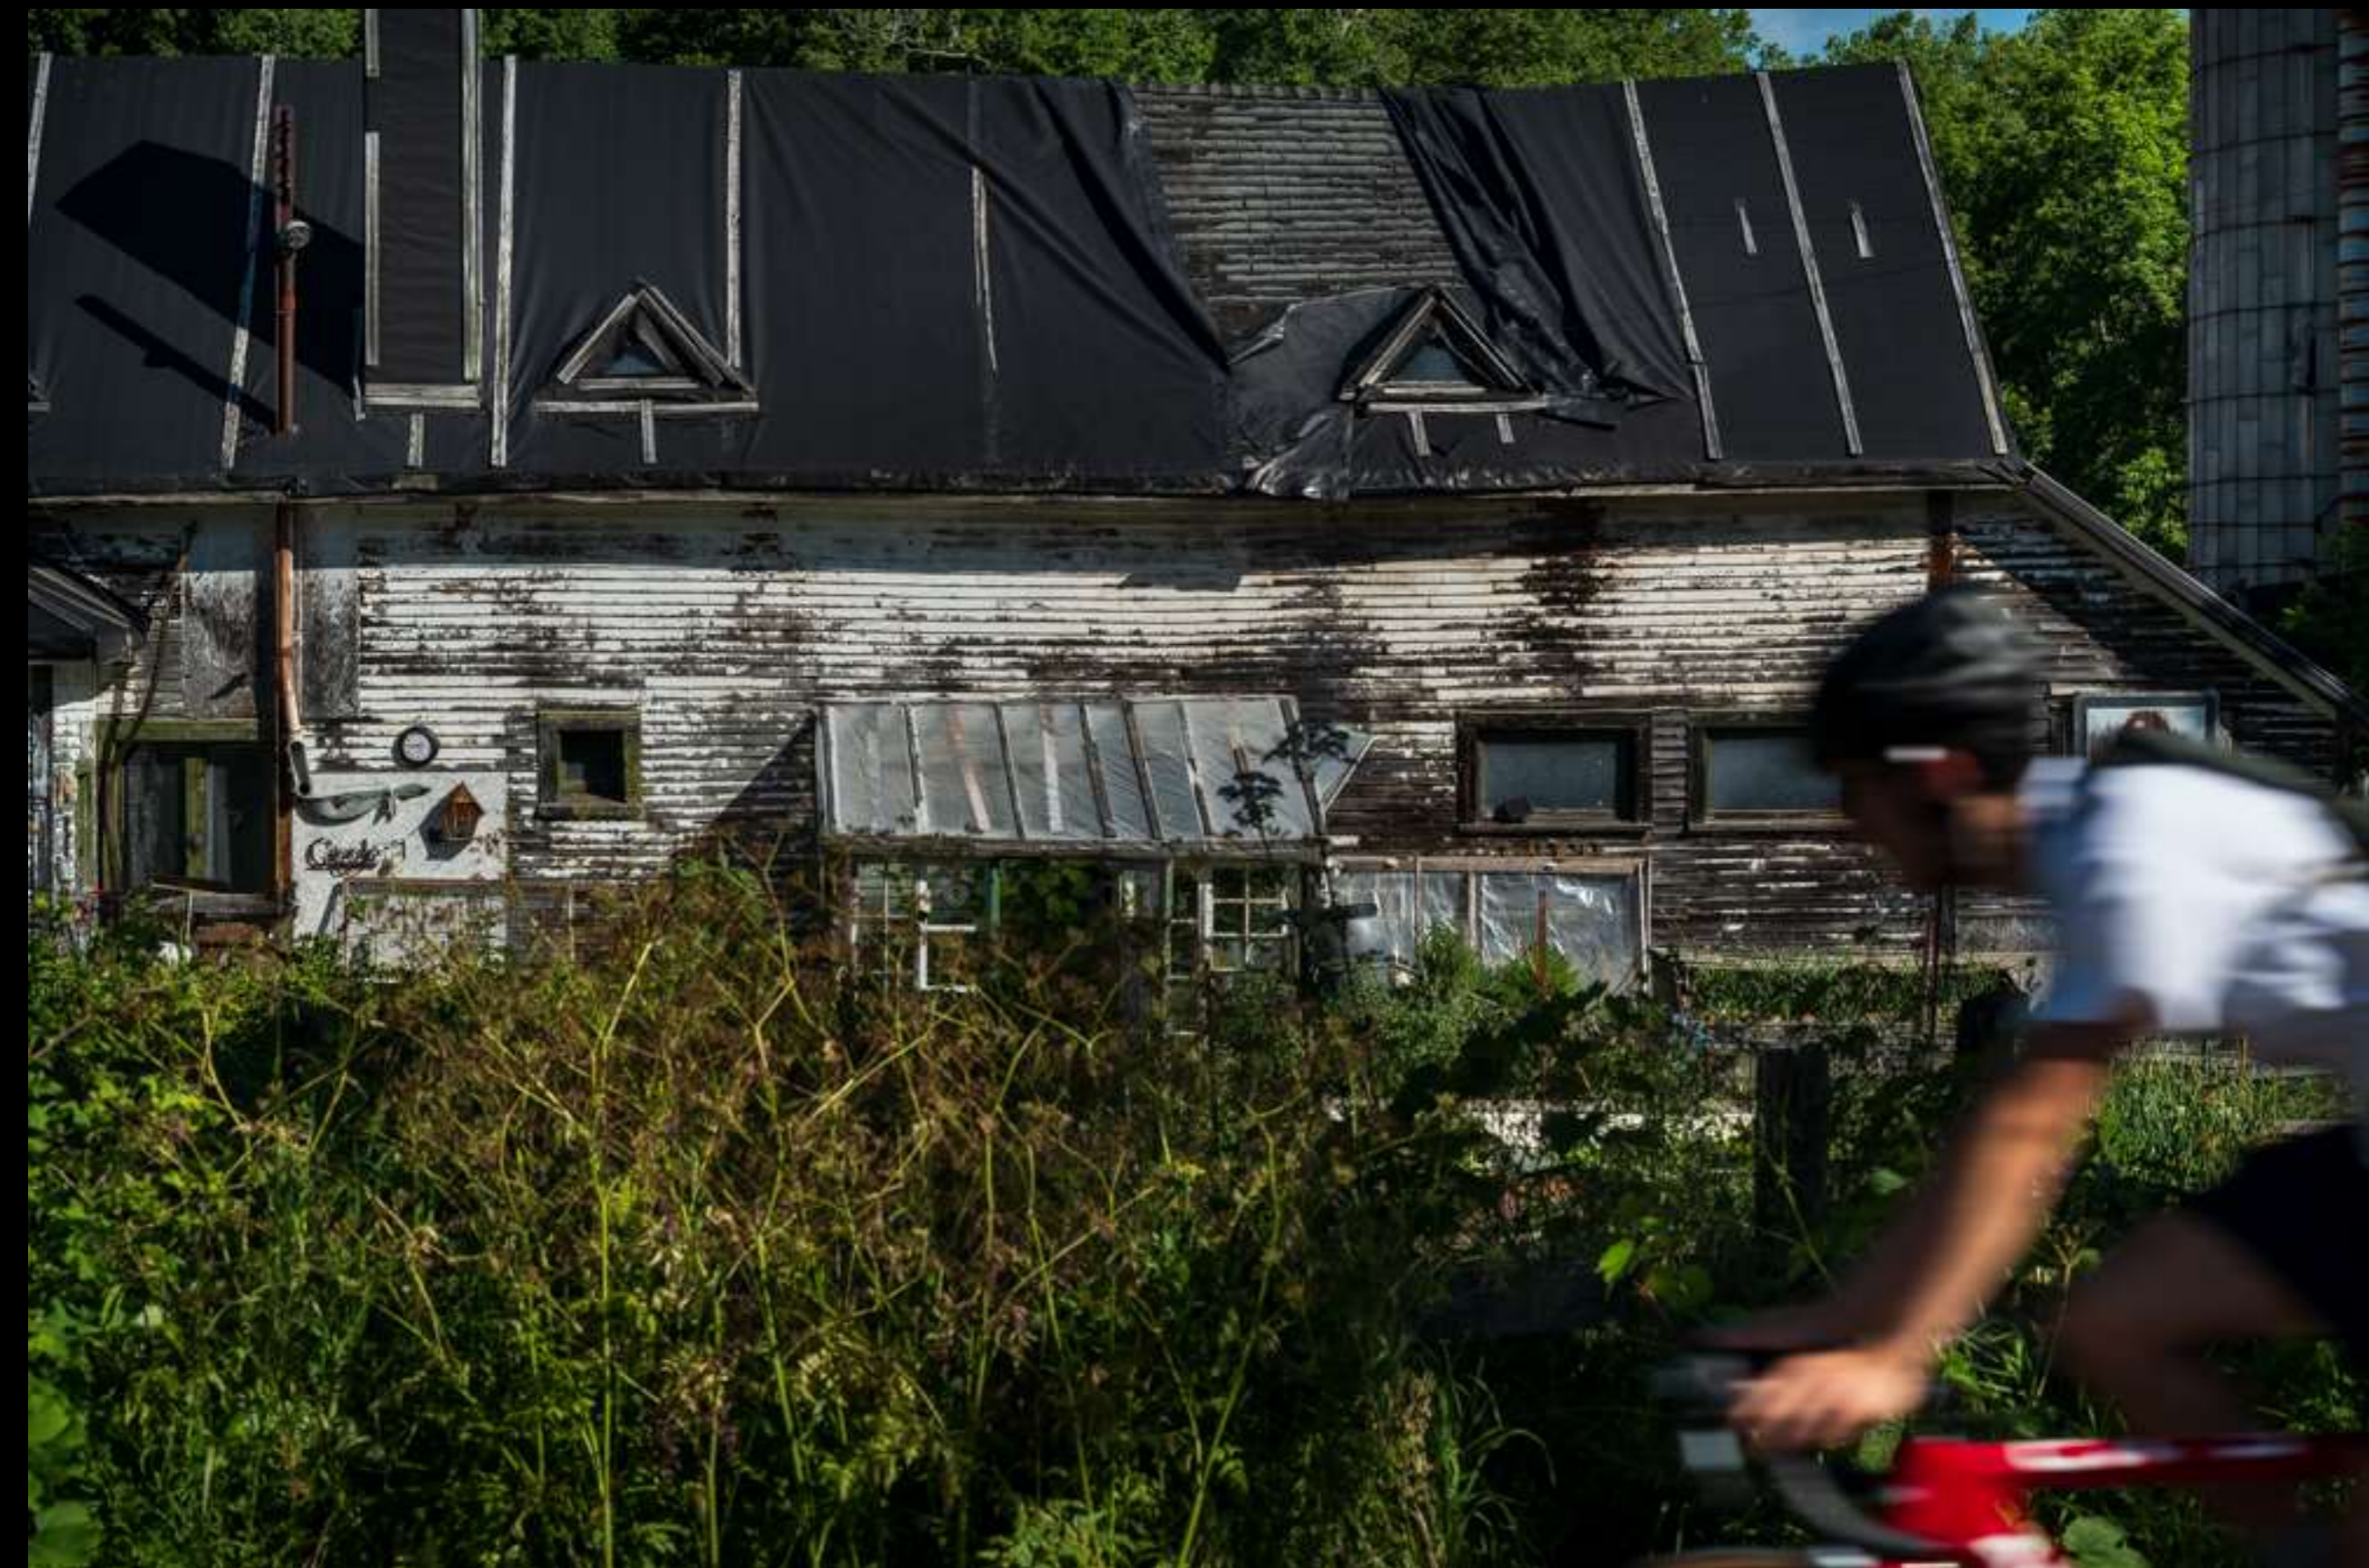
August 22 2022

An opening appears in the roof covering
